CAMPAIGN BULLETIN

Front Wheel Sensor Harness Inspection

Reference: PC721
Date: February 14, 2020

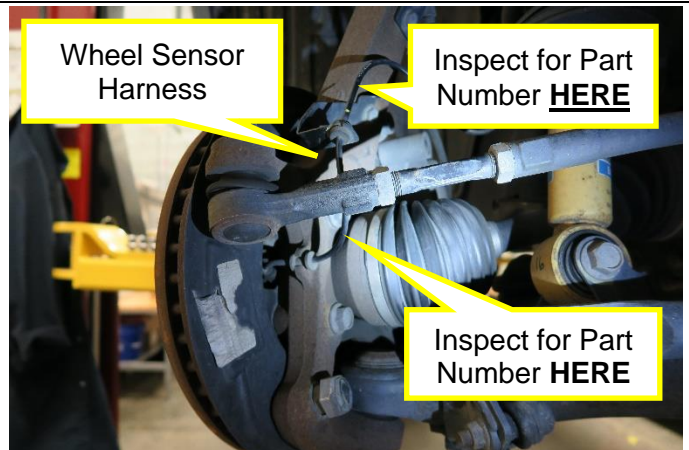
3. Locate right front and left front wheel sensor harnesses (passenger side [RF] shown in Figure 2, driver side is similar).

4. Inspect right and left front wheel sensor harness part numbers (Refer to Figures 2, 3, and 4).
- Check both locations on the harness as shown in Figure 2 for the part number
 - If the harness is dirty, clean with a water-dampened rag (do not use cleaning chemicals).

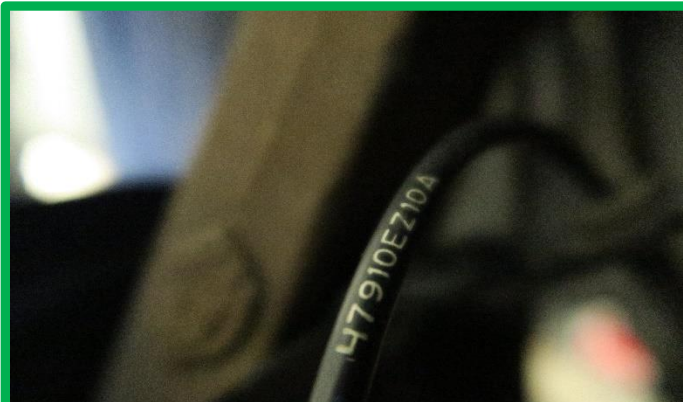
Figure 3

PN: 47910-EZ10A (GOOD)

- a. If the wheel sensor part numbers are **47910-EZ10A (GOOD)**. No further repair is required. Proceed to Step 5. Submit claim using Op Code PC7210.
- b. If ONE or BOTH of the wheel sensor part numbers is **47910-1PA0A (REPLACE)** only the affected wheel sensor per the ESM: **BRAKES > BRAKE CONTROL SYSTEM > VDC/TCS/ABS > REMOVAL AND INSTALLTION > WHEEL SENSOR > FRONT WHEEL SENSOR > REMOVAL AND INSTALLATION**. Use the part number listed in the Parts Information section. Torque the wheel sensor retaining bolt to **8.25N·m (73 in-lb)**. Submit claim per Claims Information section. Continue to Step 5.

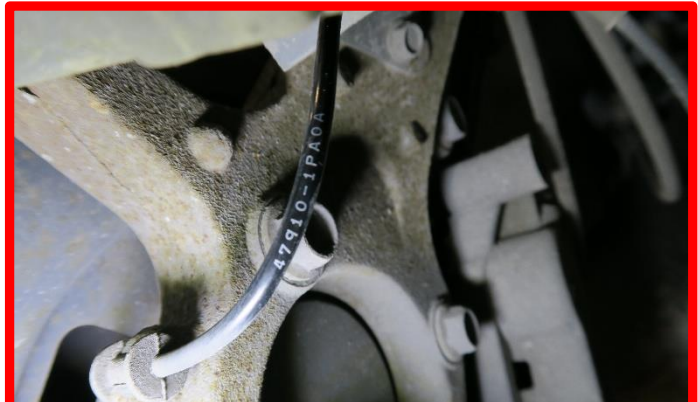
Figure 4

Due to a supplier quality issue, that has since been corrected; the incorrect sensor may have been installed on the front wheel hub.

PN: 47910-1PA0A (REPLACE)
