CAMPAIGN BULLETIN

Rear Combination Lamps

Reference: PM938
Date: February 27, 2020

PM938 – 2020 VERSA REAR COMBINATION LAMPS

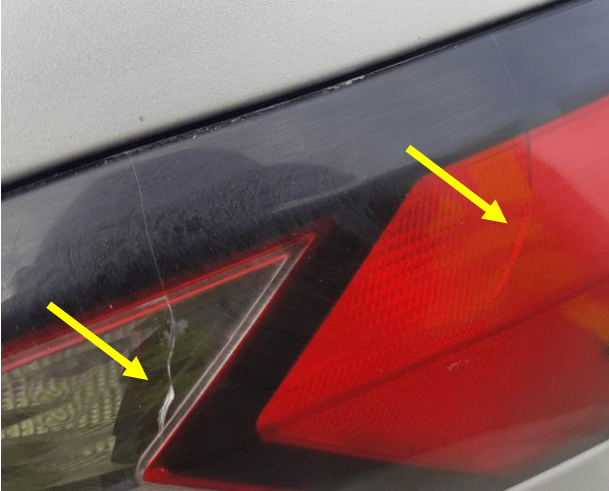
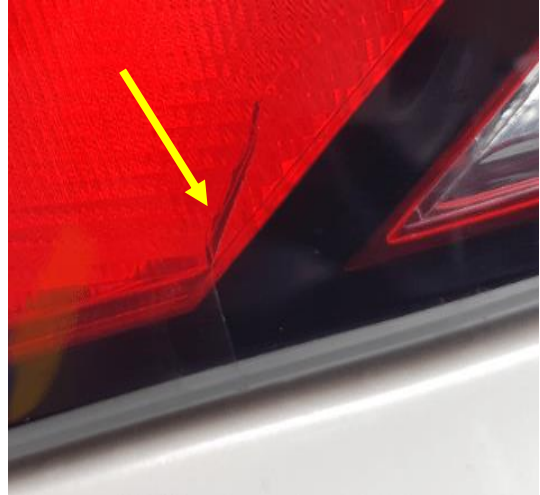
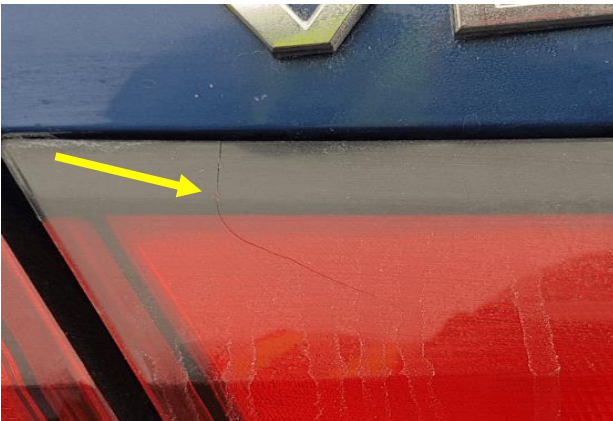
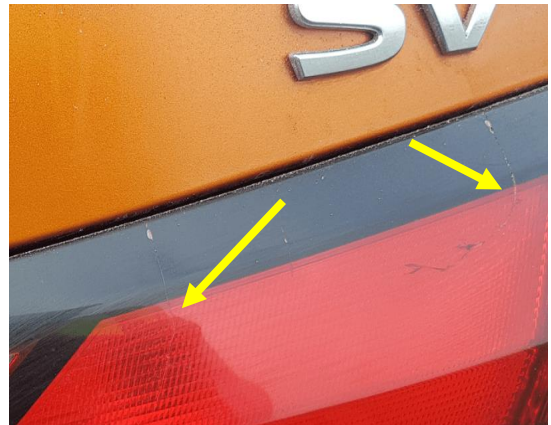
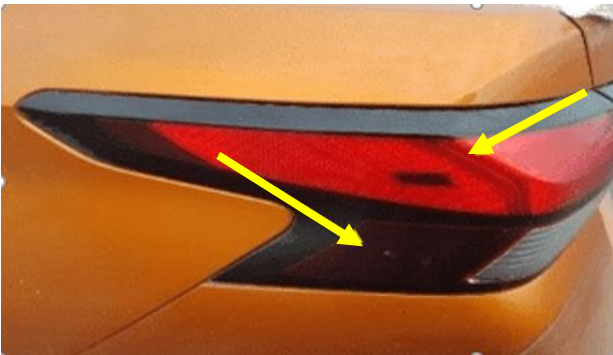
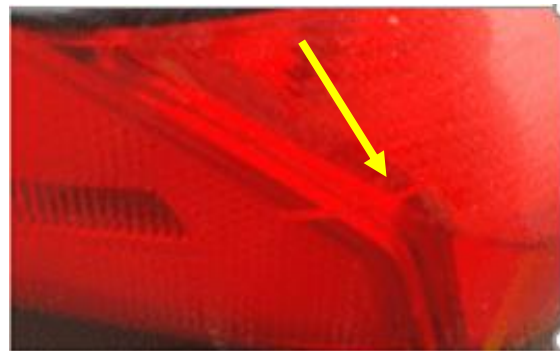
Chemical residue from the temporary exterior finish protection chemical used during handling, transportation, and storage could cause the combination lamps to crack.

- Inspect for cracks on the entire lense surface
- Refer to Figures 4-9 for examples of cracked lamp assemblies

- **NO** – No further repair is required.
- **YES** – Replace only the affected rear combination lamp per the ESM path found below. Use the part number listed in the Parts Information section.
 - Left and Right Rear Combination Lamp (Body Side): **DRIVER CONTROLS > EXTERIOR LIGHTING SYSTEM > LED HEADLAMP > REMOVAL AND INSTALLATION > REAR COMBINATION LAMP (BODY SIDE)**
 - Left and Right Rear Combination Lamp (Trunk Lid Side): **DRIVER CONTROLS > EXTERIOR LIGHTING SYSTEM > LED HEADLAMP > REMOVAL AND INSTALLATION > REAR COMBINATION LAMP (TRUNK LID SIDE)**
