Service Bulletin

Bulletin No.: 20-NA-022

Subject: Clunking Noise from Rear of Vehicle (Re-torque Leaf Spring Bolts)

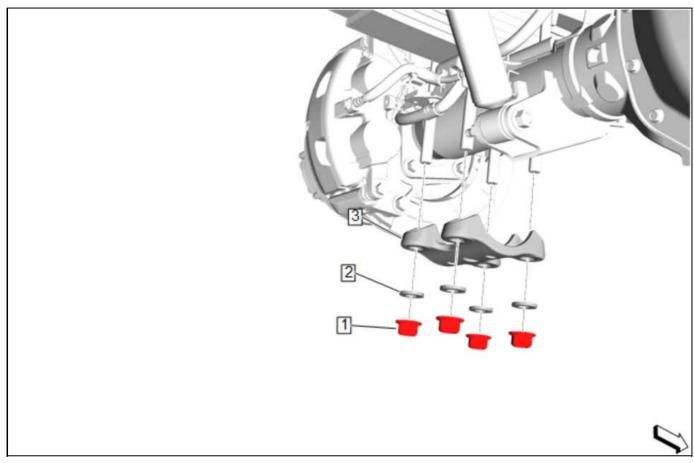
5295289

Involved Region or Country	North America, Middle East		
Condition	Some customers may comment about a clunking noise coming from the rear of the vehicle. Upon further investigation, the technician may diagnose the noise coming from the rear suspension leaf spring area.		
Cause This condition may be caused by movement between the anchor plate and axle assembly.			
Correction	The noise may be resolved by re-torqueing the joints of the leaf spring assembly.

- 2. Loosen the leaf spring U-bolts (1).
- 3. Re-torque the leaf spring U-bolts (1). Refer to SI for torque specifications.
- 4. Repeat steps 2 and 3 for the right side leaf spring.
- Re-test the vehicle for the same clunking noise. If the issue remains, continue diagnosis referring to SI.
