Service Bulletin

Bulletin No.: 13-06-01-003J

Subject: Excessive Oil Consumption – Perform Oil Consumption Test and/or Install Piston and Piston Ring Kit

Models: 2010-2013 Buick LaCrosse
2011-2013 Buick Regal
2012-2013 Buick Verano
2010-2013 Chevrolet Equinox
2012-2013 Chevrolet Captiva, Orlando (Canada Only)
2010-2013 GMC Terrain
Equipped with 2.4L Engine (RPOs LAF, LEA)

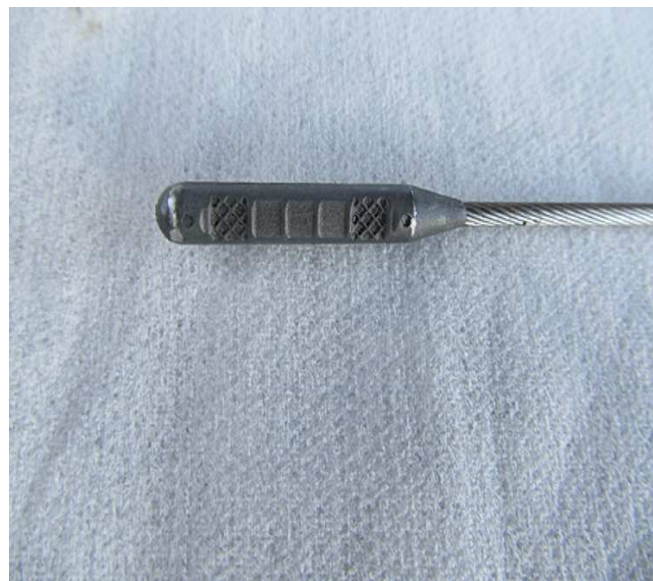
3339530

Important: When checking the oil level with the oil dipstick design shown below, please note that the oil volume per notch is not linear due to the shape of the block. The upper notches (relative to the top of the handle) equal 0.227 L (0.24 quart) between each notch while the lower notches only equal 0.132 L (0.14 quart) between each notch. As a result, no oil will appear on the dipstick if it is low on oil by approximately 1.18 L (1.25 quarts) or more. When determining the oil consumption rate, the oil volume added to return it to the starting location is the total amount of oil consumed. The consumption rate must be documented on a repair order.

Notice: Do not add too much oil. An overfill can lead to burn off of the excess oil. Advise the customer to wait until the oil is below the cross-hatched area at the tip of the dipstick before adding oil.

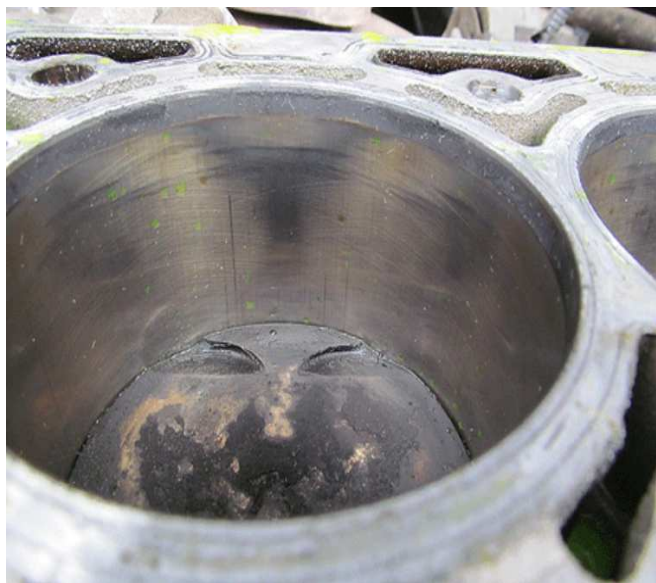
Acceptable Cylinder that Does Not Appear Uniform (Zebra Stripes)

The repair is to replace the pistons and rings. In some cases the bore surface may not have a uniform look to the finish (zebra stripes) as shown below. As a result, some technicians may question whether the engine should be repaired or replaced. After careful evaluation, GM Powertrain has determined that the new pistons and rings will perform correctly in bores that have this appearance, so engine replacement should not be necessary. The cylinder bores do not need any machine or honing work performed on them. Refer to the picture below for acceptable surface finishes.

Note: Use Piston Ring Compressor EN-47836 when installing rings.

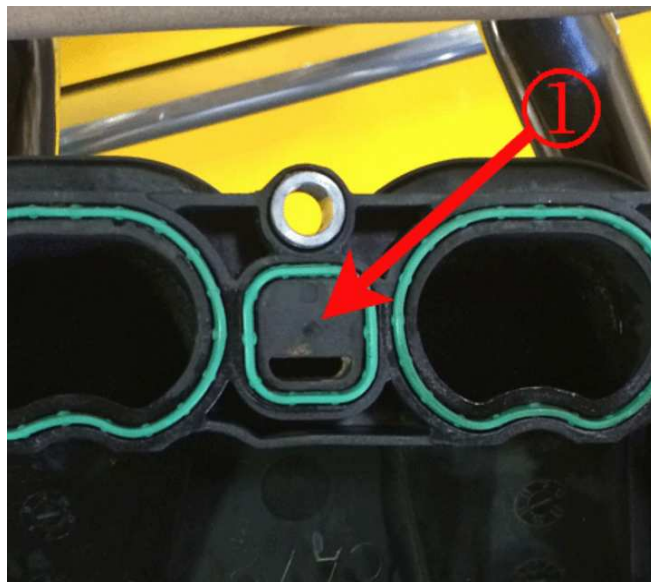
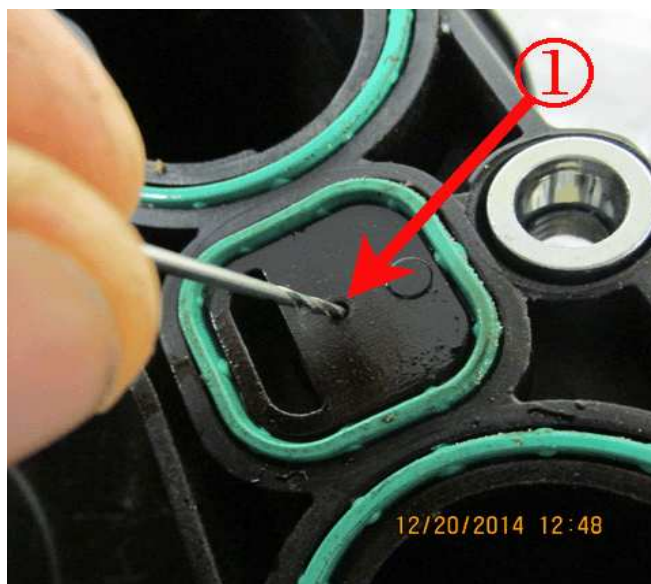
The oil consumption may have clogged/reduced PCV flow. The PCV system should be serviced.

- (1) PCV orifice in the intake manifold. Drill used for cleaning.

Clean any ice/sludge/water/carbon out of the PCV pipes/hoses, the PCV nipple on the cam cover, the PCV orifice between the #2 and #3 intake runners (use a 1/16 inch drill bit as illustrated below).

Important: DO NOT modify the PCV system. The orifice is a calibrated size based on the PCV system design. Enlarging this orifice increases the amount of

vacuum in the PCV system and will increase the crankcase overall vacuum and may cause the crankshaft seals to whistle.

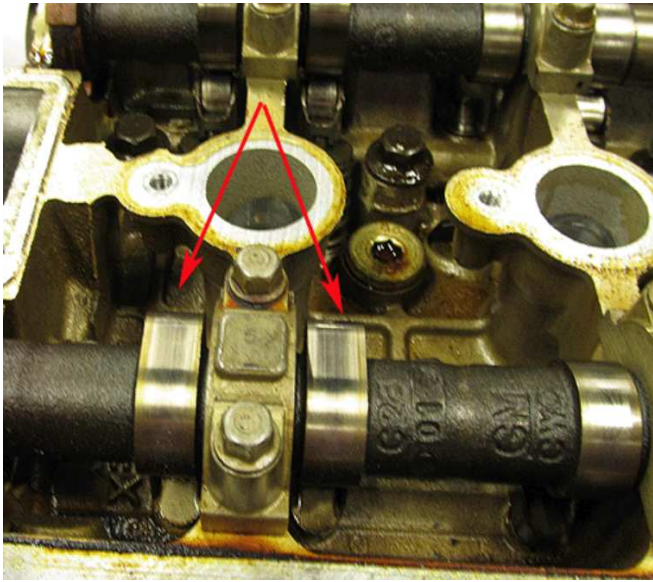
3409678

- Camshafts and roller follower will have wear markings. This is normal and do not need to be replaced (refer to picture above).

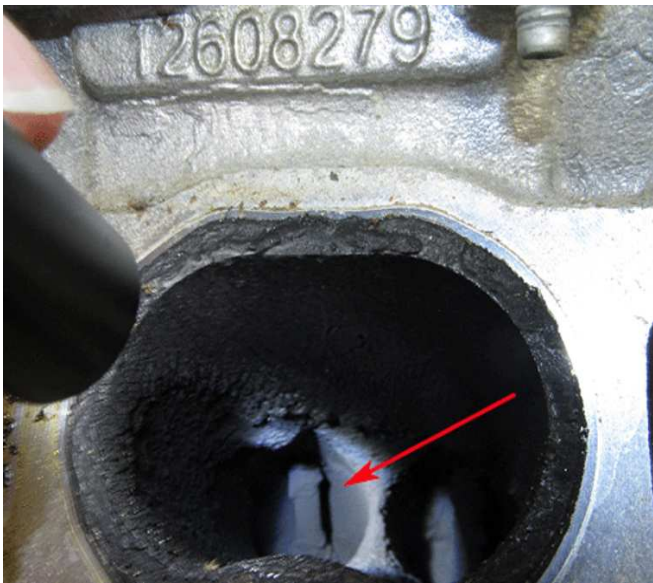
3409680

- Valves stems may have deposits build up on them. These deposits are characteristic of a direct inject engine. The valves stems do not need to be cleaned as they are not affecting engine performance (Refer to picture above).
- The oil pump does not need to be replaced as the low oil level operation did not damage the pump.
