Service Bulletin

Subject: Aftermarket Installed Service, Tool or Utility Box Sagging, Mis-aligned, Forward Box Mount Bracket Fractured on Trucks Equipped with Aftermarket Bodies

Models: 2011-2019 Chevrolet Silverado 2500HD-3500HD Series
2011-2019 GMC Sierra 2500HD-3500HD Series
Incomplete Vehicles Equipped with RPO ZW9 Box Delete and Aftermarket Bodies

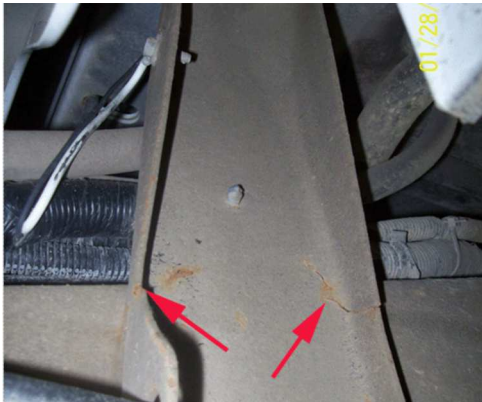
Example of mounting bracket with cracks developing (not all mounting points used).

Some customers may comment that the utility box is sagging, not level or misaligned. Upon inspection, the technician may find cracked or fractured front bed mount bracket(s).

Use the following steps to replace the affected front bed mount brackets.

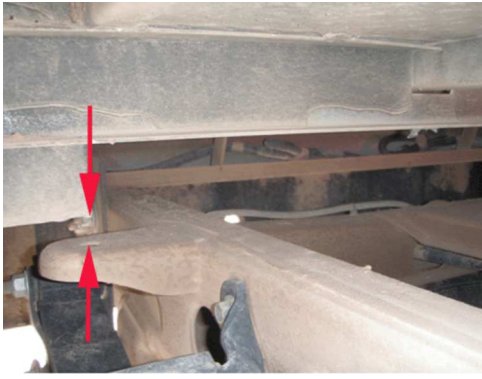
In rare occasions, situations have been identified where the incomplete pickup trucks have had an aftermarket body (typically a service body or utility type body) installed. Upon inspection it was noted that the aftermarket bed was not using all the recommended/available mounting points provided in Upfitter Integration UI Bulletin # 98 (available at www.gmupfitter.com). Every case identified so far involved an aftermarket body that only used four mounting points; one in each corner, with no additional load bearing points as described in the UI Bulletin.

Example of available body mounting locations not used by the upfitter under the service body.

Important: If the existing body is going to be re-installed after the repair, then the mounting set up of the body that contributed to this condition must be corrected to utilize the attachment scheme outlined in the UI Bulletin prior to performing the re-installation of the body. This repair only replaces the same style of bracket, which requires the correct mounting of the aftermarket body. If the body is not mounted properly, the condition may repeat. Refer to GM Upfitter Bulletin #98' for 2011 & beyond 'C/K HD Cab Chassis Mounting Guidelines' and "GM UI Body Builder's Manual Best Practices welding safety & procedures and body mounting information."

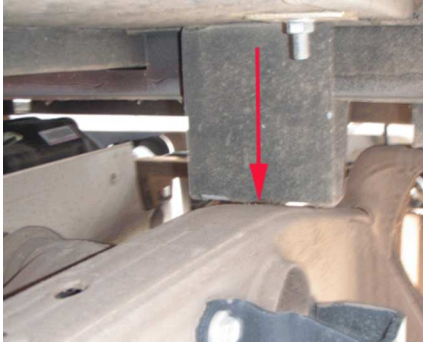
Example of support bracket not carrying any load of the body.
