Preliminary Information

PIC6401 Key & Transmitter Programming

Brand:	Model:	Model Years:	VIN:		Engine:	Transmissions:
			from	to		
Chevrolet	Camaro	2010 - 2015	All	All	All	All

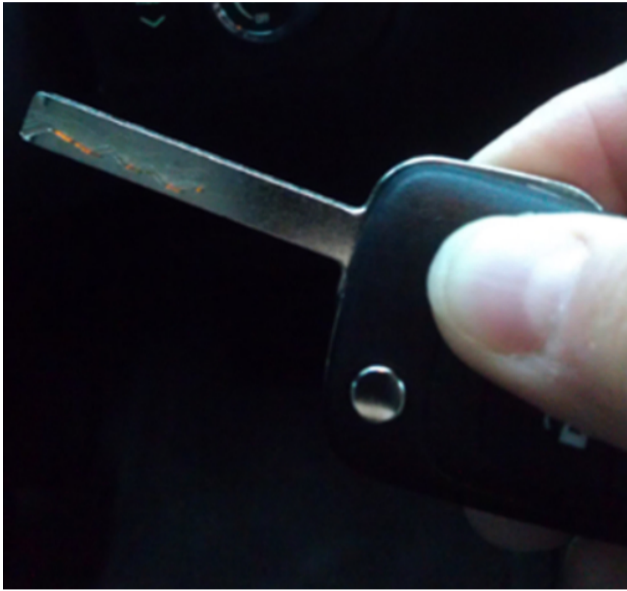
4) To add transmitters, repeat steps 1 - 3 with a transmitter and service key. Hold the service key securely against the transmitter as seen in the photo below for the entire time that the key is inserted into the ignition. Place the service key at the end of the transmitter so it is centered with the key blade projecting outward from the transmitter. Hold the service key on the side of the transmitter with the Chevrolet emblem to maintain full contact between the service key and transmitter.

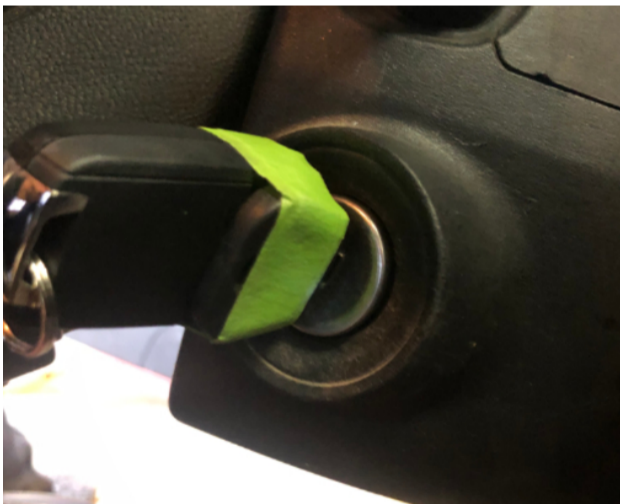
IMPORTANT NOTE: When attempting to learn a transmitter to the vehicle, the service key **MUST** be used. Do **NOT** use the regular ignition key with the black plastic head as seen in the photo below. This will **NOT** learn the transmitter as there is already a transponder embedded in the head of this style ignition key. **THIS ATTEMPT WILL NOT WORK.**

INCORRECT transmitter programming procedure being attempted.

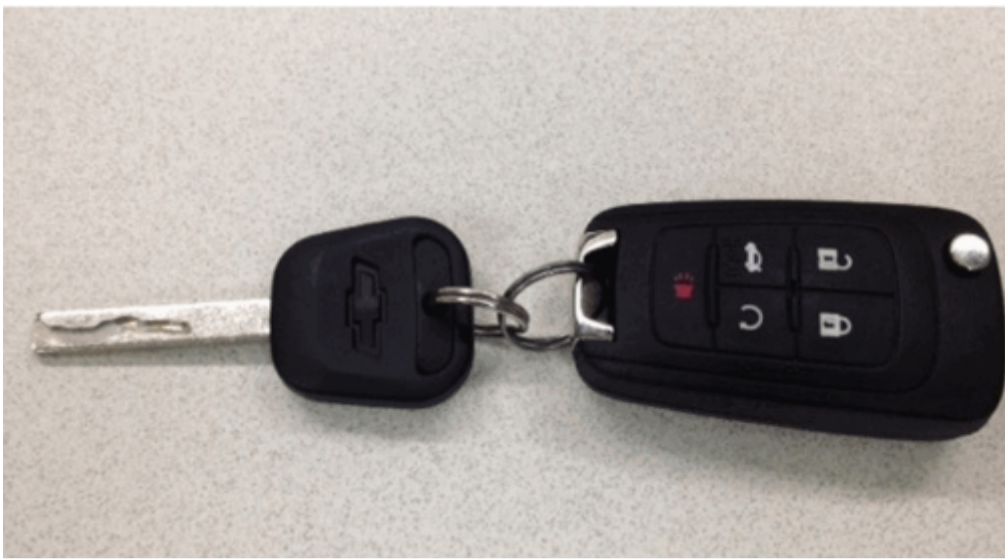
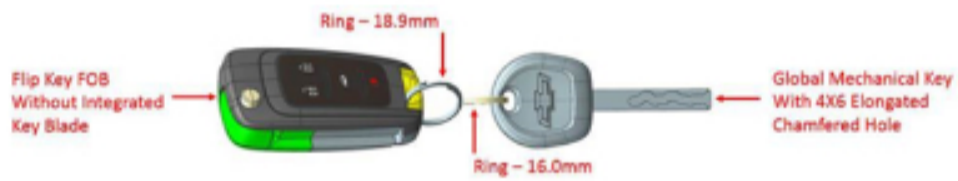
Once the required programming procedure has been completed, the technician **MUST** return the various keys and transmitters back to the customer in the following manner. No other configurations are acceptable. There must be a transmitter without the blade attached. The larger key ring (18.9 mm) must be attached to the transmitter itself. The ignition key must be attached by the smaller key ring (16 mm). The two photos below show the correct configuration of the transmitter, the key rings, and the key.
