Preliminary Information

PIP5495L Check Engine Light On With P0299 Or P0234

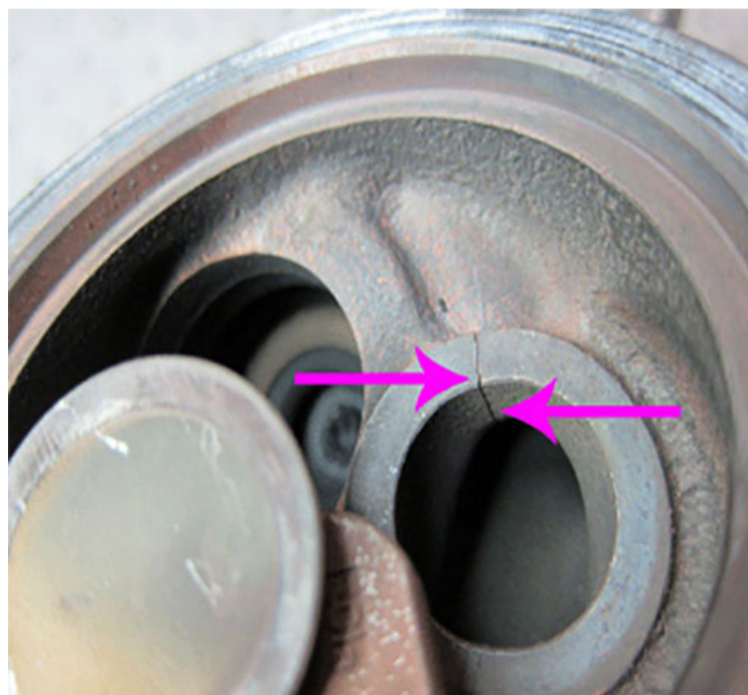
Crack(s) at the wastegate valve port (this is normal and does not affect performance)

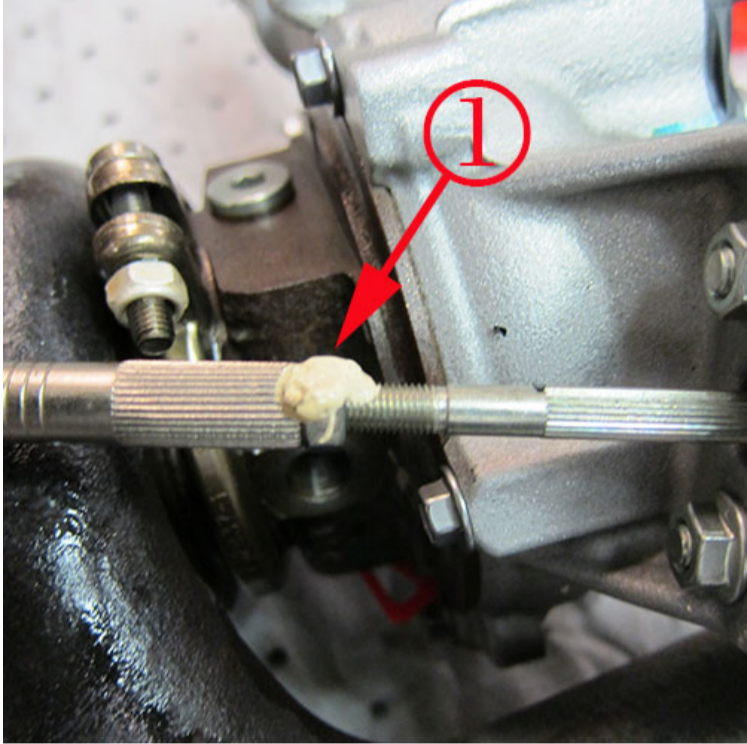
Wastegate actuator clip missing (replace wastegate actuator clip - released for service)

If the tamper paint seal is broken or missing, check the vehicle for any additional sign of modification to the induction, exhaust, or engine calibrations as this may indicate an attempt to adjust the wastegate arm to modify the powertrain operation.

If found, review the powertrain warranty status with your service manager prior to performing repairs

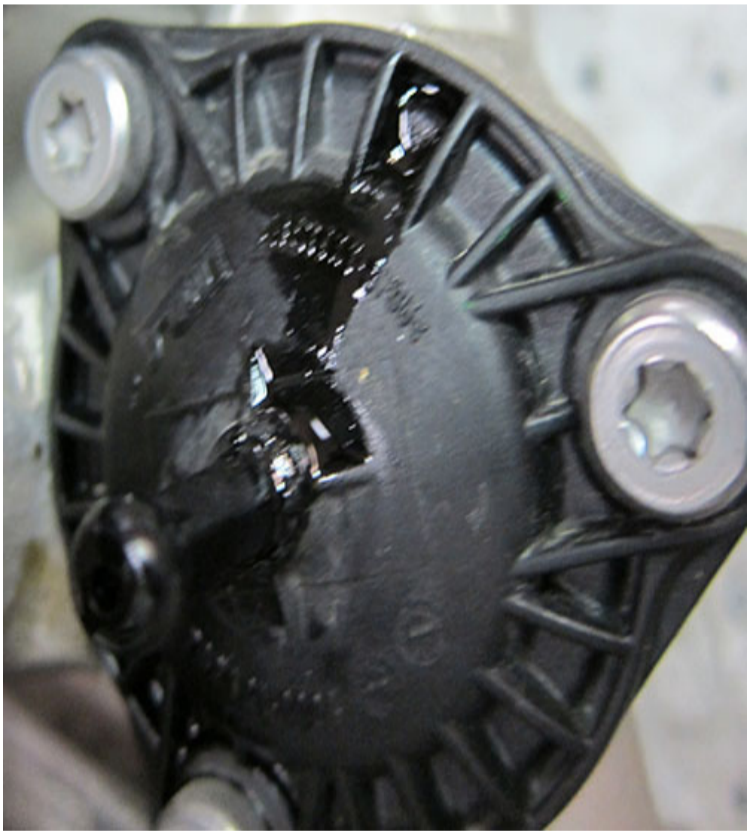
Bypass (recirculation) valve cover port broken or water/oil found inside the valve (clean the components, if necessary replace bypass (recirculation) valve assembly - released for service)

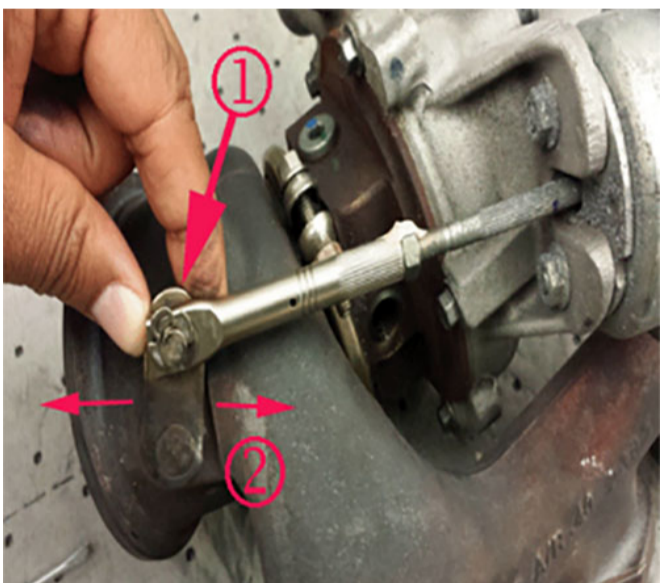
Wastegate Preload Inspection.

Wastegate lever arm (1) moves with little effort in the direction as shown (2) while the actuator rod remains static, see picture below "Wastegate Preload Inspection".

If the lever wiggles with little effort while the actuator rod remains static, the pre-load is insufficient and the turbocharger must be replaced.

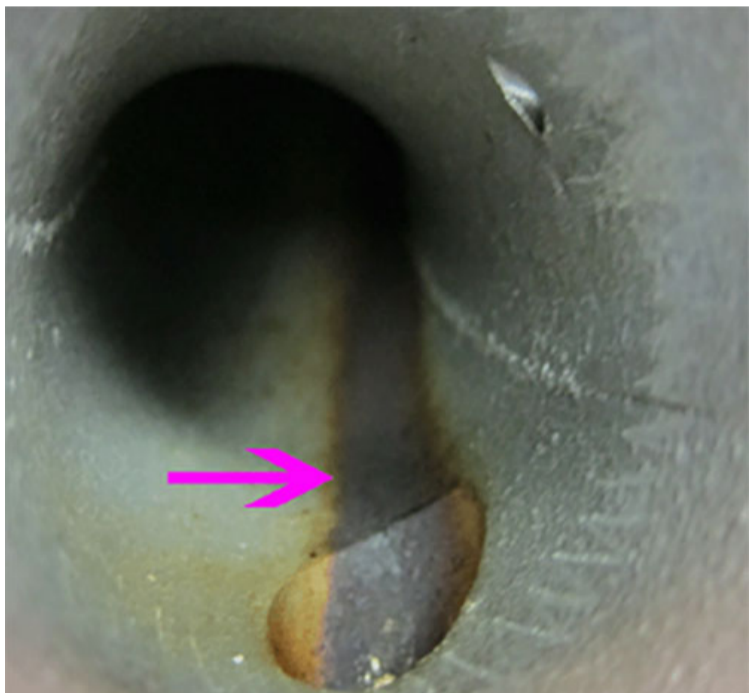
Note: The view shown below indicates NORMAL oil staining in the turbocharger outside air inlet. This dry stain does not represent an oil leak.

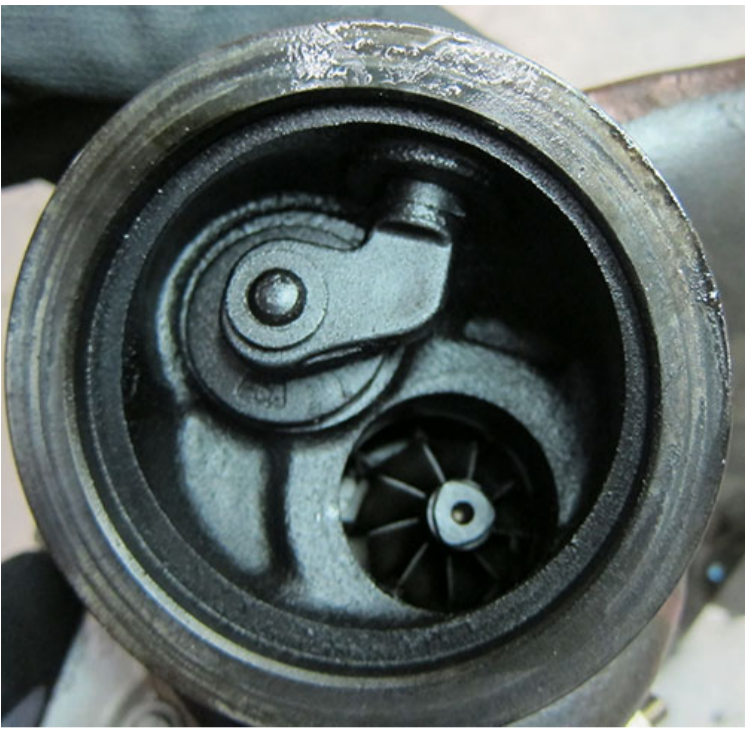
Inspect for the presence of oil in the exhaust system.

If oil is present in the exhaust system, then inspect the turbocharger turbine and compressor wheels to be sure that they are not broken off.

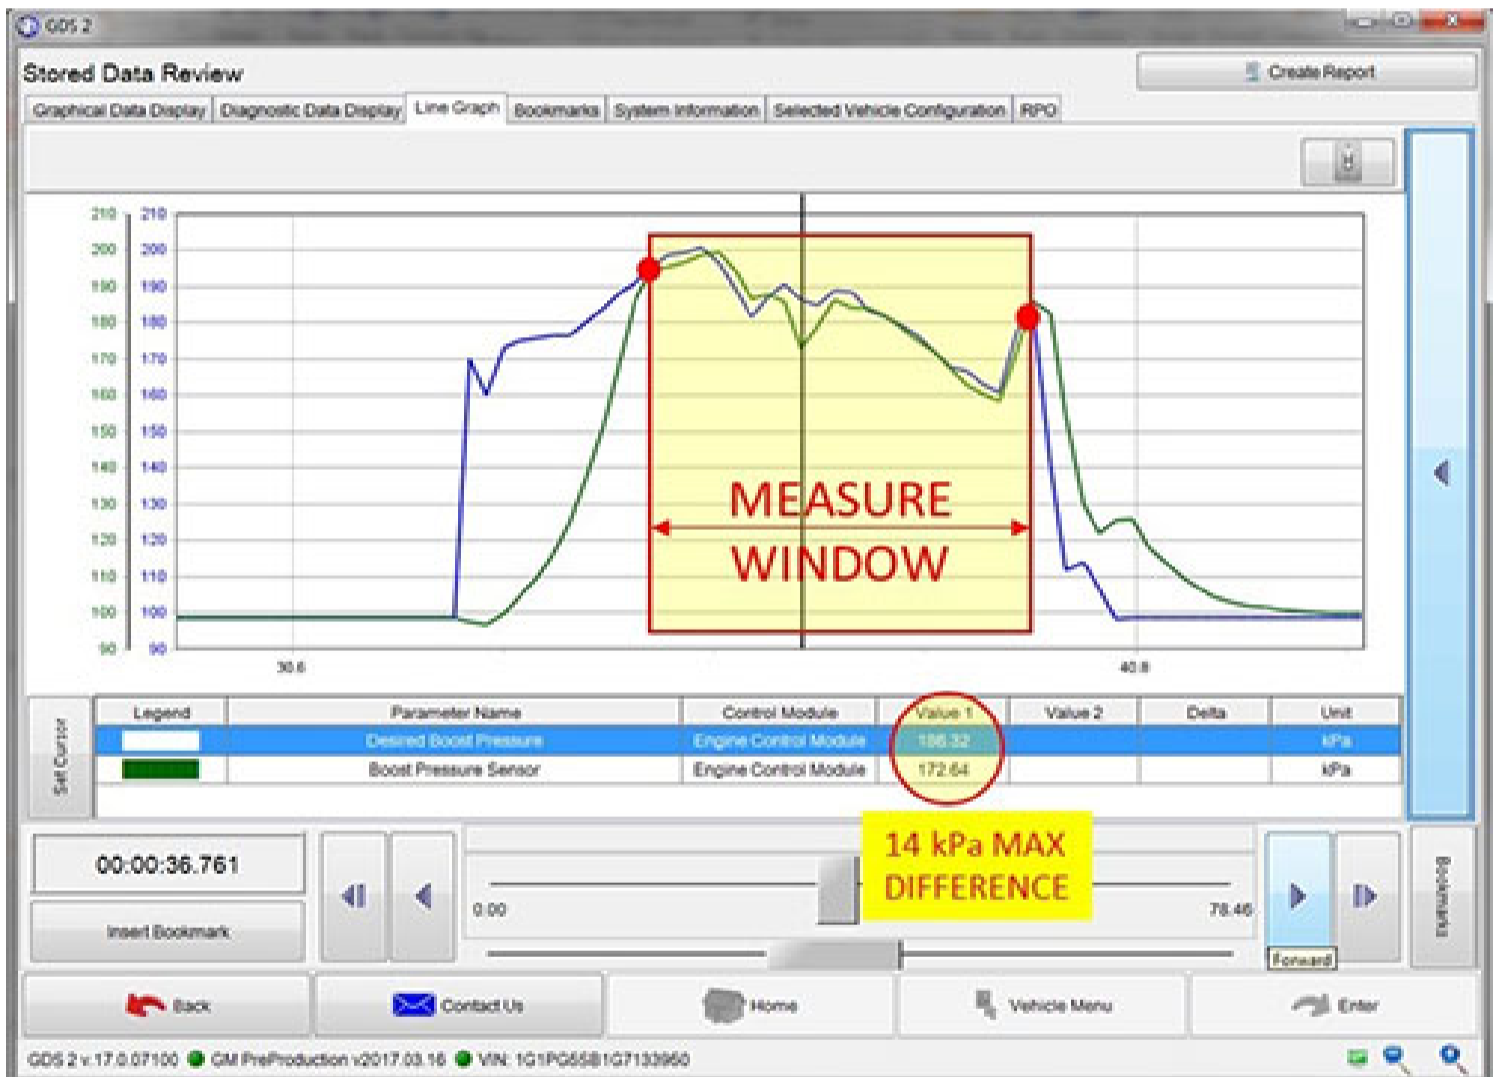
Example of normal turbocharger wastegate operation:

In this example, notice that the measure window begins once the Boost Pressure Sensor reading (Green) meets the Desired Boost Pressure reading (Blue) and ends when the APP is released per the testing instructions.

The Boost Pressure Sensor reading (Green) closely tracks the Desired Boost Pressure reading (Blue) indicating normal Turbocharger operation.

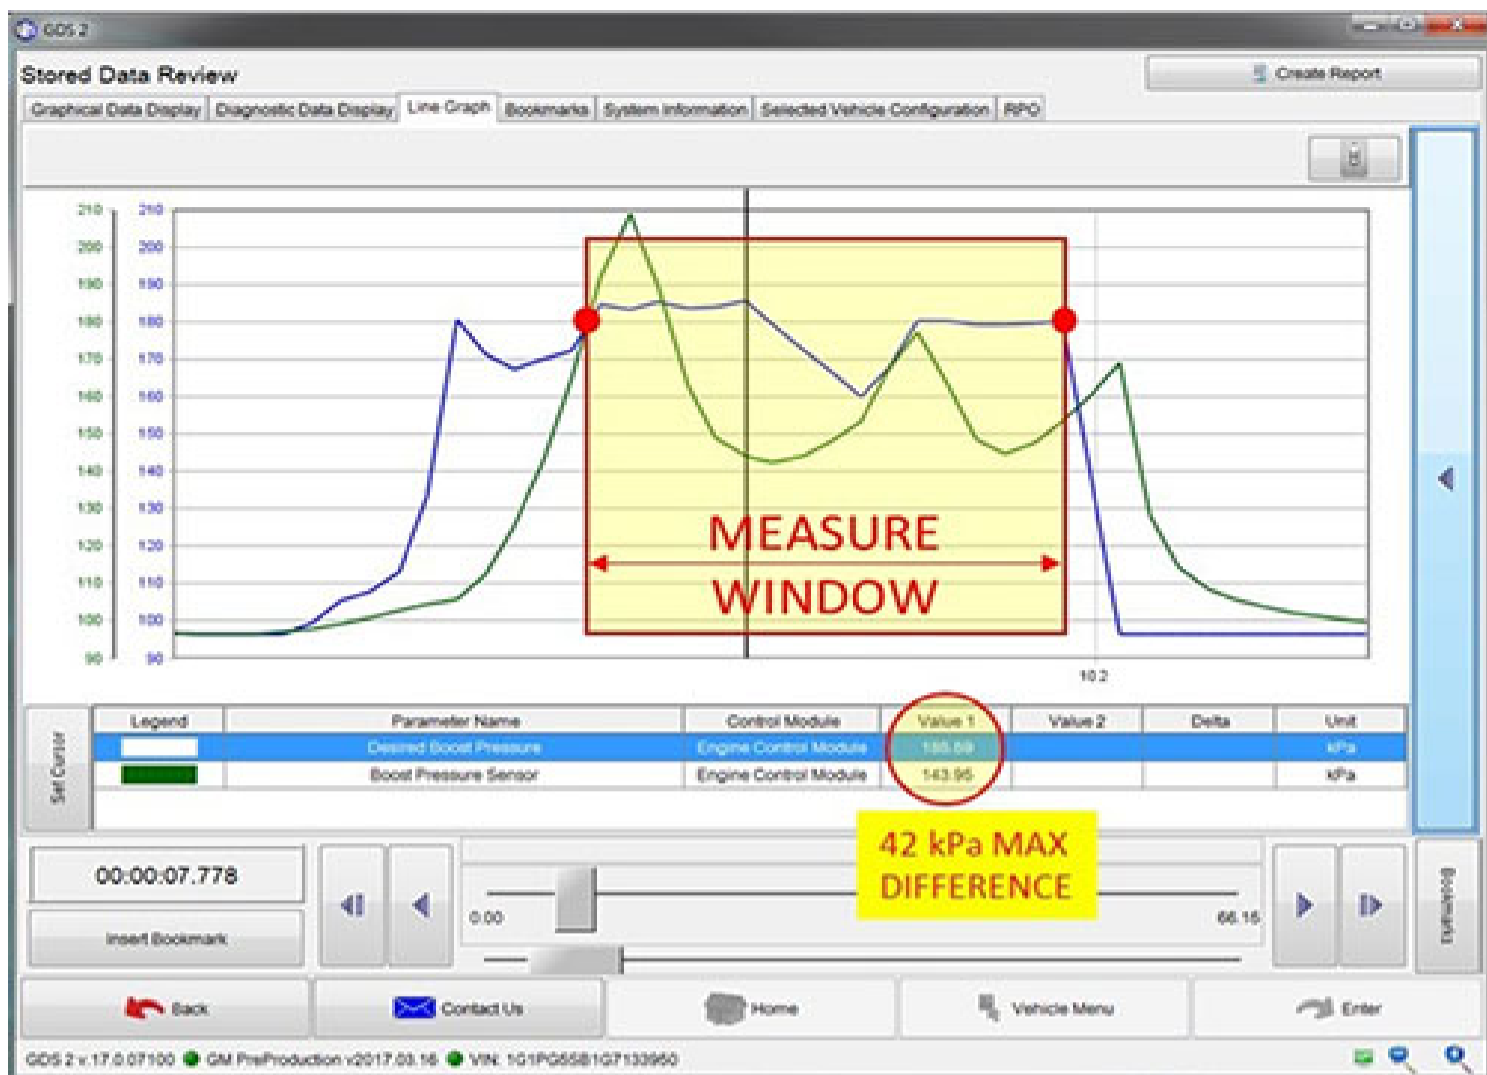
Example of a malfunctioning turbocharger wastegate:

In this example, notice that the Boost Pressure Sensor reading (Green) moves thru and well above the Desired Boost Pressure reading (Blue).

As the abnormally high pressure is corrected by the management system, the Boost Pressure Sensor reading (Green) over reacts and dips well below Desired Boost Pressure reading (Blue).

A difference of 14 KPA (2 PSI) between the Boost Pressure reading (Green) and the Desired Boost Pressure Sensor reading (Blue) Indicates a Malfunctioning Turbocharger.

9. Utilize the Print Screen Function to take a screen shot of GDS2 showing the line graph.
10. Replace the turbocharger if the difference within the Measured Window is more than 14 KPA (2.0 PSI) as shown in the examples.
