### PIC5852B No Fob Detected Message All Other Functions Normal

Brand:	Model:	Model Years:	VIN:		Engine:	Transmissions:
			from	to		
Chevrolet	Impala	2014 - 2015	All	All	All	All
Chevrolet	Malibu	2013 - 2015	All	All	All	All
Buick	LaCrosse	2010 - 2015	All	All	All	All
Buick	Regal	2011 - 2015	All	All	All	All
Buick	Verano	2012 - 2015	All	All	All	All

with Passive / Keyless Entry System (RPO ATH)

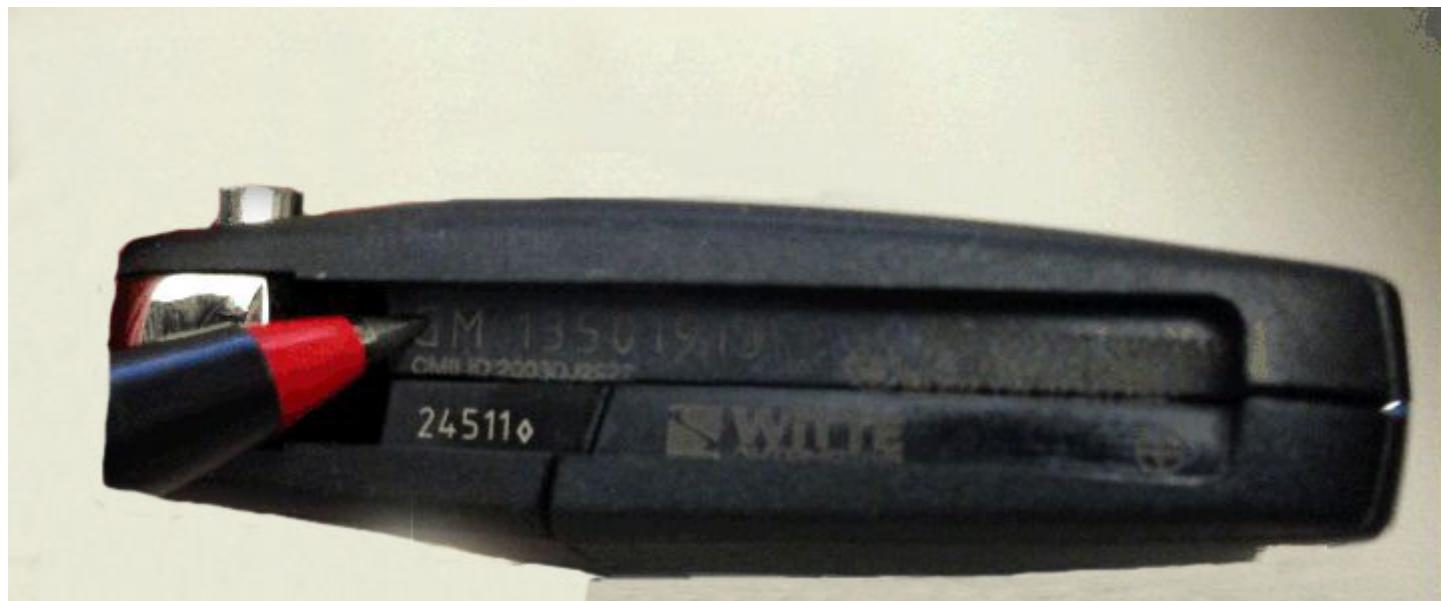
**It is possible the vehicle may have been shipped with or a dealer mistakenly added a "non-PEPS" fob to a "PEPS" (Passive Entry Passive Start) vehicle. This can be confirmed by obtaining the part number from the body of the fob behind the key blade and comparing to the Electronic Parts Catalog (EPC).**

**Replace the effected fob as required.**

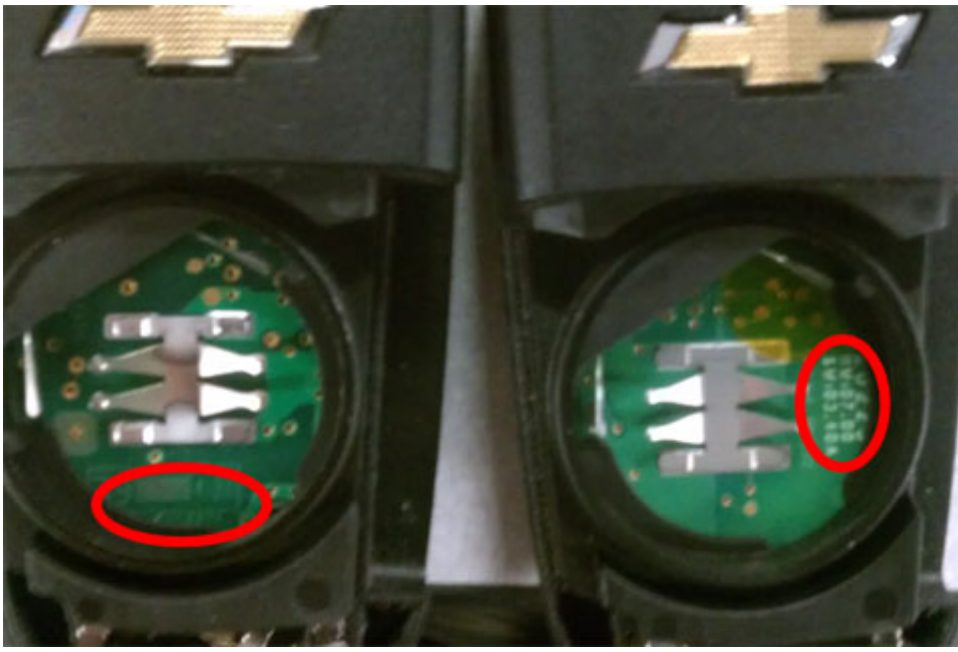
**An alternate method would be to remove the battery cover and battery from the fob. With the blade of the key at 12 o'clock, look at the printed circuit board. A non-PEPS fob (right) will have words stamped on the circuit board at the 3 o'clock position. A PEPS fob (left) will have a stamping at the 6 o'clock position.**
