Preliminary Information

PIP5708A Flex Plate Broken Teeth Starter Not Cranking Engine Grinding Noise When Starting

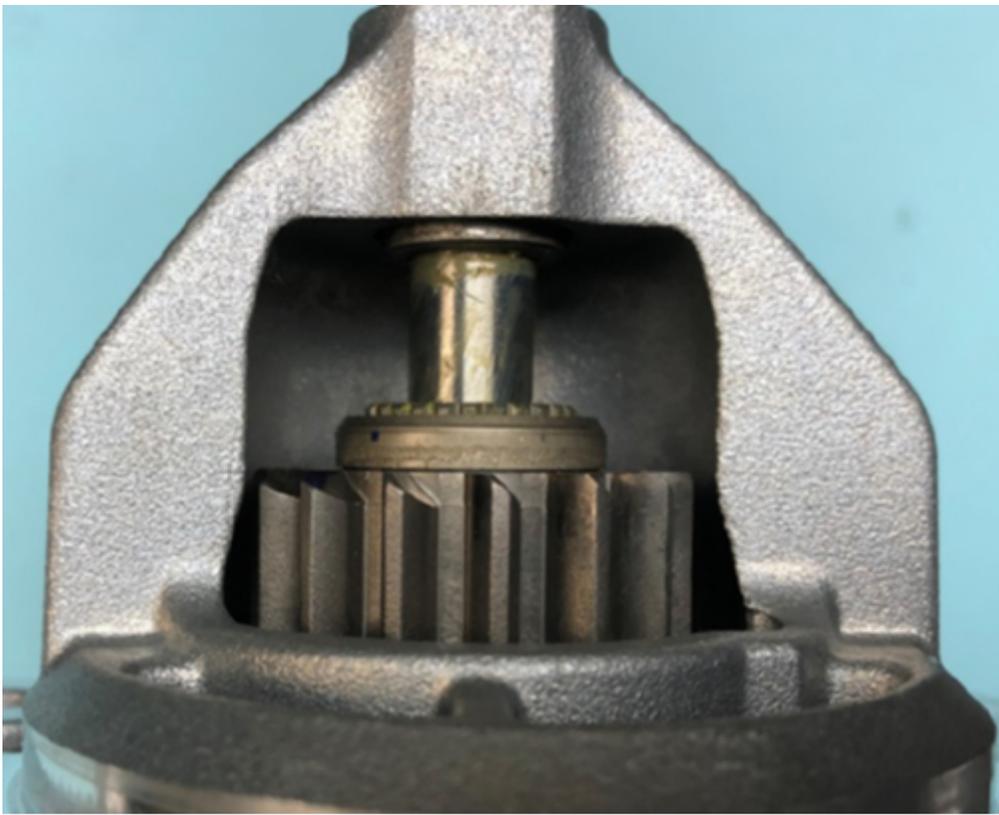
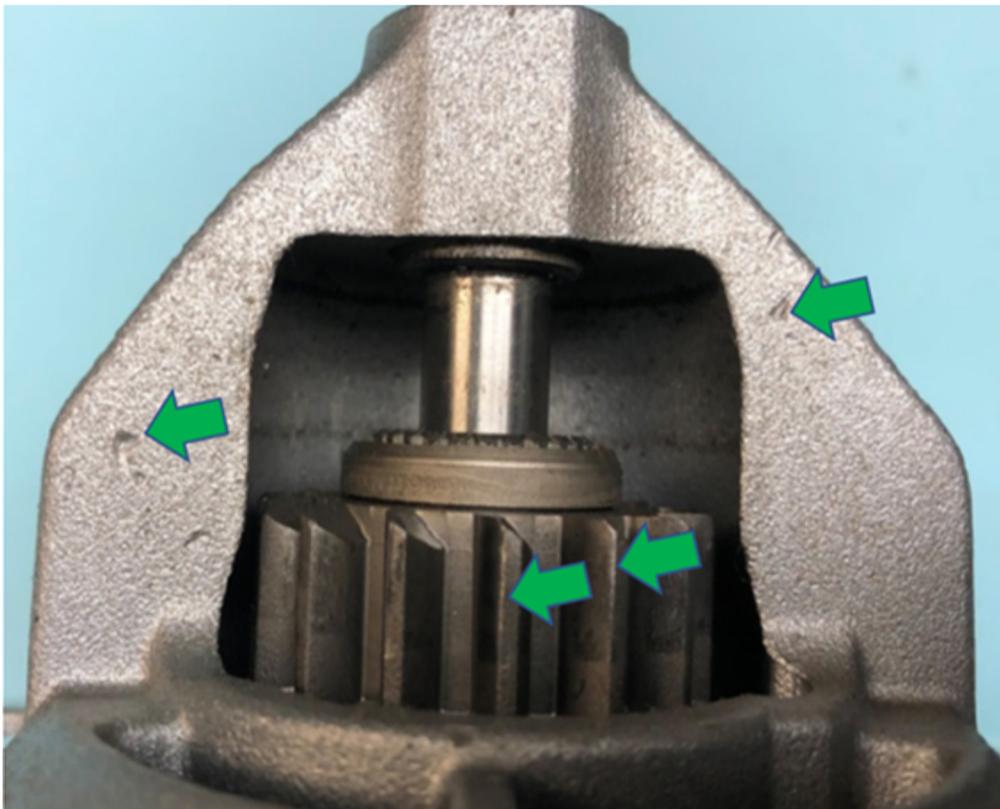
Examples of starters that can be reused / reinstalled

If the starter pinion drive teeth or housing only have very small imperfections / pitting, do not replace the starter motor assembly, reuse / reinstall it.

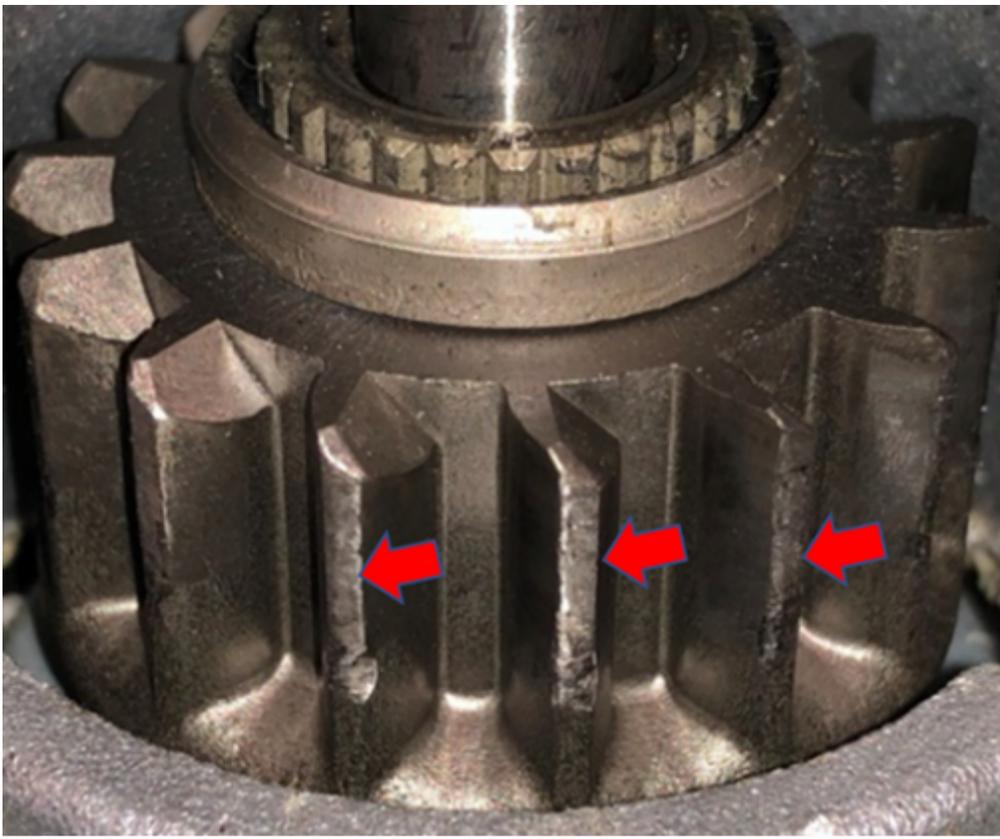
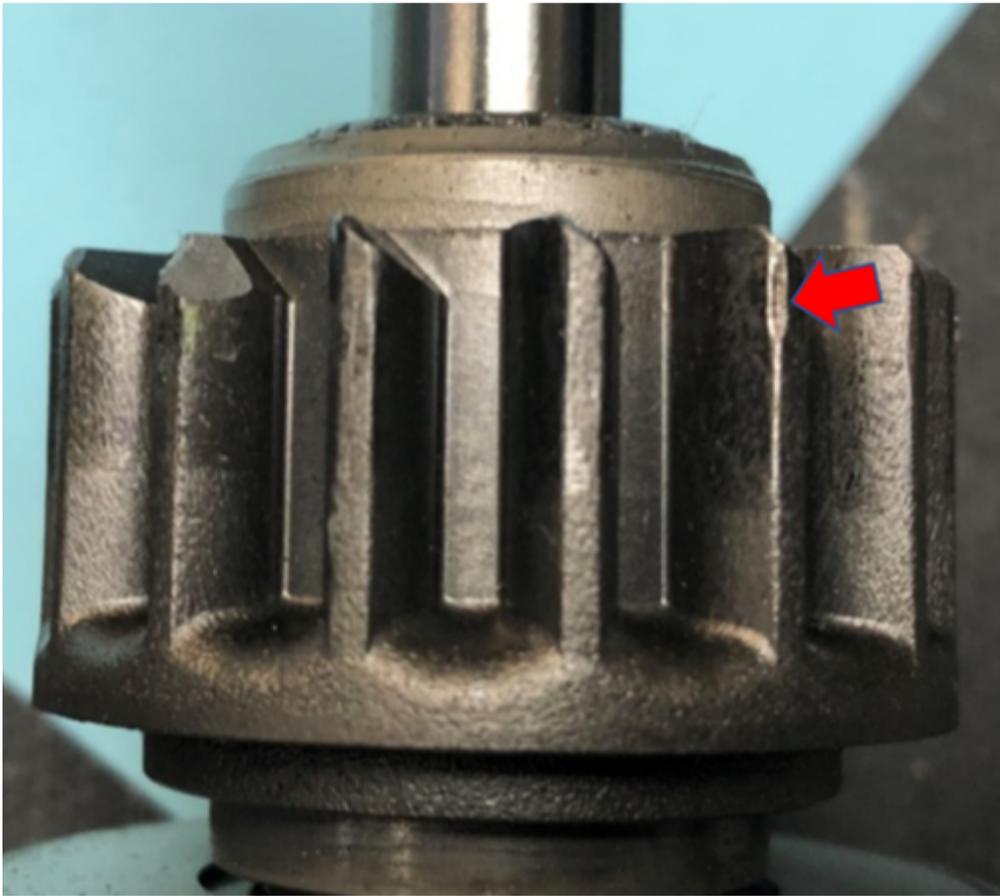
Examples of starters not to reuse / reinstall

If the starter pinion drive teeth or housing have pieces / chunks missing, replace the starter motor assembly.
