Preliminary Information

PIP5417C Diagnostic Tip - Oil Leak From Crankshaft Rear Oil Seal or DTC P1101

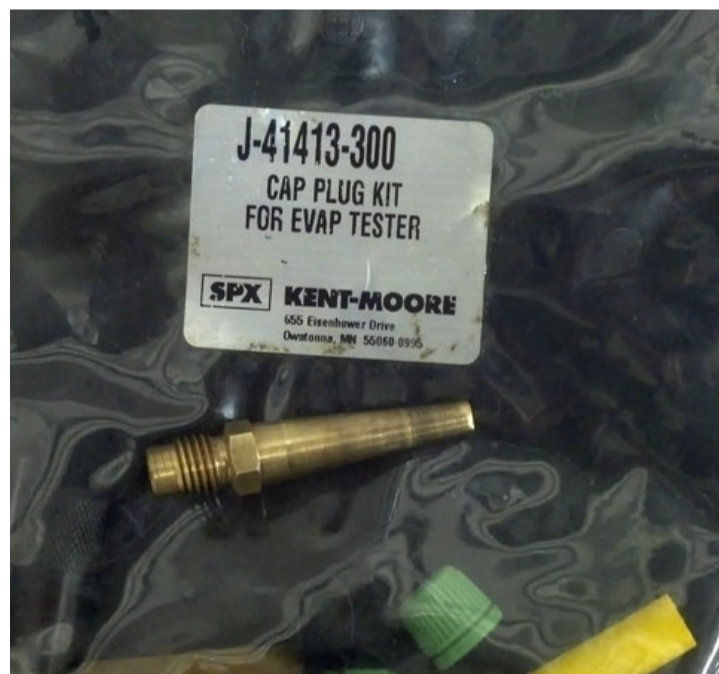
EEST hose adaptor.

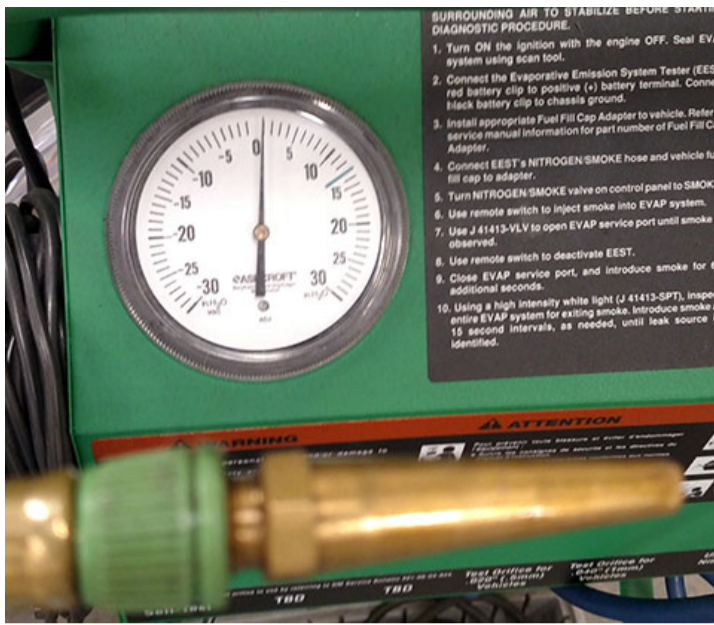
EEST Gage at 0 reading.

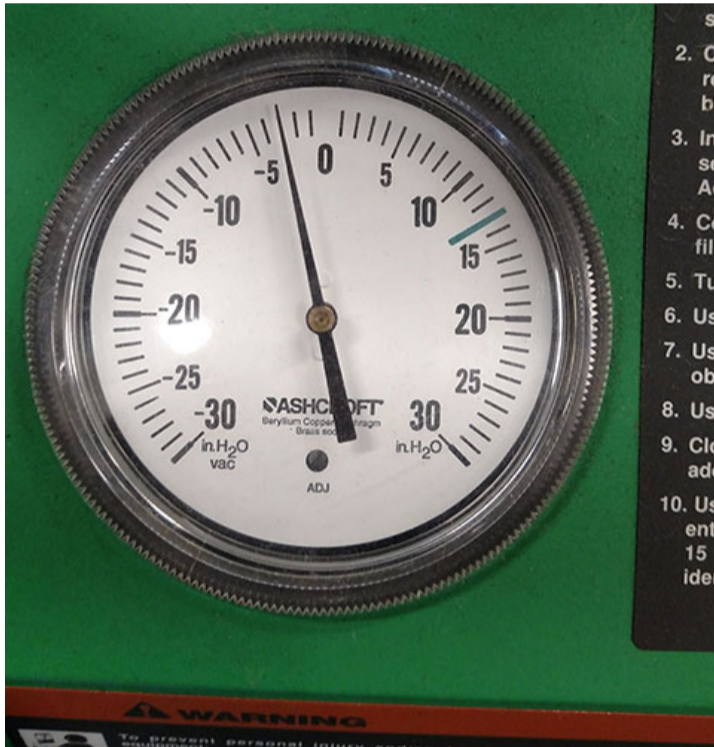
Normal crankcase pressure readings for the L3A, LE2, LFV and LYX are between -1 & -5 inches of water in park at hot idle.

If the crankcase pressure is in the proper range, follow Strategy Based Diagnostics for engine oil leaks.

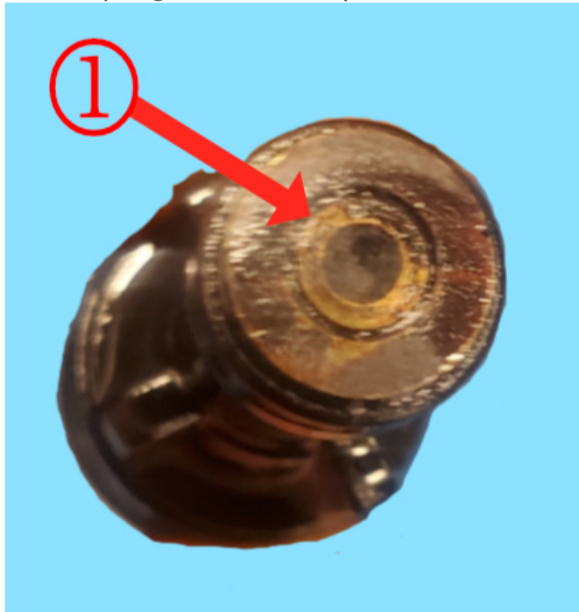
If diagnosing DTC p1101 with no engine oil leaks and excessive positive crankcase pressure exist an obstructed PCV orifice would be suspect (photo below) requiring camshaft cover replacement as the PCV orifice is not currently serviced.

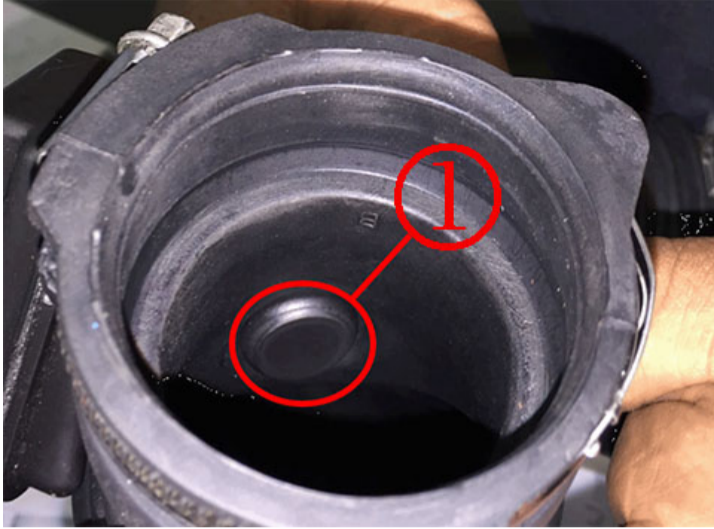
If the crankcase pressure is excessively negative, below -16 inches of water (-1 inches of HG / vacuum) then a negative crankcase pressure concern exists requiring further diagnostics.

Air Cleaner Housing Outlet Duct with port closed causing excessive negative crankcase pressure.

If the port is not blocked, then replace the camshaft cover assembly and retest for proper crankcase pressure.
