## Preliminary Information

### PIT5679A Service Park Assist Message /Hands Free Lift Gate Inoperative

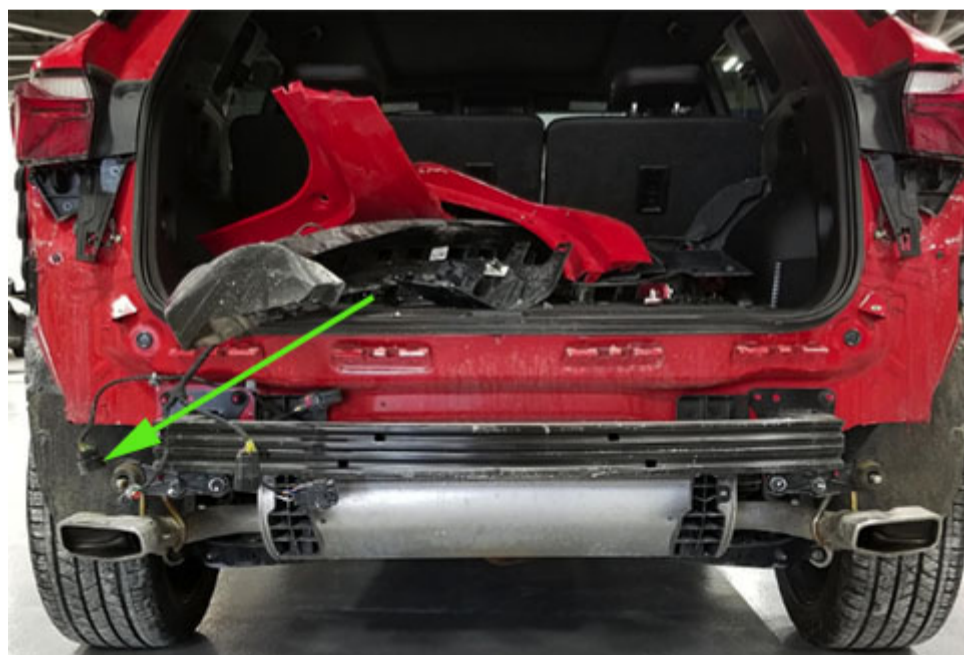
| <b>Cause</b> | Any of these issues could be caused by water intrusion in the X400 connector. |

Inspect the X400 connector located behind the rear bumper cover on the left side of the vehicle for evidence of water intrusion.

**If water intrusion or corrosion is found replace all affected terminals on the body side with terminated leads and replace the rear fascia wiring harness.**

**Ensure that the connector is securely attached to the locating stud and is mounted in a horizontal position.**

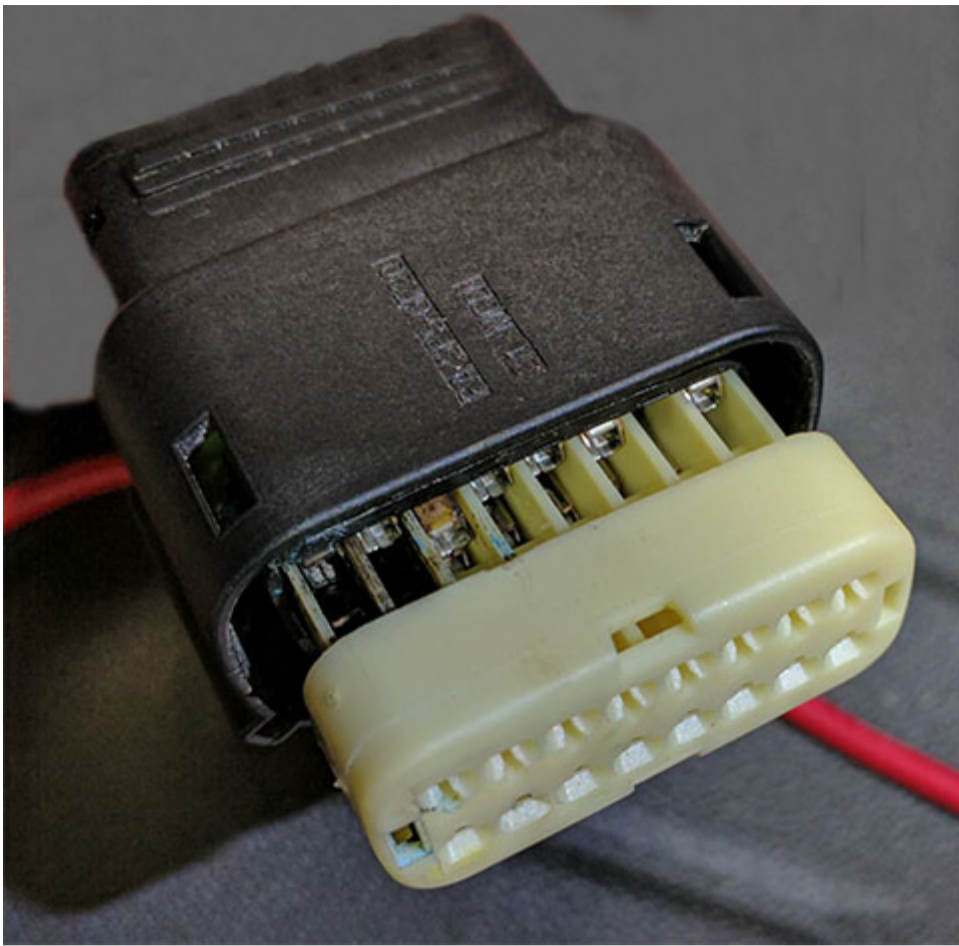
If no obvious terminal concerns are found it may be necessary to remove the TPA to be able to view inside the connector for moisture.
