Preliminary Information

PIT5452C Upper Steering Column Or Steering Wheel Pop Click Tick Snap Itch Noise While Turning The Steering Wheel

This PI was superseded to add 2018 Model Year. Please discard PIT5452B.

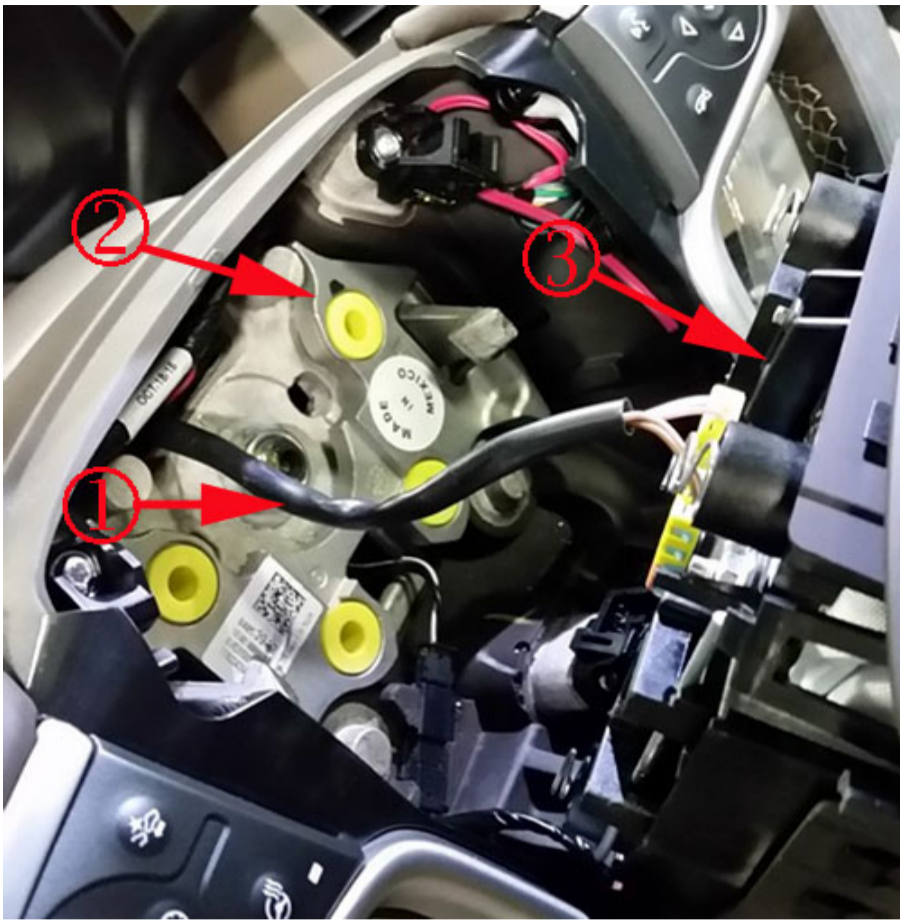
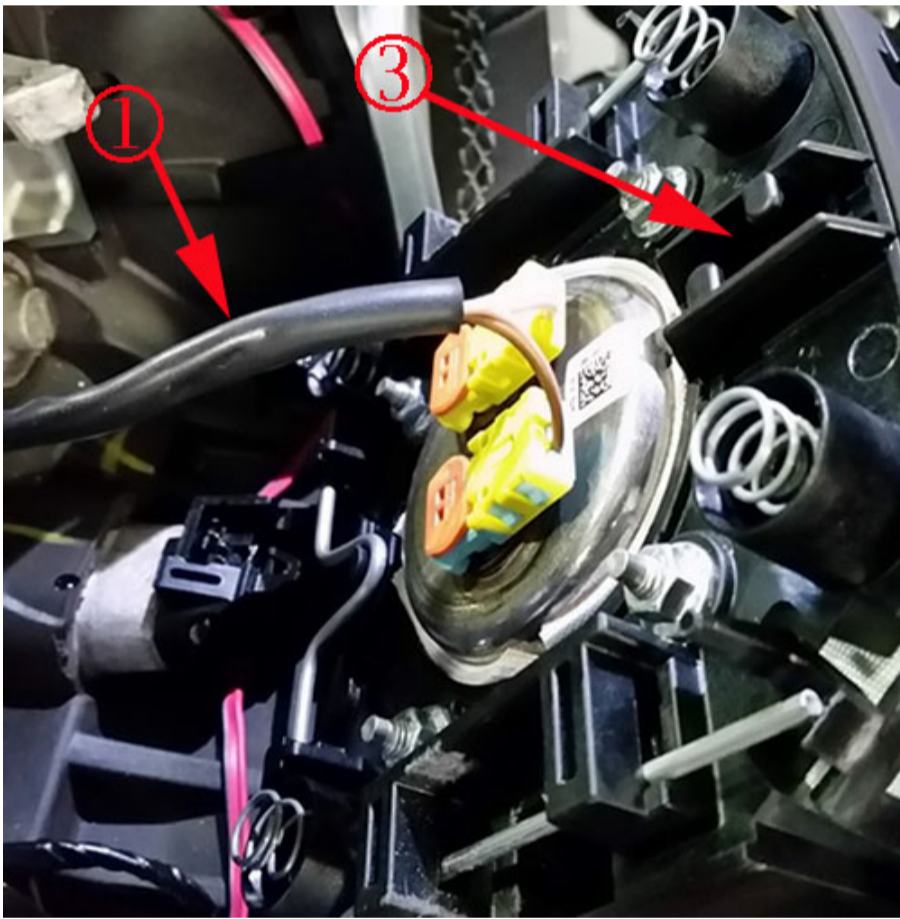
(Chevrolet / GMC design shown, Cadillac similar)

Condition-1: Some owners may comment on a click type noise when turning during low speeds or parking lot maneuvers. This noise might only occur while turning the wheel in one direction.

Cause-1: This noise may be caused by mis-routed airbag module wiring coming in contact with the vibration damper plate in the steering wheel, causing the plate to contact the side of the steering wheel while turning.

It has been found that if the steering wheel to airbag wiring harness (1) is Not routed within the wiring channel (3) molded into the back of the airbag module, the harness could contact the damper plate (2) within the steering wheel, and cause the damper plate to contact the side of the steering wheel during turns.

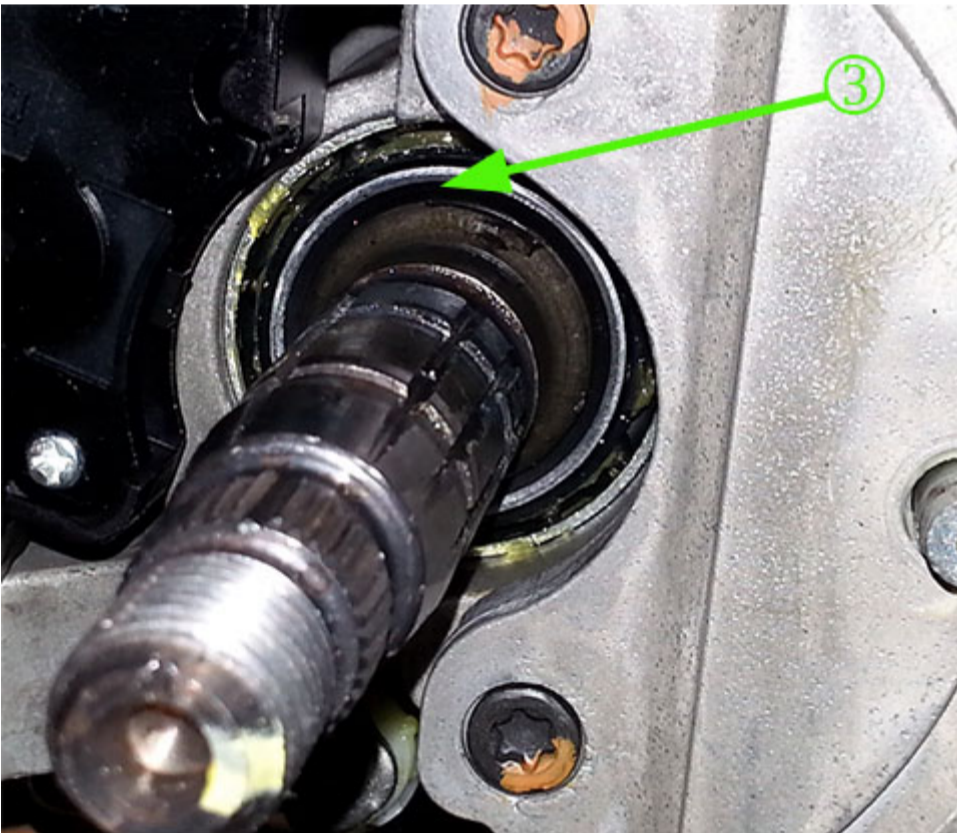
Cause-2 (RPO N38 Only): This noise could be caused by the upper column bearing race being slightly out of alignment.

1.4 Using a magnet, remove the upper bearing inner race (3) from the column. Do NOT remove the upper bearing.
