Preliminary Information

PIC6406 Front View Camera Programming - Learn Procedure Will Not Start

Brand:	Model:	Model Years:	VIN:		Engine:	Transmissions:
			from	to		
Cadillac	CT5	2020	All	All	All	All

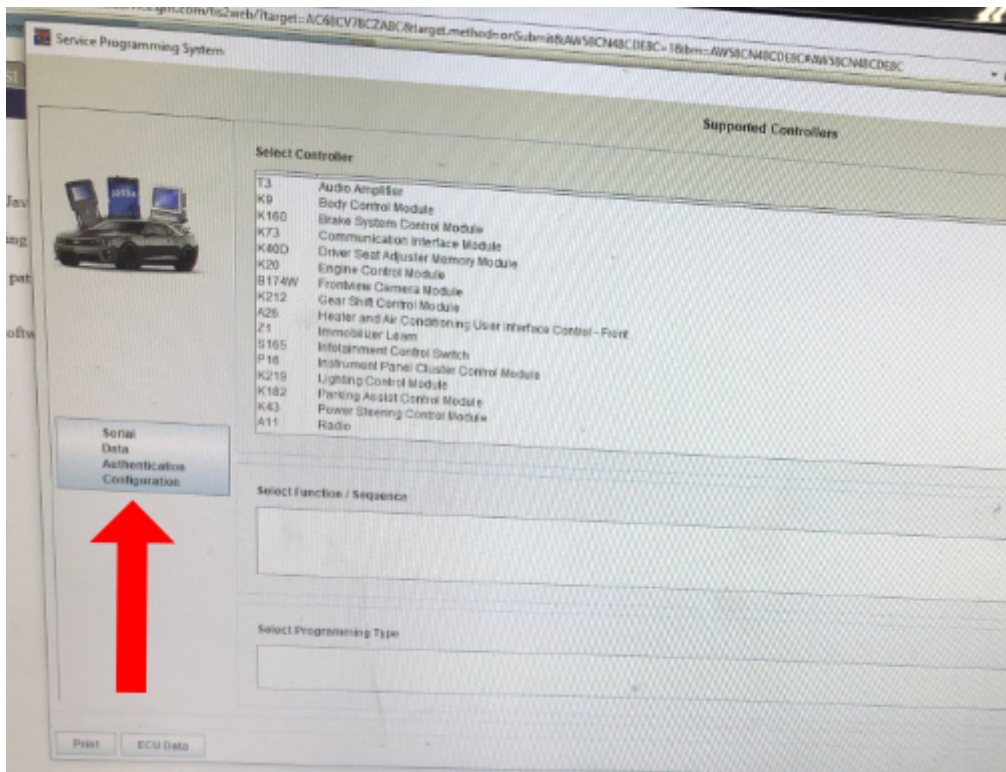
Involved Region or Country	North America
Condition	A dealer may replace a B174W Front View Camera Module (FCM) and attempt to program it. After programming they attempt to perform the learn procedure (using GDS2) and the procedure will not start. The tech may find any or all codes U0073, U0101, U0140, U0146, U0401, U0418, U0420, U0422, U0423, U0447, U0452, U0566, U1960, U1962, U3000 set.
Cause	The replacement FCM may already have the current data files, therefore when the dealer attempts to program the module programming does not actually occur due to "same cal blocking", therefore Serial Data Authentication Configuration does not actually occur. This prevents the key provisioning from being executed.

Technician will need to access Service Programming System (SPS) and perform the Serial Data Authentication Configuration procedure manually. The Serial Data Authentication Configuration button is located to the lower left of the module list on the SPS Supported Controllers screen.

Press the button for the Serial Data Authentication Configuration. Once the configuration completes all codes will go to history.
