PIT5734 Poor Heater Performance - Diagnostic Tip

Product Investigation Review Required

Brand:	Model:	Model Years:	VIN:		Engine:	Transmissions:
			from	to		
Chevrolet	Silverado 1500	2020	All	All	3.0L LM2	All
GMC	Sierra 1500	2020	All	All	3.0L LM2	All

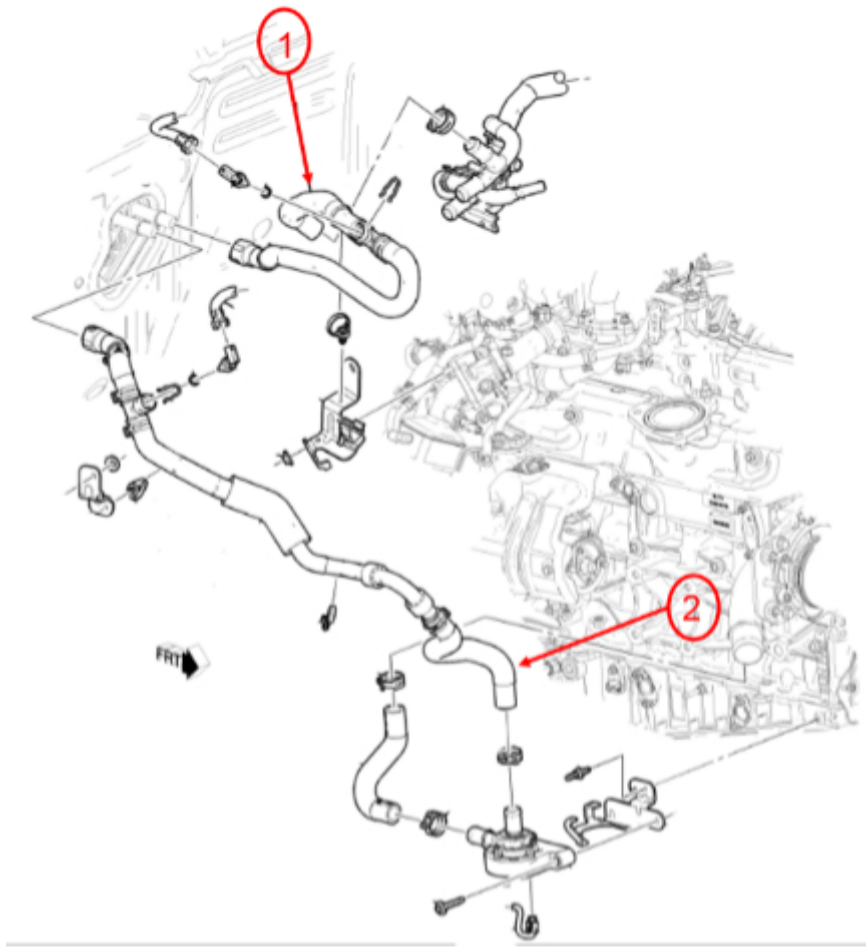
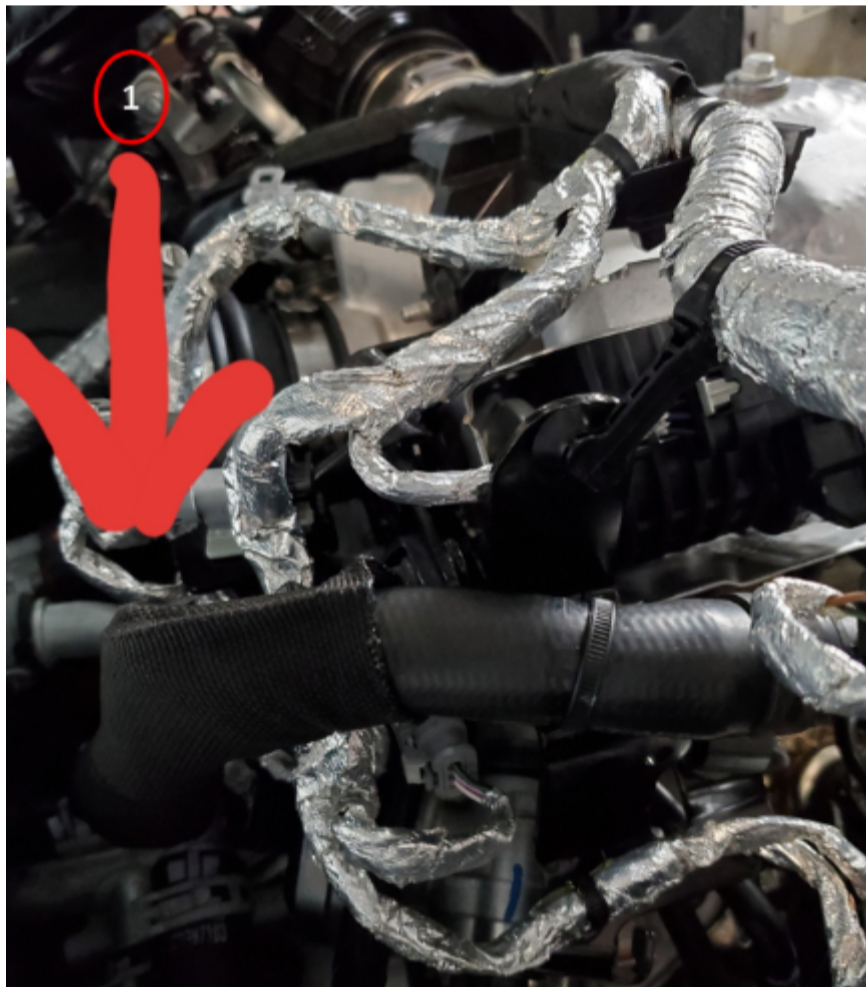
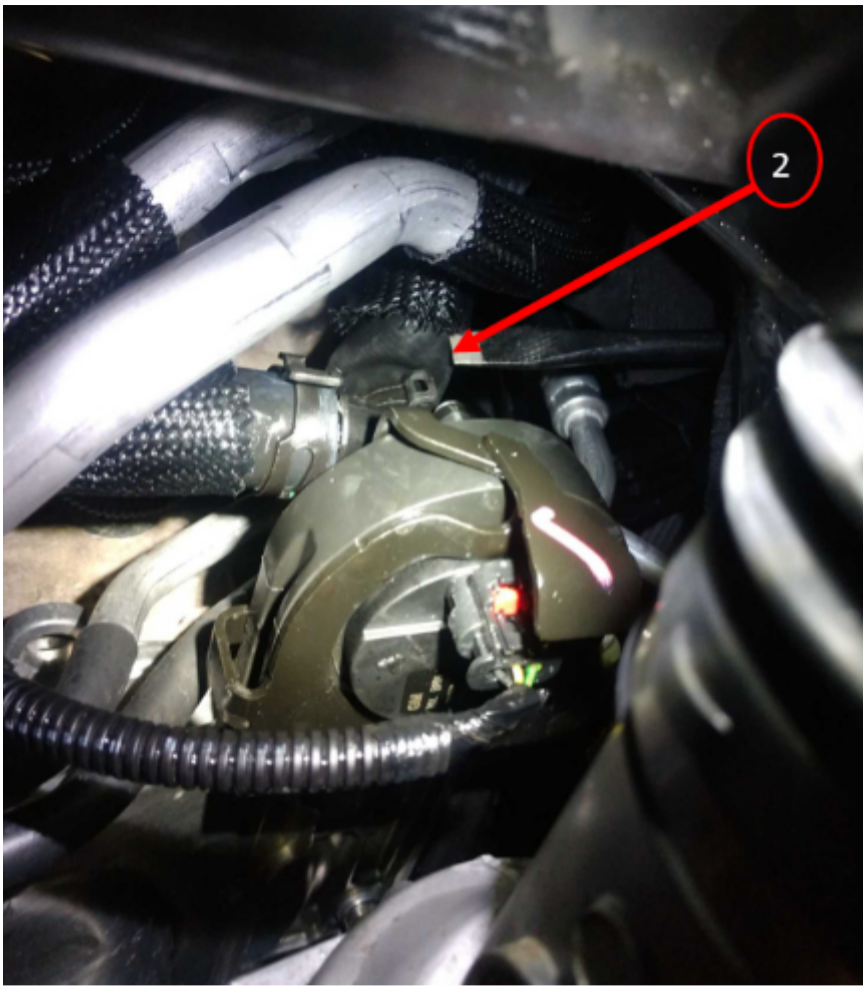
Involved Region or Country	North America
Additional Options (RPO)	3.0L Diesel Engine RPO LM2
Condition	<p>Some customers may comment on poor heater performance. When using GDS2 to compare the heater core inlet temperature sensor 3 to the heater core outlet temperature sensor 4, there will be a significant difference (example inlet temp 147 degs F and outlet temp 82 degs F, typically they are within 10-20 degs F).</p> <p>Note: When comparing the difference in the heater core temperature sensors, make sure the blower motor is on high with the HVAC temperature set to full hot.</p>
Cause	This issue could be caused by either the heater core inlet or outlet hoses becoming twisted or kinked, and as a result, this may restrict the coolant flow.

If SI diagnostics do not lead to a correction, inspect the heater core inlet (1) and/or outlet (2) hoses for being twisted or kinked, as shown below. In some cases, it can be difficult to see the twist or kink in the hose due to the conduit which covers the hoses. In the examples below, the parts catalog drawing, showing callouts 1 and 2, correlates to the actual vehicle picture callouts 1 and 2.
