## GR/GU ABS valve bracket installed incorrectly

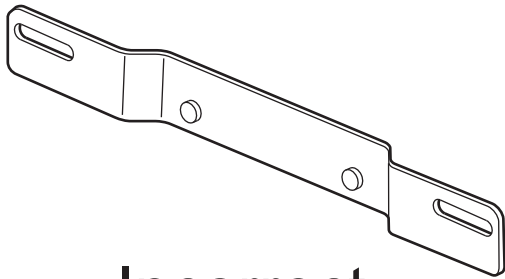
This bracket was installed upside down, allowing the attached valves to in some cases make contact with the lower radiator hose.

Incorrect

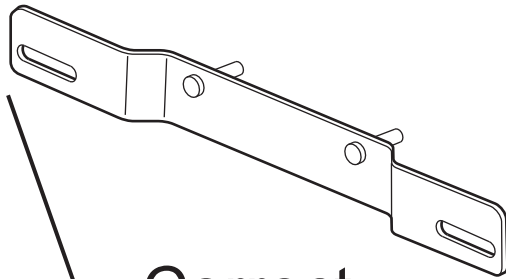
Correct

To correct this condition, the bracket needs to be removed and reinstalled in the correct orientation. (see attached photo/diagram)
