Engine Control Module (ECM), Software  
Updates  
VN Mexico Only

## SP 284-066, Engine Control Module (ECM), Software Updates

(February 2020)

### Mexico Only

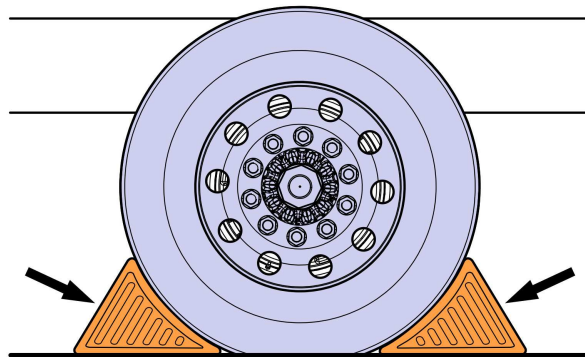
W7086748

- 1 Park the vehicle on a level surface.
- 2 Apply the parking brake.
- 3 Place the gear lever in neutral or park.
- 4 Install the wheel chocks.

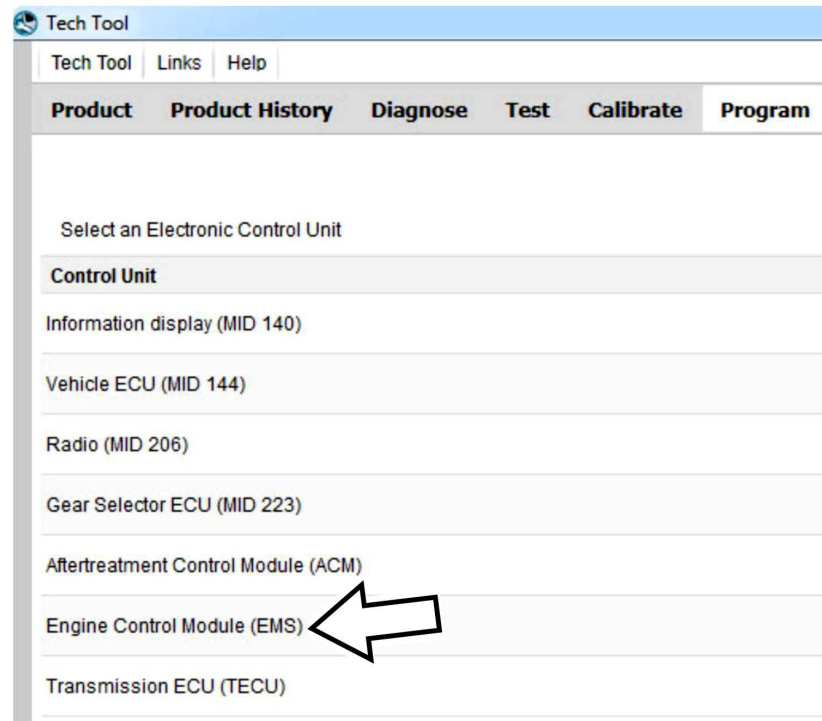
W2115479

10 Select **Engine Control Module (EMS)**.

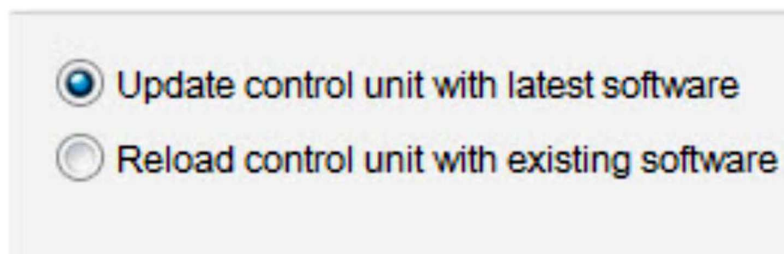
W2115480

11 Select Program to update the **ECM** with the latest software.

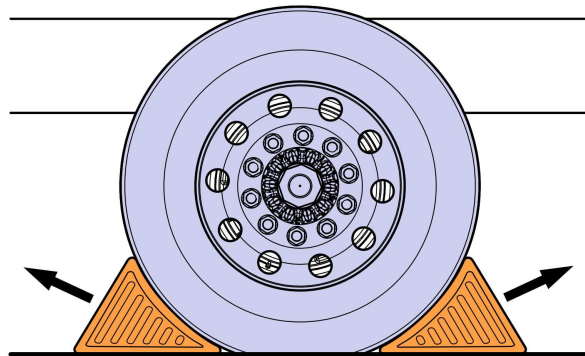
W7086759

- 14 When programming is complete, click Exit to return to Main Menu.
- 15 When all programming is complete, clear any diagnostic trouble codes (DTC) and Finish Work.
- 16 Remove the wheel chocks.
