| REFERENCE: | Nova Bus Manuals |
| RS N°: | MQR 7621-1654 |

| SUBJECT: | Allison B400 transmission harness |
| JUSTIFICATION: | Whenever experiencing multiple random transmission fault codes, it is advisable to inspect the N40216 transmission harness for chafing and, if wiring defects are found, to repair these defects. Note that not all transmission codes are caused by wiring issues. |

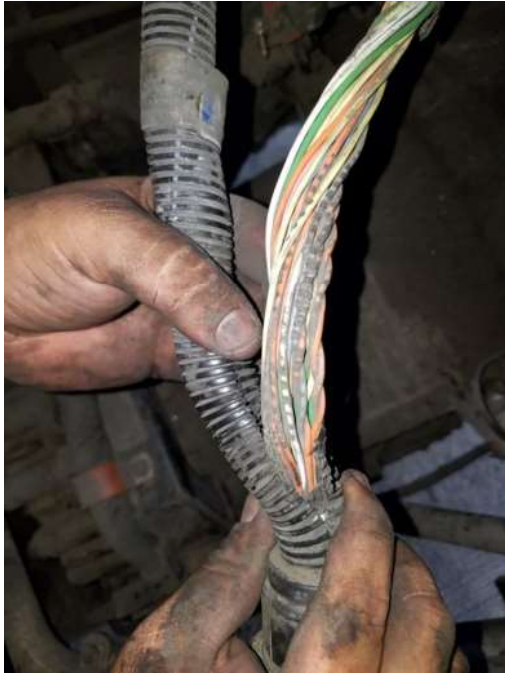
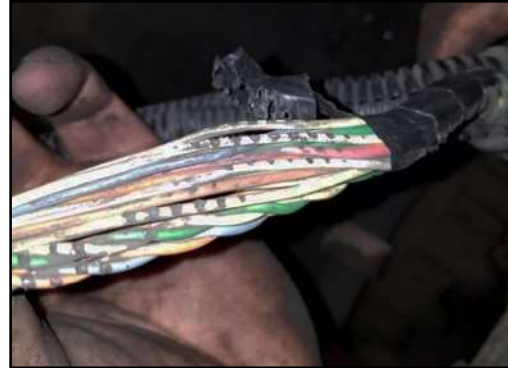
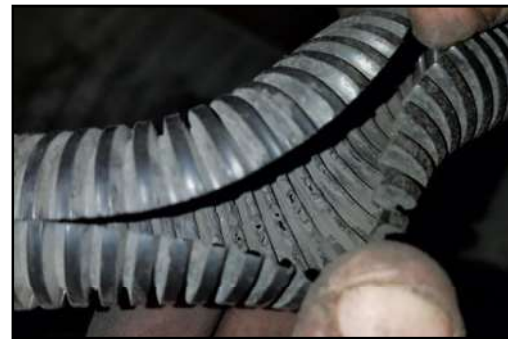
- 1.7. Remove the PVC electrical tape for 1 foot starting from the transmission connector and inspect the wires. Then inspect the rest of the convoluted tubing for signs of chafing. If there are other signs of chafing, remove the PVC electrical tape further and inspect the underlying wires (see Figure 4).

*Figure 4 - Chafed Wires and Chafed Convoluted Tubing*

| INSPECTION RESULTS | ACTION REQUIRED |
| No damage detected or only superficial damage on convoluted tubing and/or wires insulation. | Continue level 1 procedure steps 1.9 to 1.16. |
| Wiring copper strands conductors are visible (1 to 5 wires). | Go to repair procedure at step 2.1. |
| Wiring severely damaged (more than 5 wires damaged with the conductor copper strands exposed and/or corroded). | Go to repair procedure at step 2.2. |

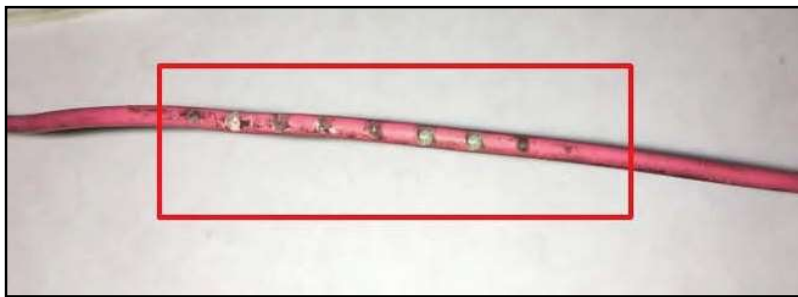
- 2.1.1. Identify all wires with visible conductor copper strands (see Figure 9) and execute step 2.1.2 to step 2.1.5 for each wire.

*Figure 9 - Wire Conductor Copper Strands Visible*

This repair procedure is only recommended for a N40216 transmission harness having 1 to 5 damaged wires. In case of more wires being damaged, the recommendation is to replace the harness (see step 2.2).

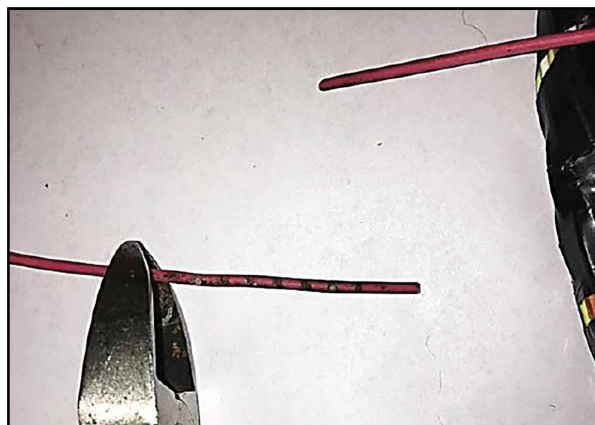
*Figure 10 - Cut Wire Damaged Section*

- 2.1.2. Cut out the damaged section of the wire (see Figure 10).

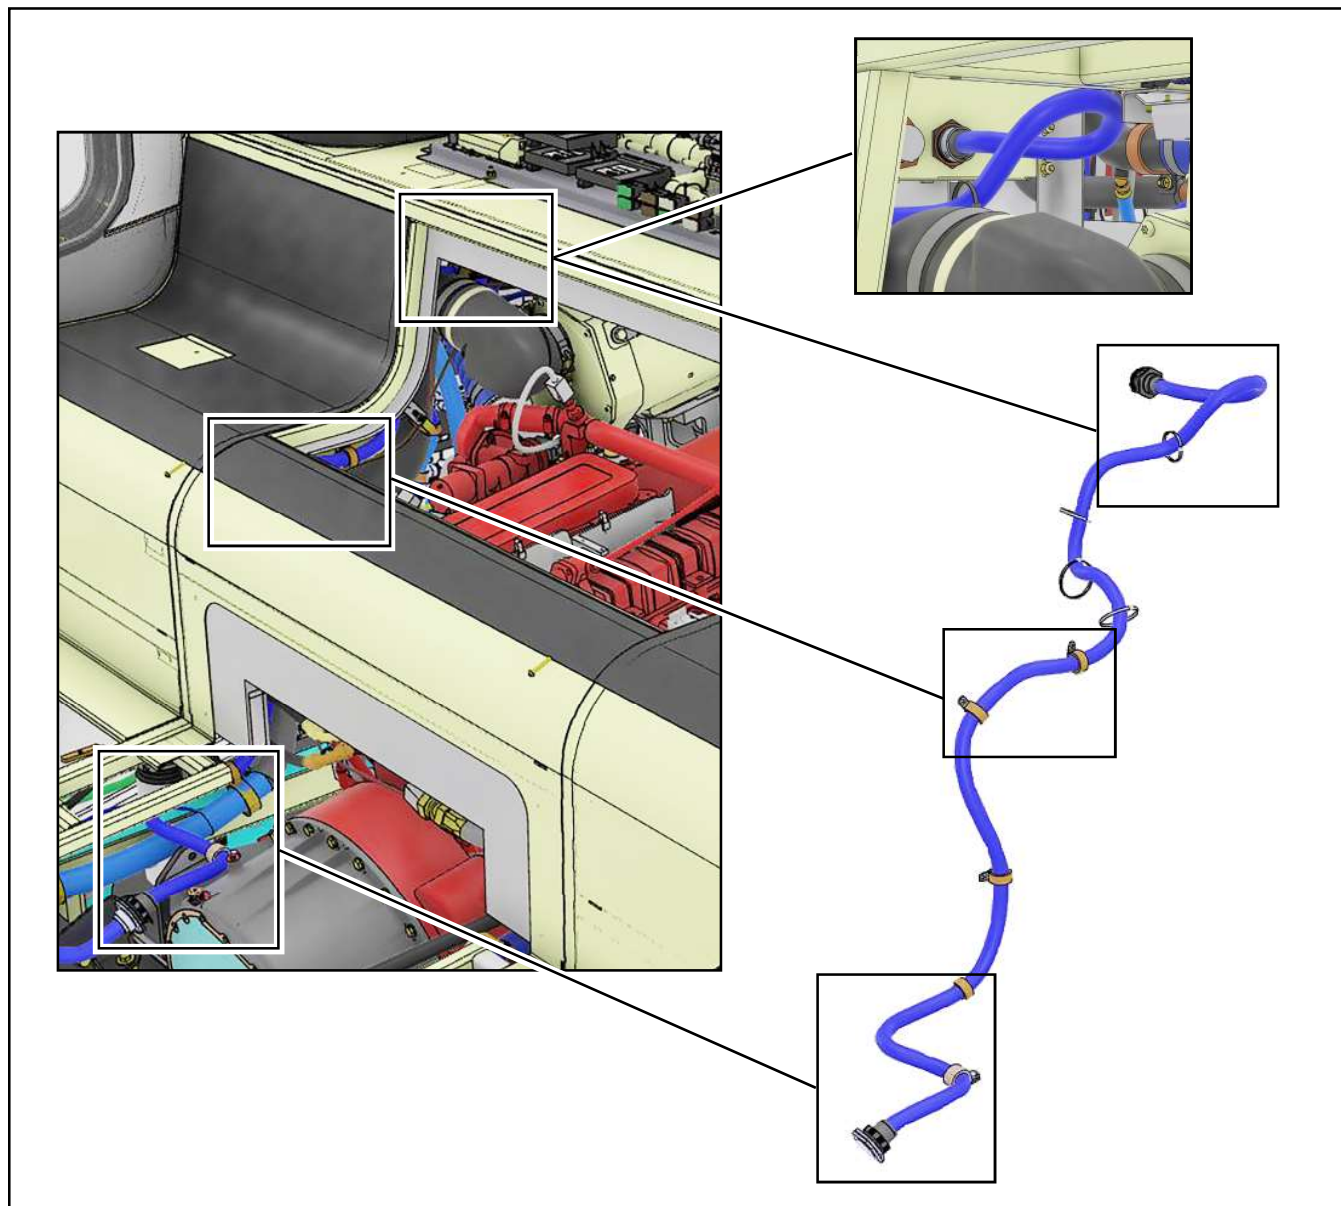
Figure 19 - N40216 Transmission Harness and P-clamps Locations

2.2.1. Remove the P-clamps (there should be 5) and the cable ties to free the damaged N40216 harness and replace it with N99235 harness (see Figure 19).
