Technical Journal

Storage box under driver seat, handle loose

REF NO: TJ 35399.1.0	ISSUING DEPARTMENT: Technical Service	CAR MARKET: United States and Canada		
3 US 7	PARTNER: '510 Volvo Car USA	ISSUE DATE: 2020-01-30	STATUS DATE: 2020-02-05	
FUNC GROUP: 8529	FUNC DESC: Miscellaneous	Page	1 of 3

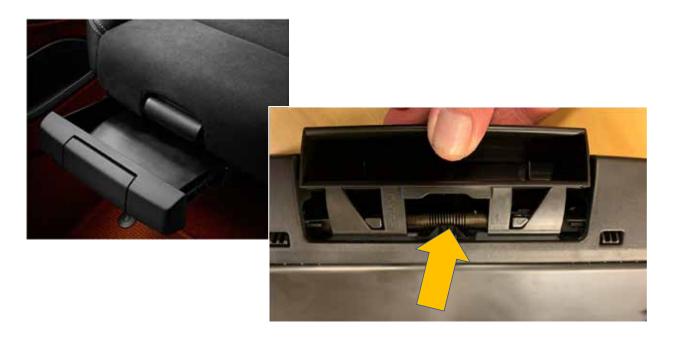
Pict TJ 35399

The spring can come loose if the driver tries to grab the handle but reaches too far and grabs under the handle. Just push the spring in place again, use a finger or screw driver or similar. It is not needed to remove the box. See "PictTJ35399.pdf". The spring is in the correct position in the picture. Inform the customer.
