Technical Journal

Info request, door sealing strip coming loose

REF NO: TJ 34071.2.0	ISSUING DEPARTMENT: Technical Service	CAR MARKET: United States and Canada	
PARTNER: 3 US 7510 Volvo Car USA		ISSUE DATE: 2018-09-11	STATUS DATE: 2020-02-05
FUNC GROUP: 8451	FUNC DESC: Sealing moulding for side door	Page 1 of 3

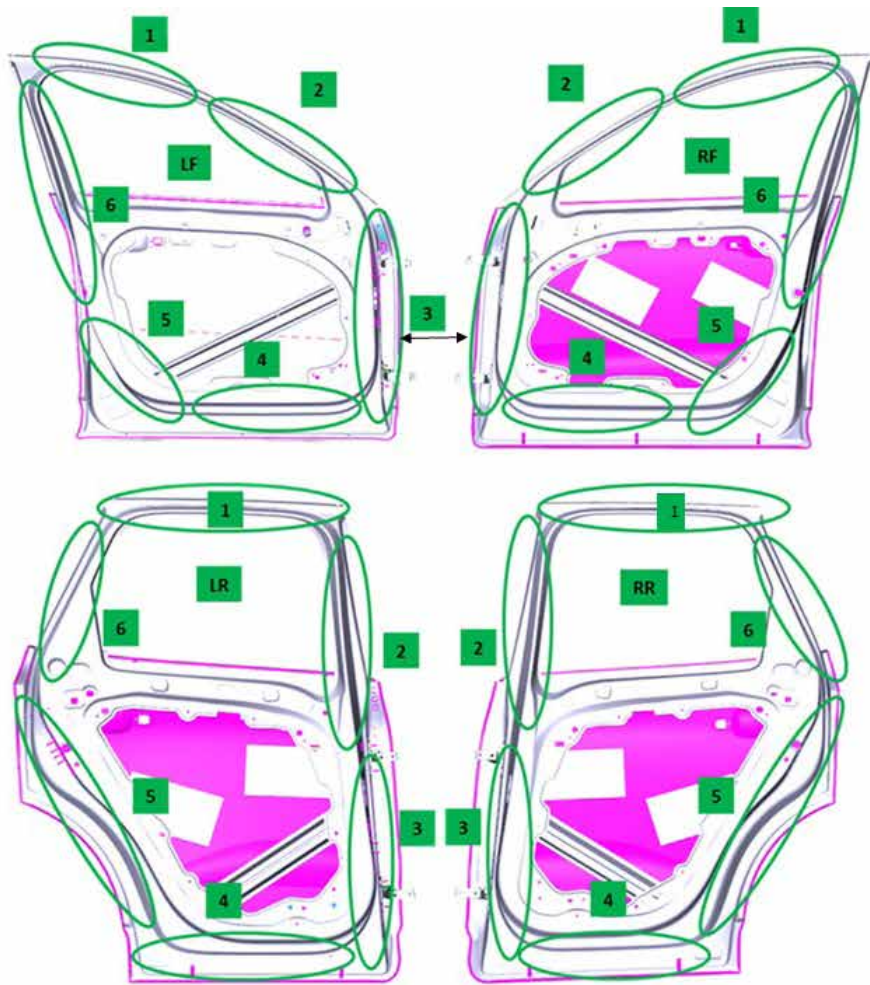
TJ 34071

If front or rear door mounted sealing strip coming loose.

Include what door that is affected and the failure area, see attachment.

Yes, please submit a Vehicle Report with detailed photos showing the failure. Add the nr of the failure area and what door that is affected according to attachment. Use concern area "Vehicle Report" and sub concern area "Support not needed", use function group 8451.

Replace the sealing strip according to VIDA.
