TITLE: Panoramic sunroof, noise or hard to close

REF NO:	ISSUING DEPARTMENT:		ARKET:
TJ 35154.1.0	Technical Service		s and Canada
3 US 7	PARTNER:	ISSUE DATE:	STATUS DATE:
	7510 Volvo Car USA	2020-02-04	2020-02-07
FUNC GROUP: 8360	FUNC DESC: Roof hatch	Page	1 of 7

Volvo	Car Customer Service	TJ Instruction VCC-517920-1		
Title	Sun roof	Page	1(5)	
Action	Adjustment	Operation number:	99922-2	
			98738-2

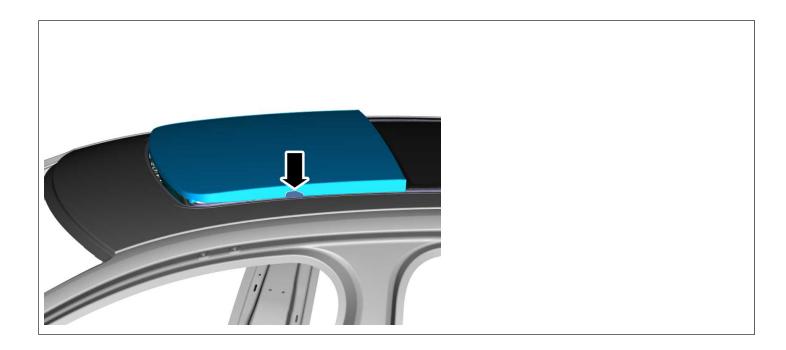
Check

Inspect the rubber lip, left and right side of the front panoramic glass panel, for deformity and if confirmed perform repair as per attached TJ instruction.

Note! If noise is evident, follow information below to correct the problem.
