SIB 12 33 14

Fault Code 1D2008 Stored in DME

This Service Information Bulletin (Revision 5) replaces SI B12 33 14 **dated February 2016**.

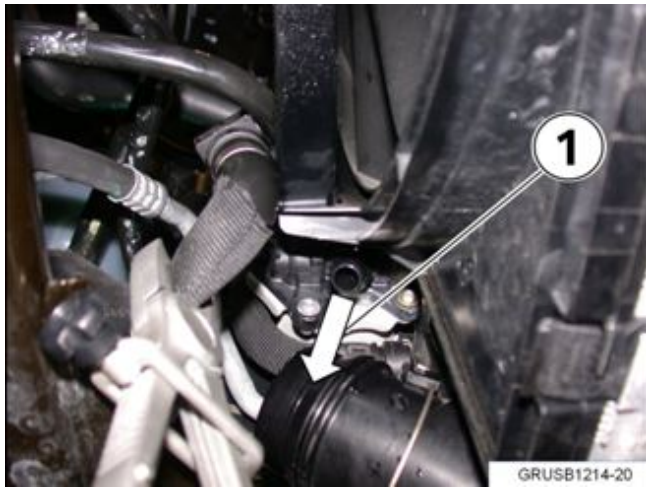
If any coolant starts leaking out of the transmission heat exchanger (1), the internal thermostat is jammed and the heat exchanger will need to be replaced.

Follow Repair Instruction RA 17 22 010, "Removing and installing/replacing transmission oil cooler for automatic transmission (N20, N26, N55)."
