SIB 51 05 20 FUEL FILLER DOOR STICKING

2020-02-10

E-Series	Model Description
G06	X6 Sports Activity Coupe
G07	X7 Sports Activity Vehicle

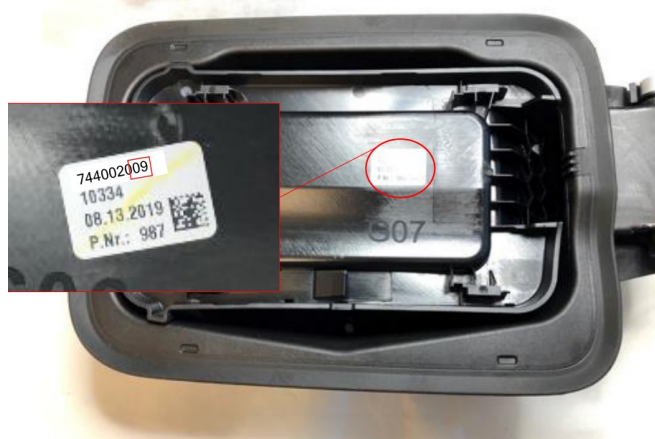
Inspect the white label on the hinge arm (circled).

For G07: Are the last 2 digits less than 10?

For G06: Are the last 2 digits less than 09?

1. Remove the fuel tank filler flap following repair instructions **REP 41 63 000** "Removing and installing the fuel filler flap".

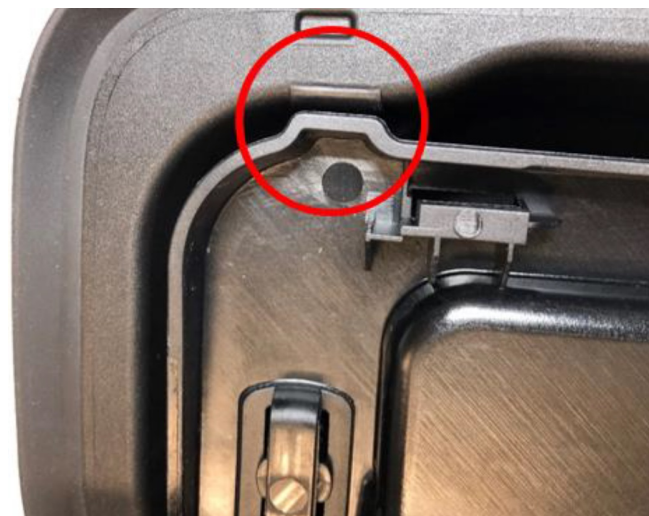
2. This is the area which will be modified (circled). **Do not modify the lower tab, only the upper.**
