SIB 51 13 18

LIN BUS FAULTS WITH EXTERIOR REARVIEW MIRROR GLASS DAMAGE

This Service Information Bulletin (Revision 2) replaces SI B51 13 18 **dated February 2020**.

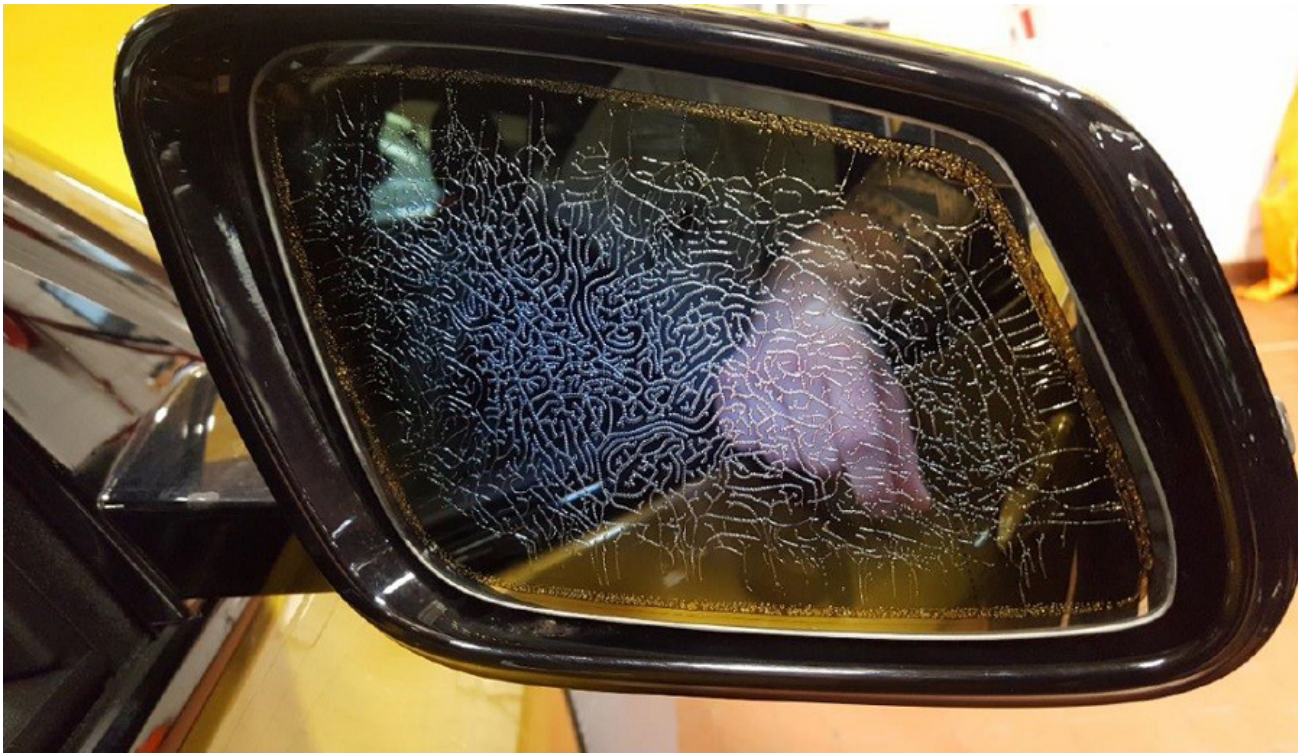
The exterior rearview mirror glass is discolored or cracked. The power windows and folding mirrors may not operate, and one or more of the following LIN bus faults are stored in the BDC (Body Domain Controller):

Faulty exterior rearview mirror electronics have created a short on the LIN bus, damaging the mirror glass and causing functional errors in power window and exterior mirror operation.

1. Test the operation of the power windows, side rearview mirror adjustment, and side rearview mirror folding functions. Inspect the side rearview mirror glass on both sides for damage as shown in the photo above.

Replace the mirror electronics in the exterior mirror.

3. Replace the mirror electronics of the affected mirror following repair instructions **REP 67 13 526** “Replacing mirror electronics for electrically adjustable exterior mirror left or right”.

4. Replace the mirror glass, if damaged.
