SIB 64 04 16

Water Ingress In Footwell Area From A/C Condensate Drain
This Service Information Bulletin (Revision 1) replaces SI B64 04 16 dated March 2016.

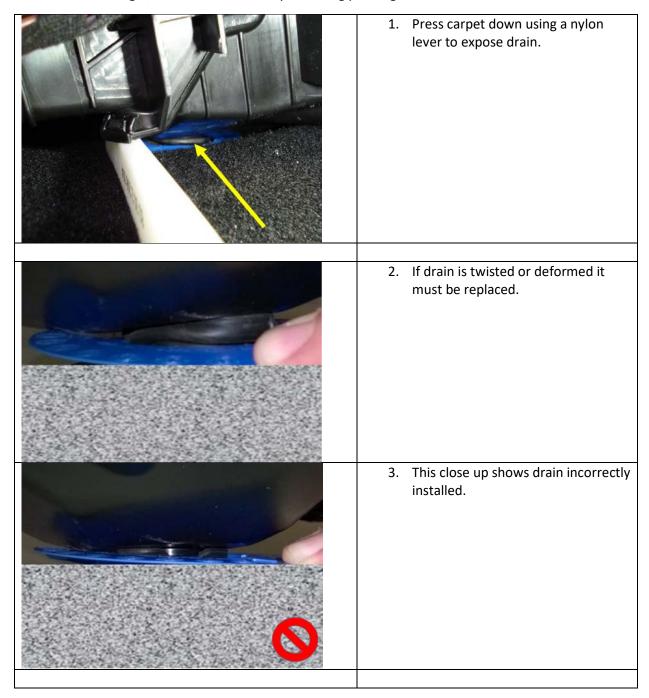
Locate IHKA housing A/C condensate drain by removing passenger side console foot well trim.

4. Water leaks can occur in these areas causing the molding smell from carpet.
