SIM 54 03 17

CONVERTIBLE TOP WILL NOT COMPLETELY STOW

E-Series	Model Description
F57	MINI Convertible

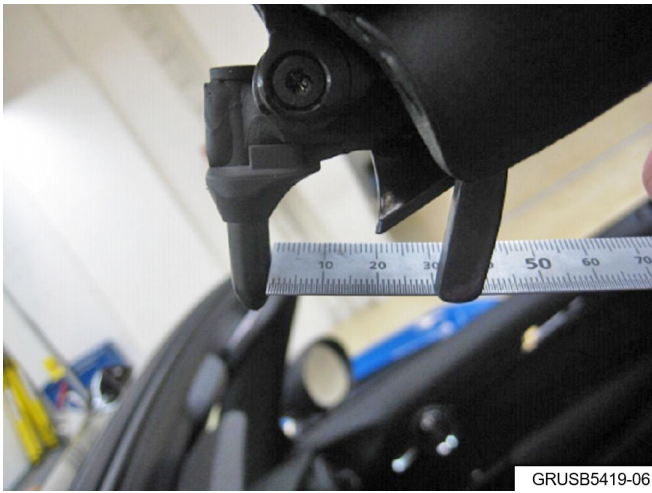
1. Open the folding top half way to gain access to the stowage lock (gripper hook). Measure the distance of the hook to the centering pin.

Is the distance less than 28 mm on either side?

YES: Replace the folding top assembly following repair instructions REP 54 34 105 – “Replacing complete convertible top” and retest.

- If the top stows correctly, no additional repair is necessary.
- If the top does not stow correctly, continue to Step 2.

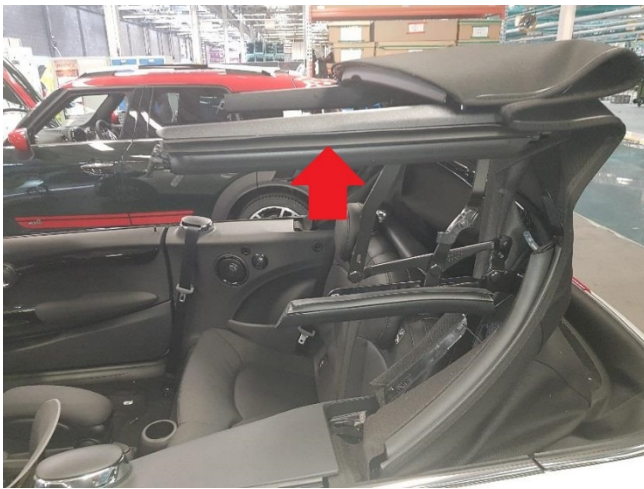
2. Open the folding top half way to inspect the felt strip in the area shown to the left.

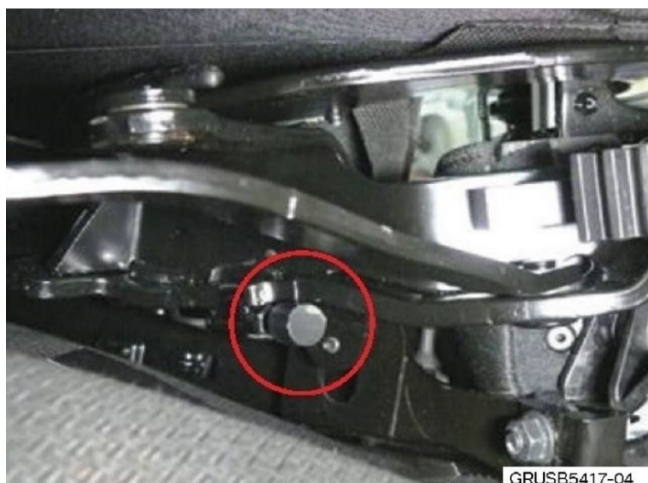
GRUSB5417-04

5. Expose the left convertible top spacer adjustment bolt shown to the left by opening the loading aid.

Loosen the lock nut.

Turn the adjustment bolt in 1 - 2 turns.
Retighten lock nut.
