XITE 360* CAMERA TROUBLESHOOTING MY20 & 21

Bulletin Type:	INC
Bulletin #(s):	20-008
Job Code(s):	N/A
Flat Rate(s):	N/A

Publication Date:	March 2020
Make(s):	EMBARK, REATTA, ENTEGRACOACH
Model(s):	UNITS EQUIPPED W/XITE 360* CAMERA
Model Year(s):	MY2019 TO 2021

Incident:	"NO VIDEO DETECTED" on camera monitor screen.
Affected Units:	UNITS EQUIPPED W/XITE 360* CAMERA
Parts Kit:	Parts Kit #: N/A
	Parts Kit Contents: N/A
Misc. Tools & Supplies:	N/A
Parts Return Information:	N/A

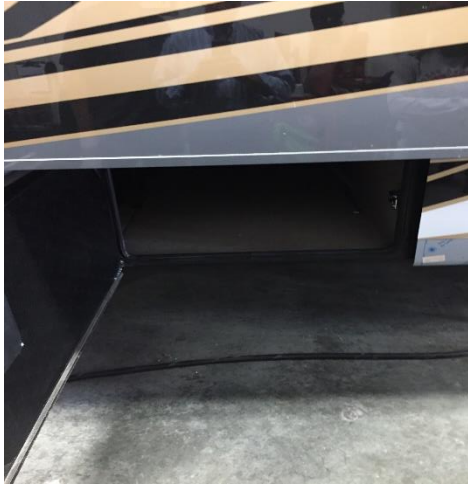
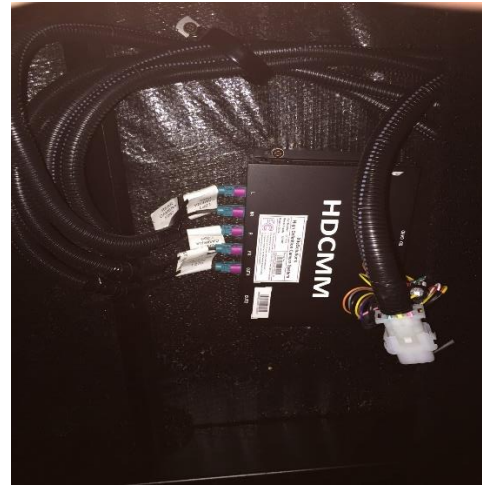
The HDCMM will be found in the third cargo door from the front driver side tire; fastened to the cargo ceiling.

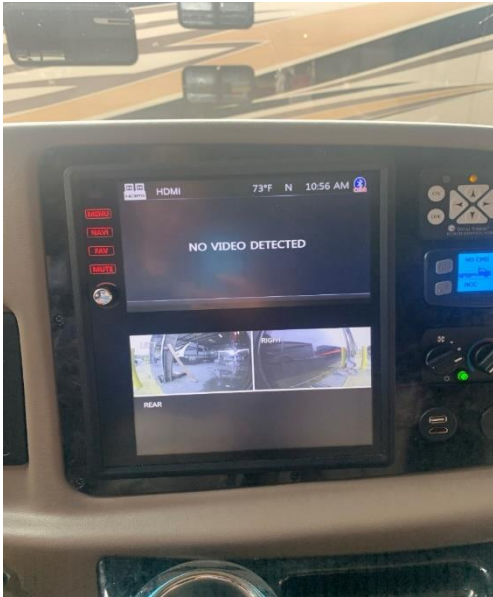
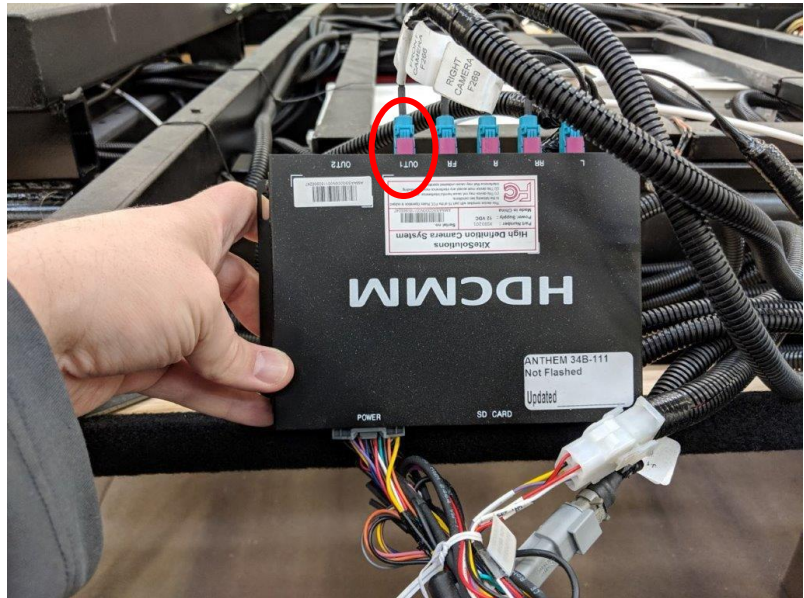
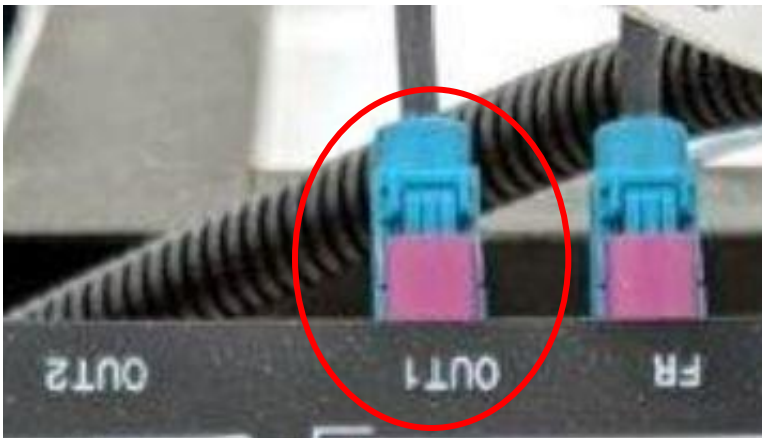
If no image is present from the HDCMM, on screen will be “No Video Detected”. If after a hard reset the screen still shows “No Video Detected”, **bypass the installed cable between “Out 1” and the Core with a tester cable.** This confirms whether or not the installed cable is damaged.

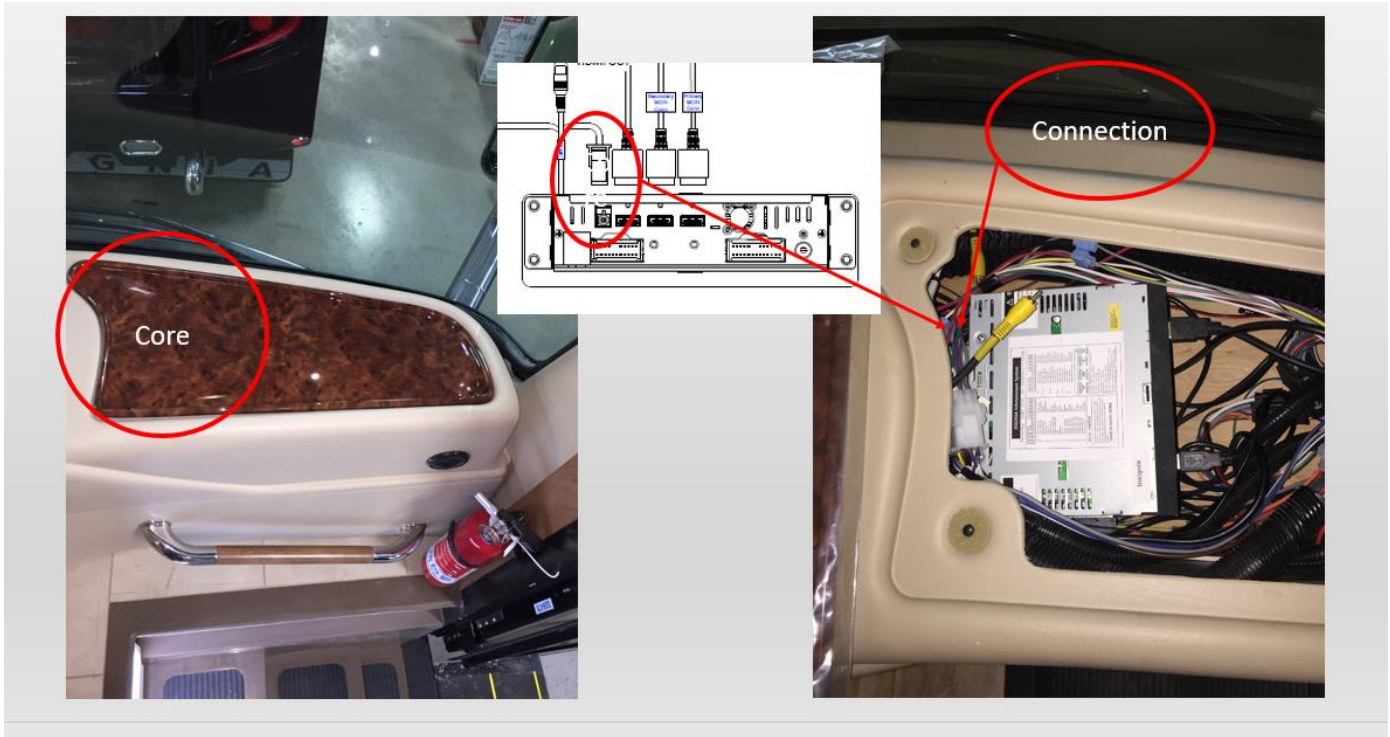
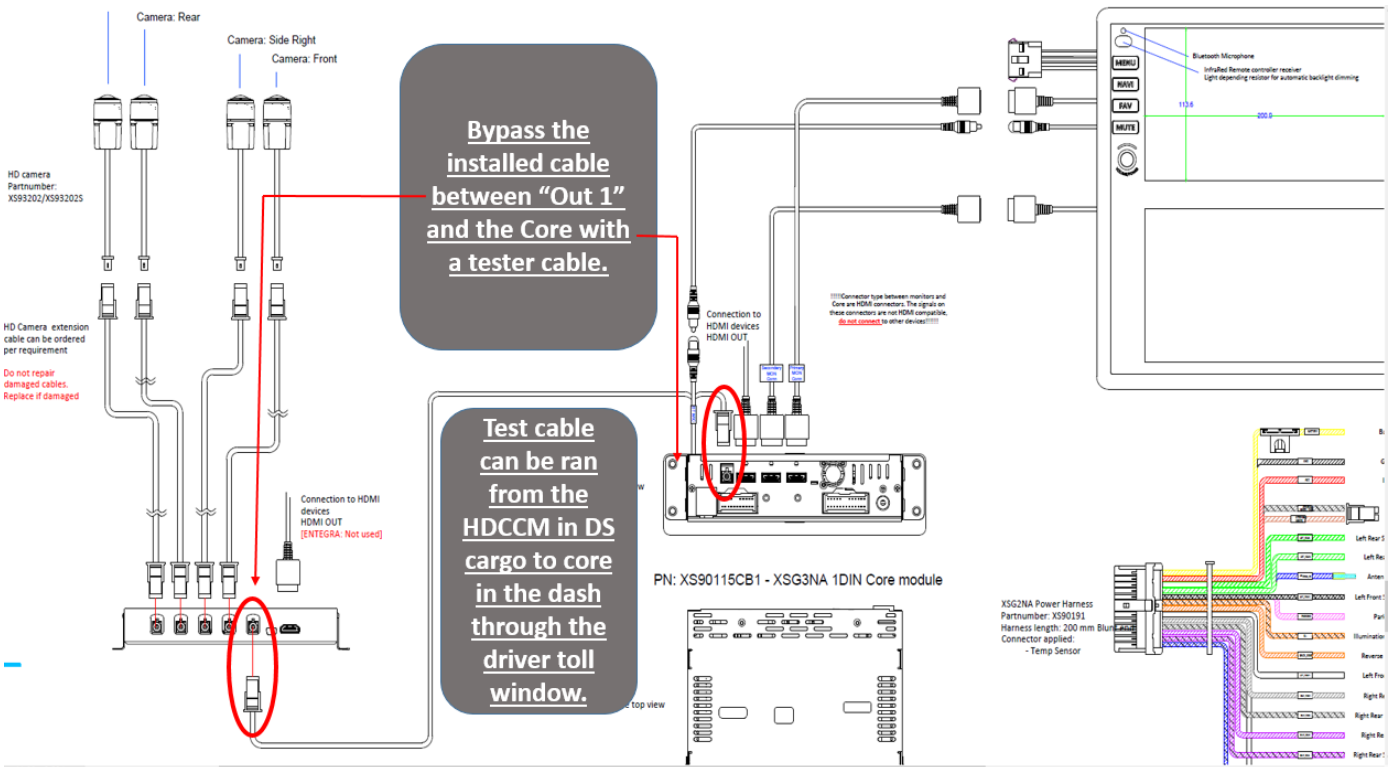
The Core will be located in the dashwell in front of the passenger seat.
 The connection for the HDCMM will be at the front back side of the core.

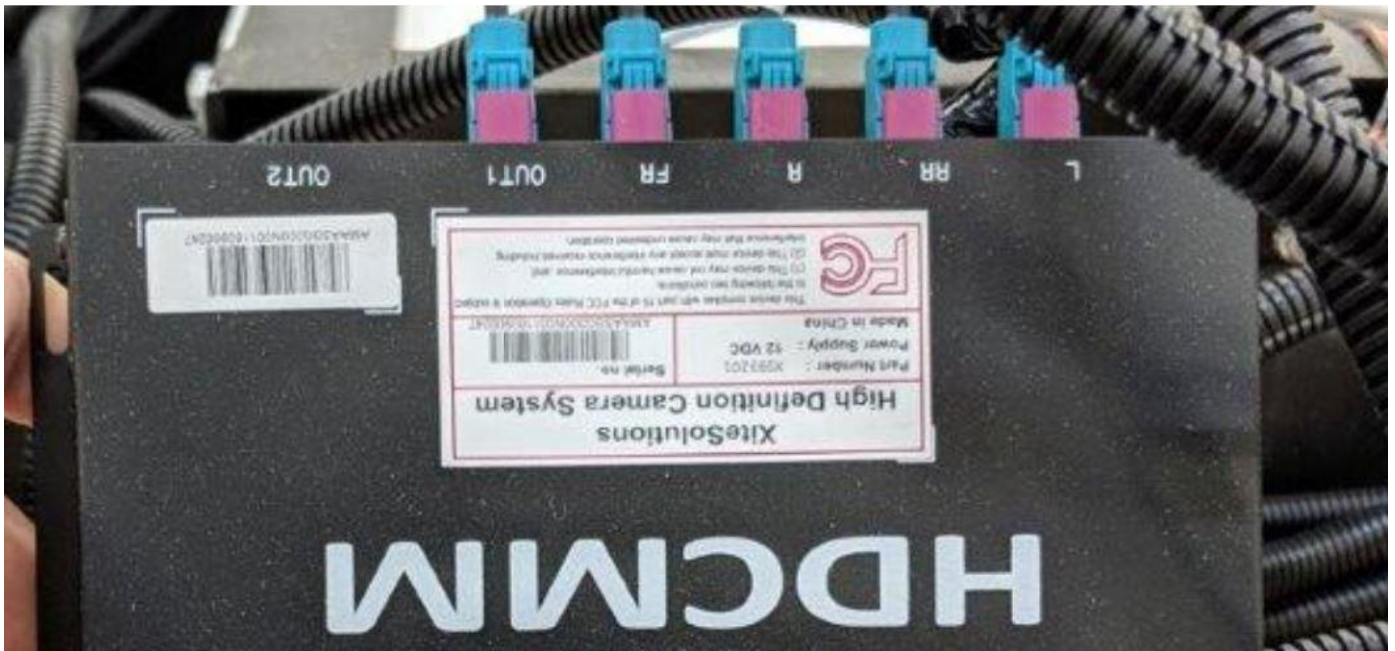
Test the HDCMM port by swapping the cable with a known working cable. (Plug a known working left camera feed into the suspect front camera input.)

If the known working feed does not appear at the suspect input, you have confirmed the port is bad.

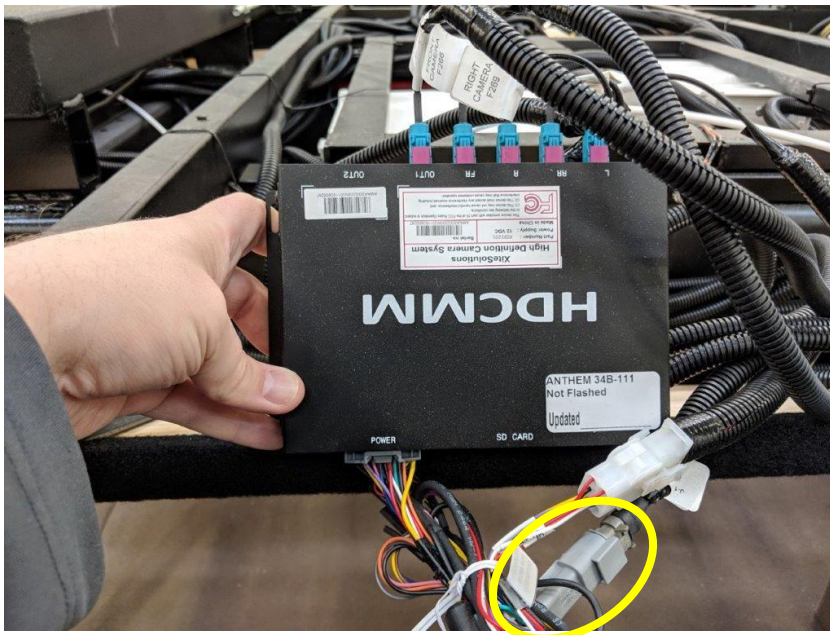
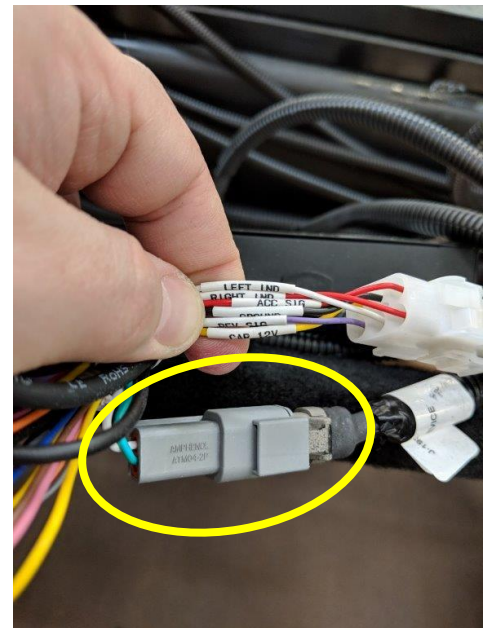
Dynamic Parking Gridlines will appear on screen when in reverse. If the lines are not moving with the steering wheel, **check the CAN hi and lo connection at the HDCMM. (White and Green twisted pair.)** If connection is made at the HDCMM, contact **Spartan Motors (800 543 4277)** in regards to troubleshooting the steering wheel sensor.
