Service Action

Code: 66L4

Subject	Under Hood Cowl Seam															
Release Date	March 03, 2020															
Affected Vehicles

Subject: Service Action 66L4 - Under Hood Cowl Seam

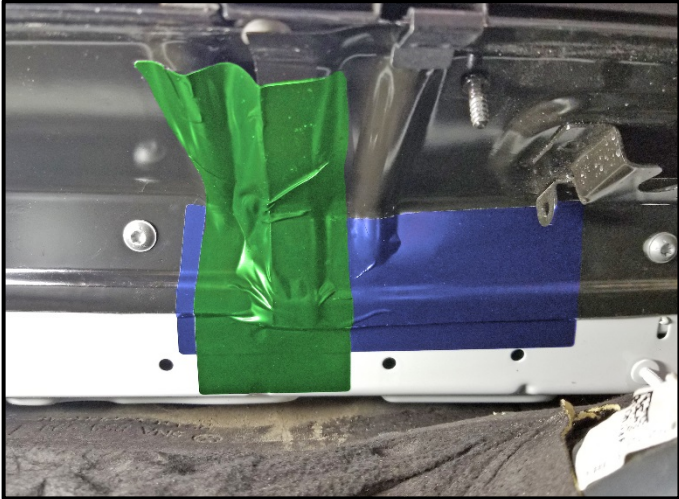
Repair Overview

What is the issue? In certain situations, water may leak through the seam in the under hood cowl and into the vehicle interior.

- Inspect cowl seam area and either replace or install water tape (if necessary)

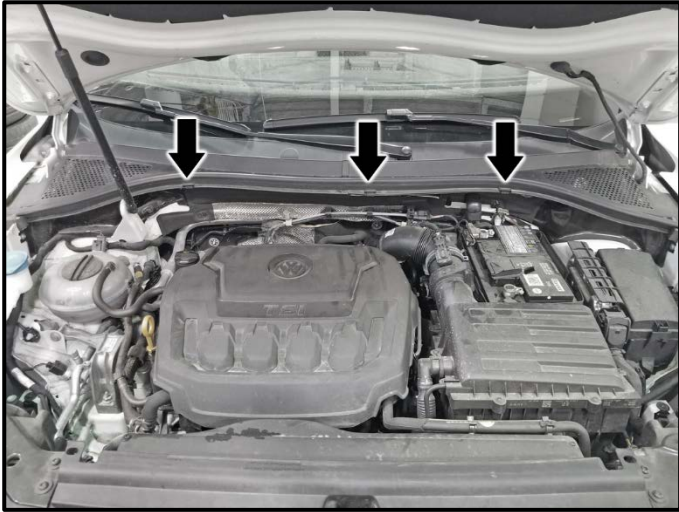
Visually inspect cowl seam area:

- Remove cowl cover clips <arrows>.
- Pull back heat shield slightly.

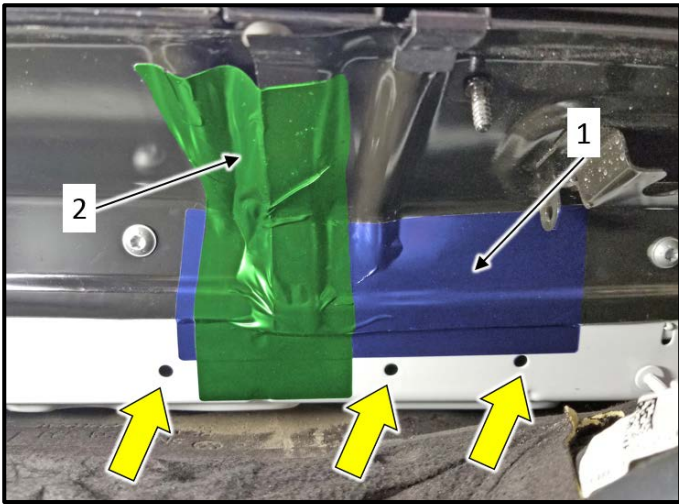
Inspect water tape installation:

Correct installation shown:

- Water tape is not covering the holes <arrows>.
- Horizontal tape <1> is installed first (vertical tape <2> is on top).
- If water tape is present and installed correctly, no further work is required, **proceed to Section C.**
- If water tape is present, but installed incorrectly (any of the holes <arrows> are covered), **proceed to next step.**
- If water tape is not present, **proceed to next step.**

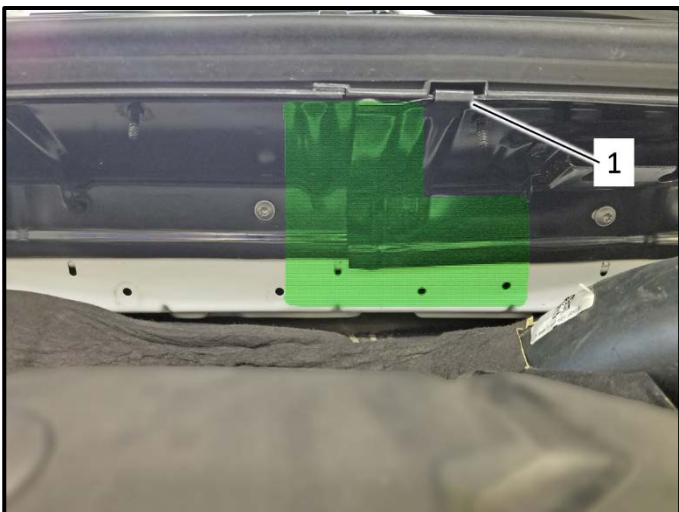
Prepare cowl and firewall:

Reinstalling clip <1> secures both sections of the cowl to allow for proper installation of the water tape.

- Reinstall clip <1>.

- Remove original tape (if present).
- Clean shaded area with a lint free cloth and isopropyl alcohol.
- Allow the alcohol to completely evaporate (approx. 5 minutes) before installing the water tape.

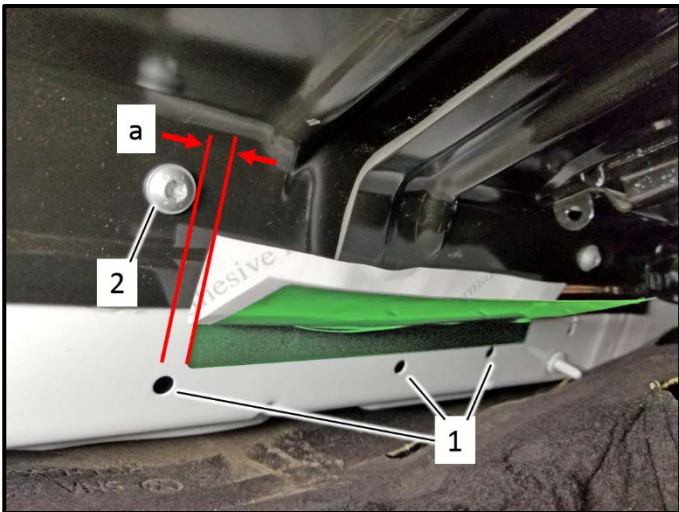
Install the first piece of water tape horizontally:

The 1 cm dimension must be achieved to ensure the water is diverted correctly.

- Ensure the holes <1> are not covered.
- Start the tape approximately 1 cm <dimension a> from bolt <2>.

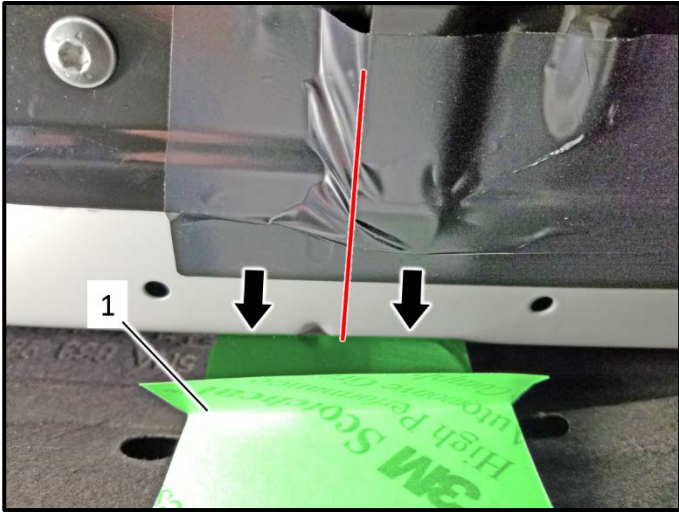
Apply the second piece of water tape <1> vertically:

- Start the tape at the bottom edge of the firewall <arrows>.
- The tape will be centered with the cowl sections seam.
