SS 1034679 M2 ABS Wiring Harness Rubs On Forward Cab Mount

All M2 platform, to date especially 160 MM cab height applications.

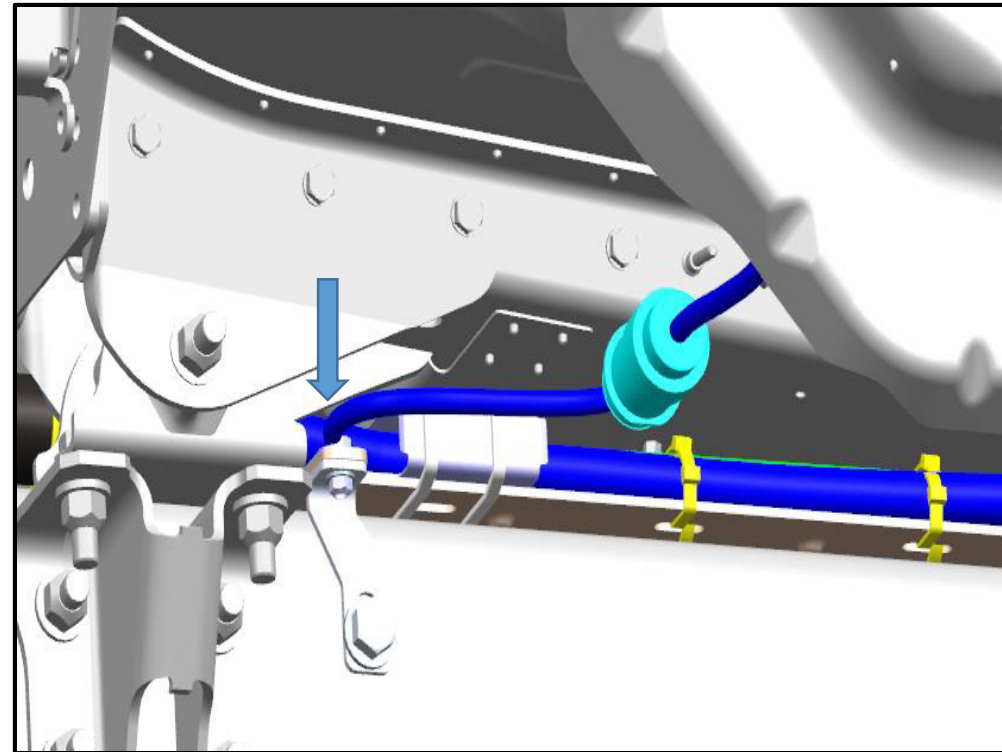
ABS chassis harness is rubbing on the rear of the driver side forward cab mounting bracket on M2 106 trucks with a 160 MM Cab Hgt. This may cause open or shorted circuits in multiple wires in the harness transitioning from the chassis to the cab. Noticeable symptoms include illumination of the ABS and ATC indicator lamps.

Note location of conflict below

Rerouting the ABS chassis harness alongside the 87L content forward pneumatic bundle protects the harness from both pinch points and chafing. See attached document for visuals and basic steps. There is no need to corrections to the harness other than repairing any damage prior to rerouting.
