# Technical Service Bulletin

## 26 Droning, buzzing, or vibration from front of the vehicle - Q7

26 20 38 2058574/2 March 11, 2020. Supersedes Technical Service Bulletin Group 26 number 20-37 dated February 13, 2020 for reasons listed below.

Model(s)	Year	VIN Range	Vehicle-Specific Equipment
Q7	2019	023480 - 999999	3.0TFSI

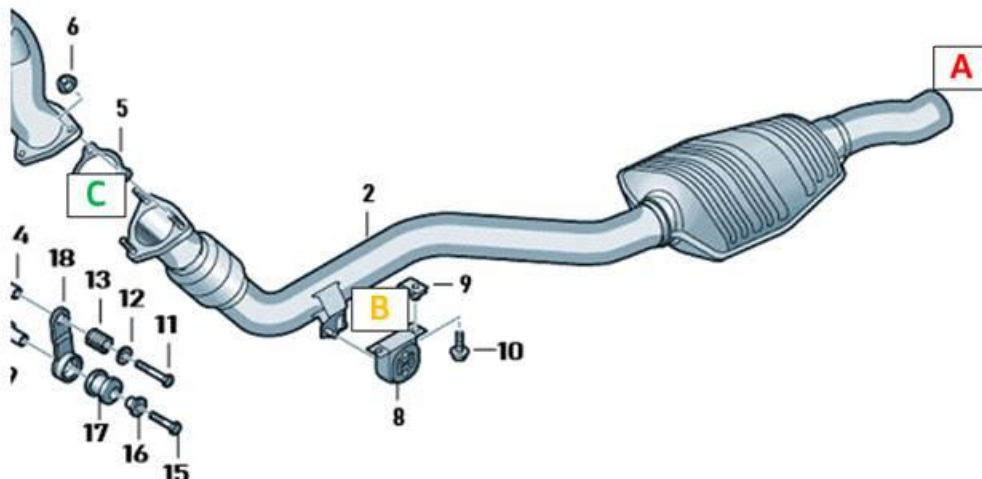
- Droning, buzzing, or vibration; especially between 1,000 – 1,400 rpm.

- The issue can be isolated to underside and front of the vehicle.

**Figure 1.** Example of locations to loosen and tighten.

- Loosen the exhaust clamp (A), exhaust bracket (B).
- Then re-tighten beginning with clamp (A) and then the bracket (B) (Figure 1).

3. Test drive and if issue persists continue with the following step (Figure 1):
  - Repeat and loosen the exhaust at (A), (B), and also the flange (C) to the catalytic converter.
  - Then tighten in the following sequence: First, the flange (C), second the exhaust clamp (A), and finally the exhaust bracket (B).
4. Test drive vehicle to verify that the concern is no longer present.
