Technical Service Bulletin

40 Noises from the front axle and swivel joint (ball joint)

40 20 02 2058421/2 March 12, 2020. Supersedes Technical Service Bulletin Group 40 number 20-99 dated February 4, 2020 for reasons listed below.

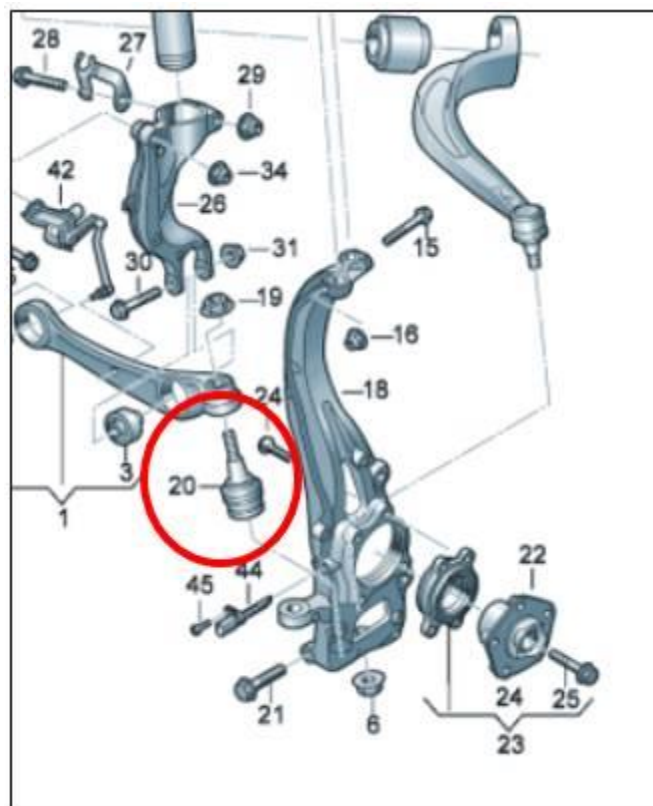
Figure 1. Swivel (ball joint).

- The customer statement can be reproduced.
- The noises can be assigned to the swivel joint (ball joint) of the left or right front axle (Figure 1, pos. 20).

Identify and replace the affected swivel joint (ball joint) of the left/right front axle according to the instructions in Elsa at Repair Manual, *Chassis >> Suspension, Wheels, Steering >> 40 Front Suspension >> Lower Control Arm and Ball Joint >> Ball Joint, Removing and Installing*.
