# Technical Service Bulletin

## 40 Rumbling/creaking noises from front of the vehicle when driving - Q7, Q8, A8, and Audi e-tron quattro

40 20 03 2058489/2 March 12, 2020. Supersedes Technical Service Bulletin Group 40 number 20-01 dated February 6, 2020 for reasons listed below.

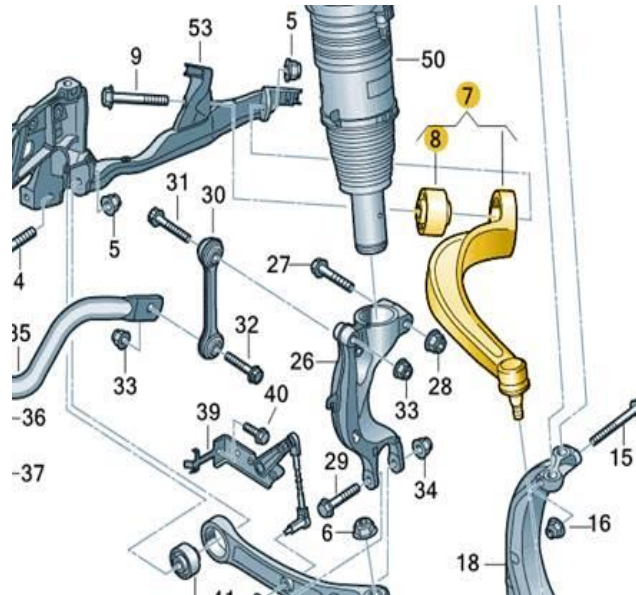
**Figure 1.** Hydro-bush.

The noises can be generated on the lower left guide in the area of the hydro-bush.  
(Figure 1 – Position 7 and 8).

The noises from the guide link can be transmitted into the vehicle interior by the connection of the sub frame on the body and are noticeable in the foot well.

1. Replace the hydro-bush on the guide link in pairs (Figure 1 – Position 8) according to the instructions in Elsa at Repair Manual, *Chassis >> Suspension, Wheels, Steering >> 40 Front Axle >> Lower Control Arm and Ball Joint >> Guide link bonded rubber bushing, Removing and Installing*.
2. Before installation, ensure that the new parts of the hydro-bush have a parts version of **03S** or higher (Figure 3).

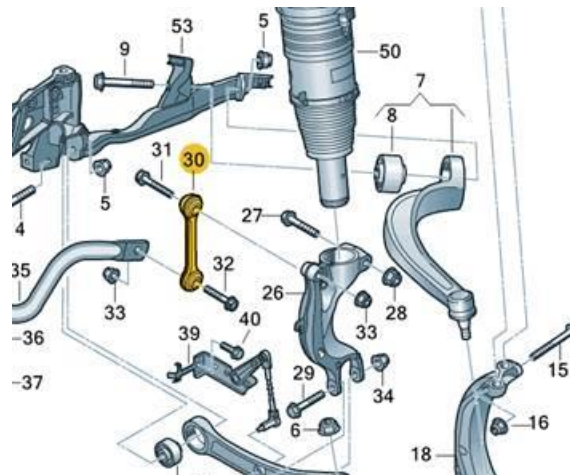
**Figure 2.** Coupling rod.

Parts such as the coupling rod (Figure 2 – Position 30) are usually replaced by mistake, presenting no problems.
