44 Tire wear, Goodyear Eagle 285/45 R20 All Season

44 20 74 2048563/3 March 6, 2020. Supersedes Technical Service Bulletin Group 44 number 17-67 dated October 24, 2017 for reasons listed below.

Model(s)	Model(s) Year VIN Range		Vehicle-Specific Equipment	
Q7	2017 - 2021	All	Not Applicable

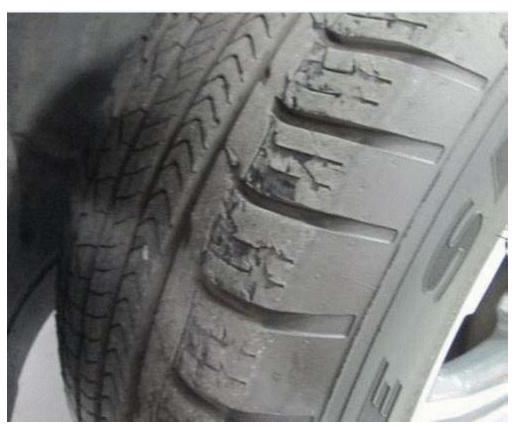
High ambient temperatures in connection with rough roads lead to increase wear only on the outer edges of the tire.

The following photograph shows an irregularity on the outer side and on the inner side of the tire (Figure 1). For this specific type of concern the tire must be replaced.

Figure 1. Irregularity on the outer side and on the inner side of the tire.

- The remaining tread depth is above 6.5mm (8/32^{nds}").
- Wear on outer/inner edges is the same as Figure 1, then proceed as follows:
- 1. Replace all 4 tires with:
 - Pirelli Scorpion Verde 285/45 R20 112 H XL AOE.
- 2. Upload pictures of the tires to DOC-IT for claim validation (4 pictures: one for each tire with visible marks FL, FR, RL, and RR).
- Submit tires through Warranty Claim Portal on Dealer Tire website >> Workmanship and Materials >> tearing of tread.
- 4. If tires are similar to Figure 2, do not replace the tires and proceed with tire rotation.

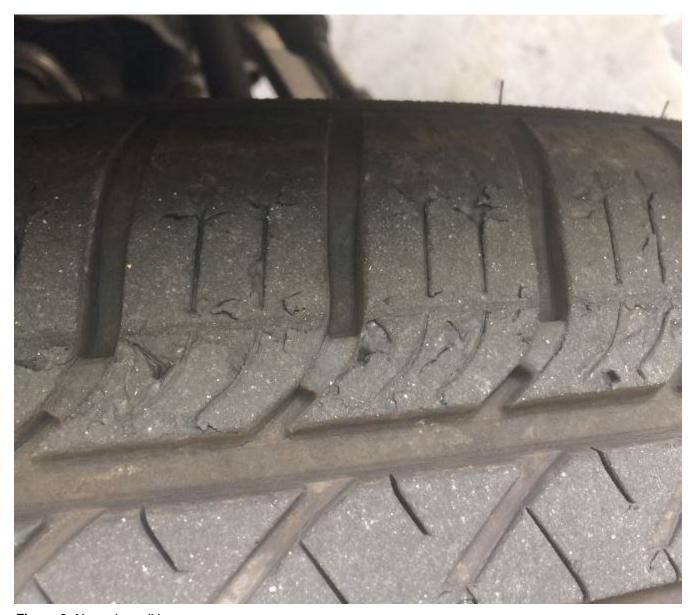
The following photograph shows a normal condition and the tire cannot be replaced (Figure 2).

Figure 2. Normal condition.
