# Keystone RV Company

## SERVICE ADVISORY # 20-375

### Kinro Frameless Windows

# 3000 SERIES WINDOW VENT BONDING INSPECTION

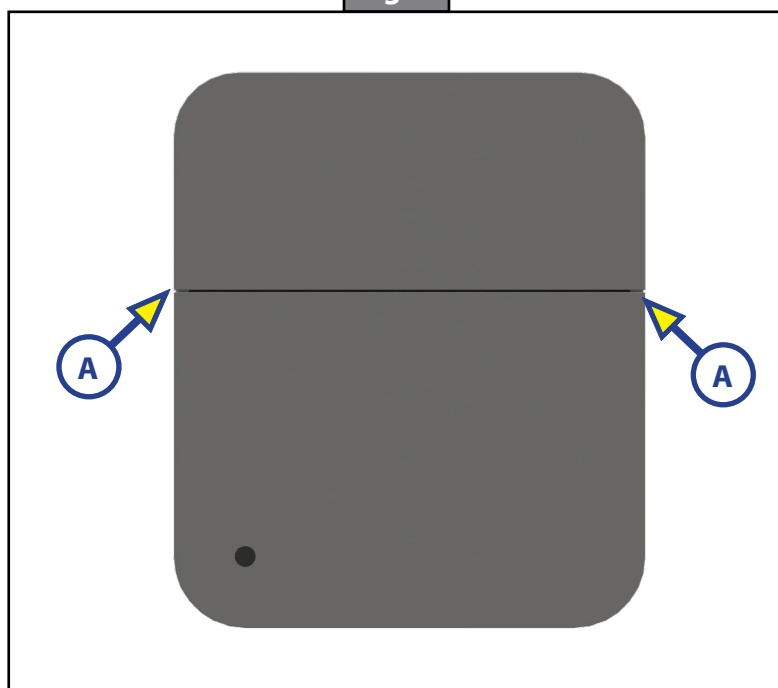
Fig. 5

1. Make sure the unit is on a level, flat surface then chock the wheels.
2. Inspect the frameless window for proper adhesive bond where the glass meets the hinge frame (Fig. 5A).

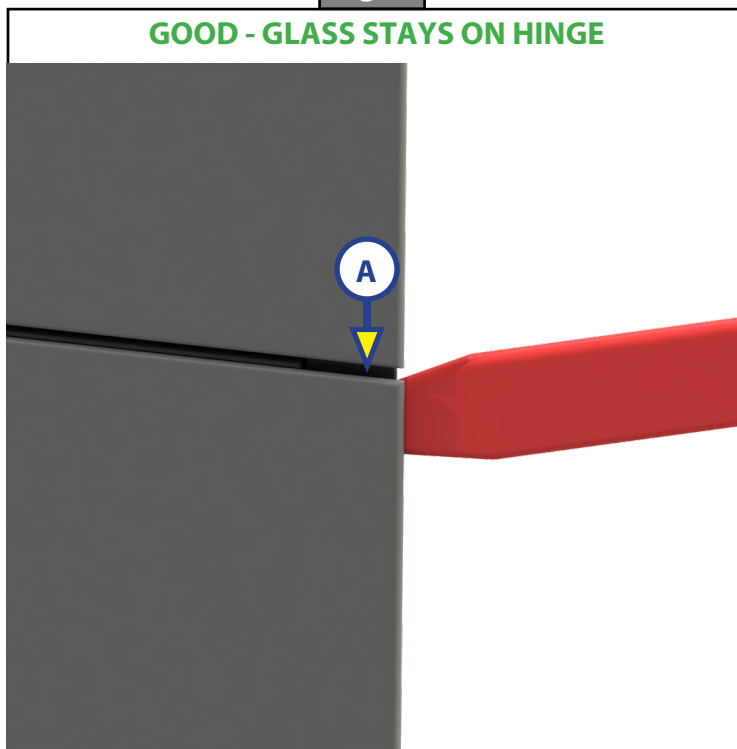
Fig. 6

4. If the glass does not separate from the hinge (Fig. 6A), it is a good bond. **DO NOT REPLACE** the vent. If the glass is not adhering to the vent (Fig. 7A), the glass **DOES NEED TO BE REPLACED**.

**GOOD - GLASS STAYS ON HINGE**

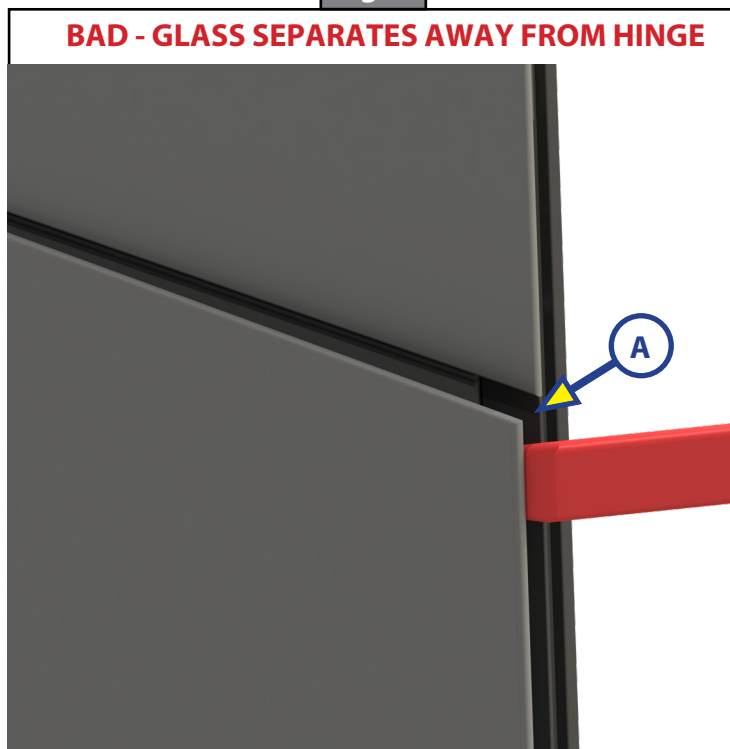
Fig. 7

**BAD - GLASS SEPARATES AWAY FROM HINGE**
