GLOBAL SAFETY FIELD INVESTIGATIONS
DCS5315
URGENT - DISTRIBUTE IMMEDIATELY

Subject: N192275630-02 – Customer Satisfaction Program
Brake Assist Feature - Frontview Camera Reprogramming and
Configuration
Revised Bulletin Title

Models: 2019 Chevrolet Silverado 1500 (New Model)
2019 GMC Sierra 1500 (New Model)

N192275630 Brake Assist Feature - Frontview Camera Reprogramming and Configuration

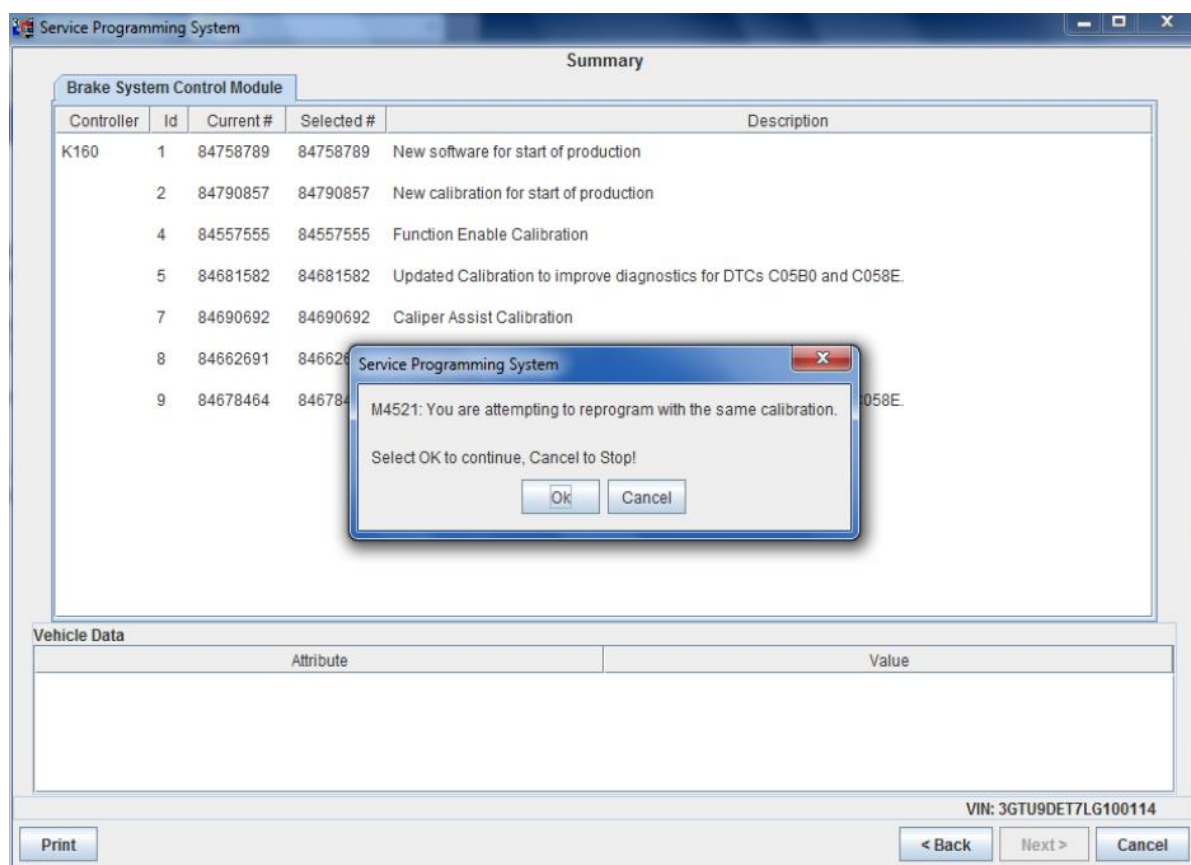
5431207

Note: If the Same Calibration/Software Warning is noted on the SPS screen, select OK and follow screen instructions. After a successful programming event, the WCC is located in the Service Programming System dialogue box of the SPS Summary screen. No further action is required. Refer to the Warranty section of the bulletin.

1. Reprogram the frontview camera by performing the SPS Programming/SPS Configuration/GDS2 Learn. Refer to *B174W Frontview Camera - Windshield: Programming and Setup* in SI.

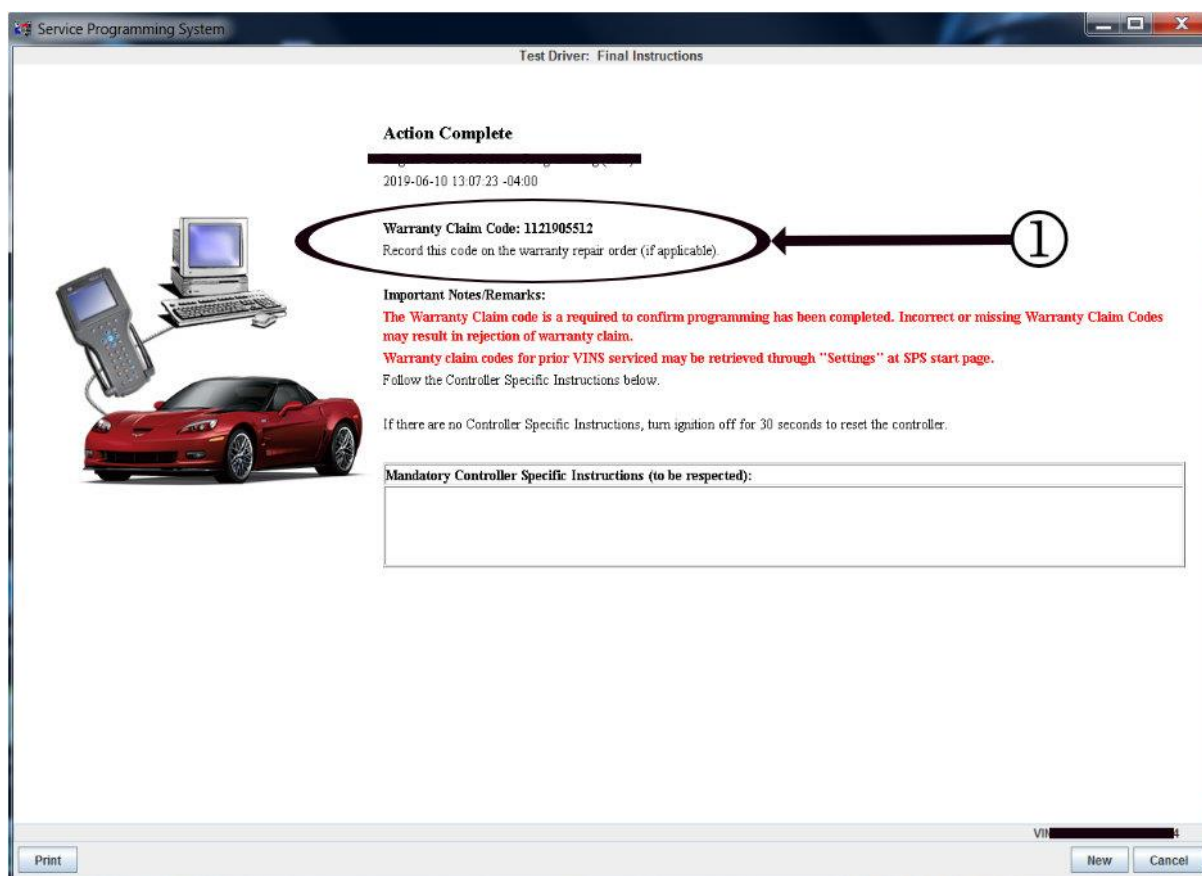
5431209

Note: To avoid warranty transaction rejections, you **MUST** record the warranty claim code provided on the SPS Warranty Claim Code (WCC) screen on the job card. Refer to callout 1 above for the location of the WCC on the SPS screen.

2. Record SPS Warranty Claim Code on job card for warranty transaction submission.
