Subject: N202292220 - Service Update

Engine Heat Shield Missing Bolts

Models: 2020 Chevrolet Blazer

N202292220 Engine Heat Shield Missing Bolts – US Only

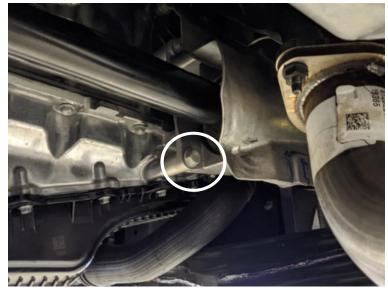
5515365

2. Locate missing front wheel drive half shaft shield bolt.
