GLOBAL SAFETY FIELD INVESTIGATIONS  
DCS5321  
URGENT - DISTRIBUTE IMMEDIATELY

Subject: N192216430 - Special Coverage  
Airbag Light On Due to PPS Sensor Disconnect

Models: 2014-2017 Chevrolet Impala  
Equipped with Front Heated Seats (RPO KA1)

## N192216430 Airbag Light On Due to PPS Sensor Disconnect

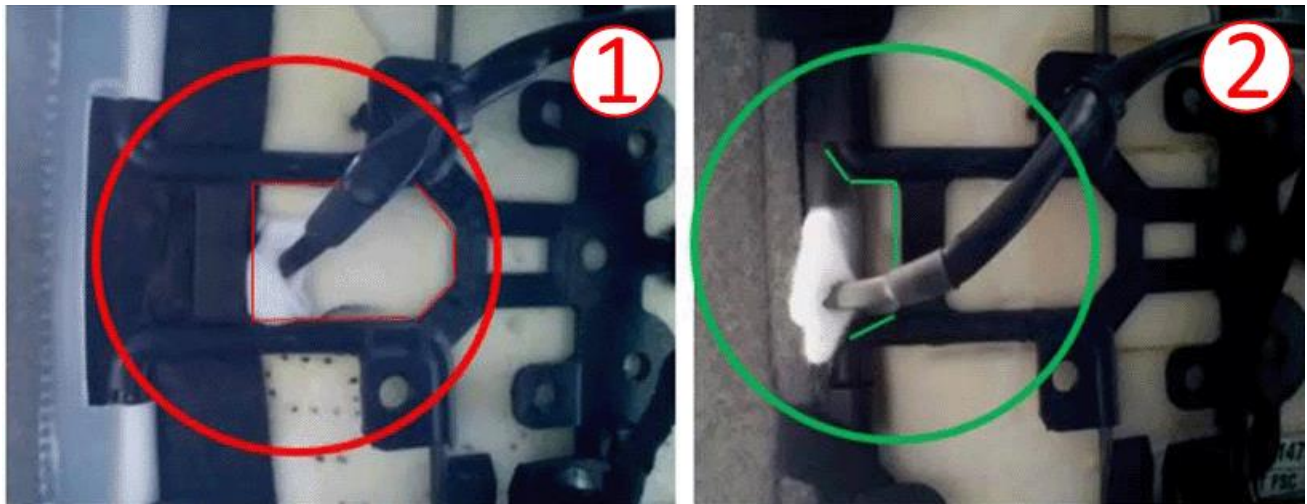
4920551

**Note:** The graphic above depicts the incorrect pigtail harness route (1) and the correct pigtail harness route after repair (2).

6. Reconnect all electrical connectors and install the trim cover. Refer to *Front Seat Cushion Cover and Pad Replacement* in SI.
7. Install the passenger side seat. Refer to *Driver or Passenger Seat Removal and Installation* in SI.
8. Check the PPS Module for any DTCs in history status and clear DTC.
9. Perform the Passenger Presence System Preload Test (PPS Setup). Refer to *Passenger Presence System Preload Test (PPS Setup)* in SI.
