GLOBAL SAFETY FIELD INVESTIGATIONS
DCS5331
URGENT - DISTRIBUTE IMMEDIATELY

Subject: N192286190 - Service Update
Fuel Leak Due to Accelerated Corrosion

Models: 2020 Chevrolet Silverado 2500/3500
2020 GMC Sierra 2500/3500
Equipped with 6.6L Diesel Engine (RPO L5P)

N192286190 Fuel Leak Due to Accelerated Corrosion

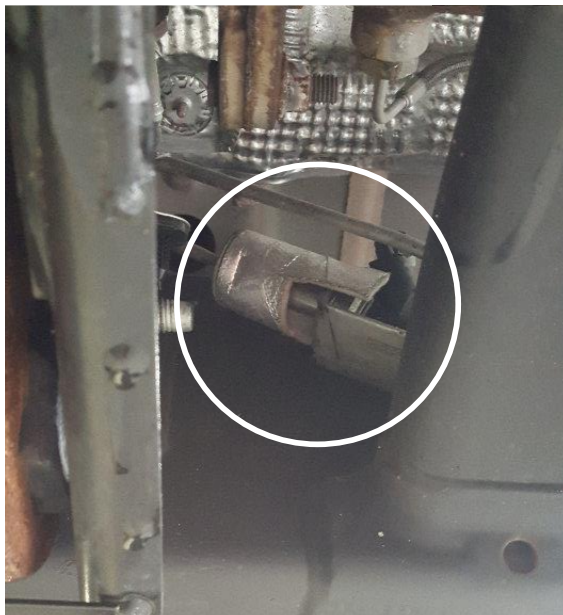
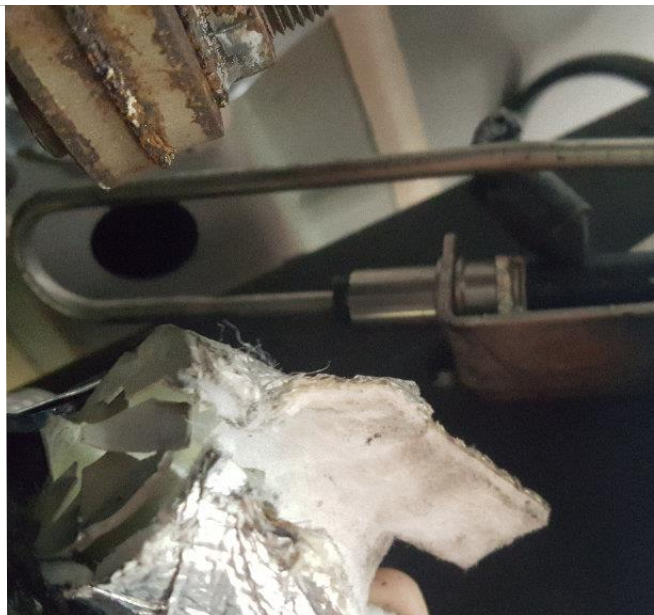
5515750

Condition	Certain 2020 model year Chevrolet Silverado 2500/3500 and GMC Sierra 2500/3500 vehicles may have a condition where the thermal cover may accelerate corrosion of the low pressure diesel hydrocarbon injector.
Correction	Dealers are to remove the low pressure diesel hydrocarbon injector thermal cover.

1. Lift the vehicle. Refer to *Lifting and Jacking the Vehicle* in SI.
2. Locate the hydrocarbon injector in the exhaust behind the torsion bar crossmember as shown.
3. Using wire cutters or tin snips, carefully cut the heat shield off the hydrocarbon injector and discard it.
4. Lower the vehicle. Refer to *Lifting and Jacking the Vehicle* in SI.
