GLOBAL SAFETY FIELD INVESTIGATIONS
DCS5334
URGENT - DISTRIBUTE IMMEDIATELY

Subject: N192285430 - Service Update
Engine Control Module Calibration Error

Models: 2020 Chevrolet Silverado HD
2020 GMC Sierra HD
Equipped with Diesel Engine, 8 CYL, 6.6 L (RPO L5P)

N192285430 Engine Control Module Calibration Error

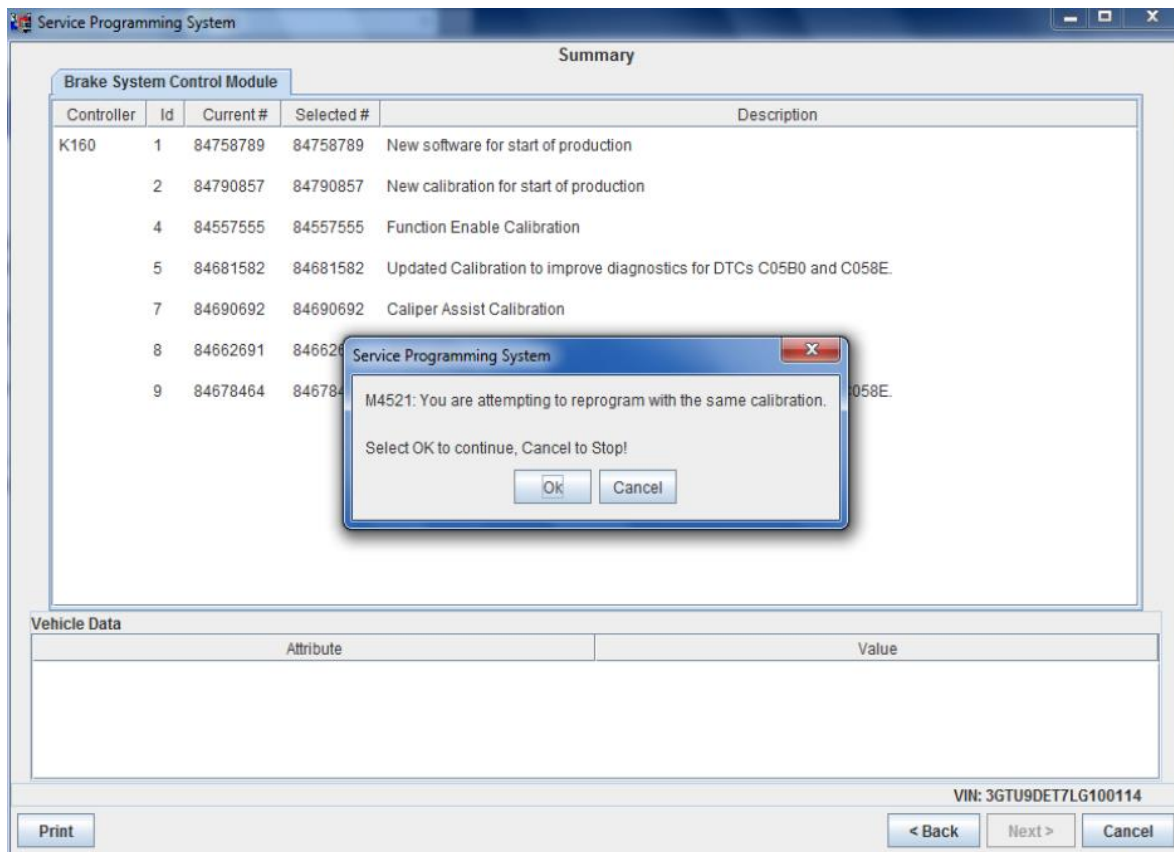
5431207

Important: If the Same Calibration/Software Warning is noted on the SPS screen, select OK and follow screen instructions. After a successful programming event, the WCC is located in the Service Programming System dialogue box of the SPS Summary screen. No further action is required. Refer to the Warranty section of the bulletin.

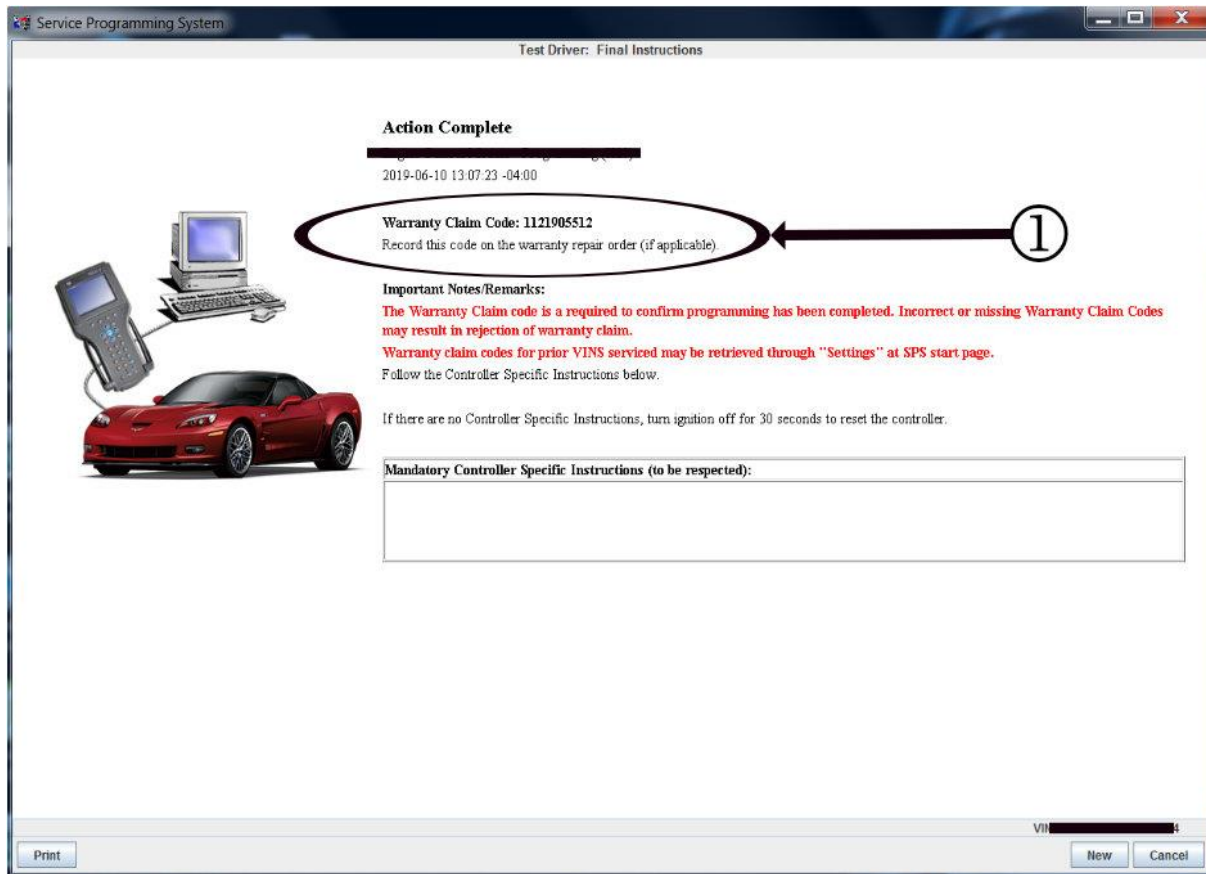
5431209

Important: To avoid warranty transaction rejections, you **MUST** record the warranty claim code provided on the SPS Warranty Claim Code (WCC) screen on the job card. Refer to callout 1 above for the location of the WCC on the SPS screen.

- Record SPS Warranty Claim Code on job card for warranty transaction submission.
