GLOBAL SAFETY FIELD INVESTIGATIONS DCS5335 URGENT - DISTRIBUTE IMMEDIATELY

Subject: N192287890 - Service Update

Dash Panel Silencer Attachment Stud Lacks Clearance

Models: 2020 GMC Acadia equipped with:

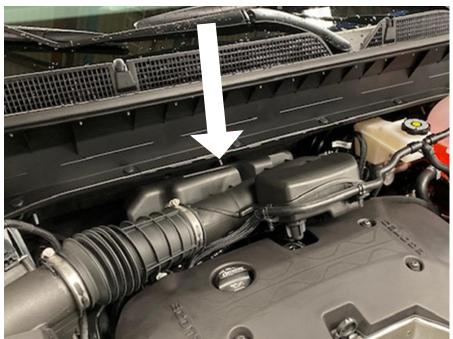
5515714

Condition	On certain 2020 model year GMC Acadia vehicles, equipped with a 2.5L engine (RPO LCV), the dash			
	panel silencer attachment stud may lack sufficient clearance to the intake manifold resonator. When the			
	engine is under load, the stud could make contact with the resonator.			
Correction	Dealers will cut off 6mm of the center stud.
