## MBUX multimedia system: Vehicle position on navigation map inaccurate/route guidance inaccurate

| Topic number | LI82.85-P-070427 |
| Function group | 82.85 Navigation and Communication systems |
| Validity | BR253 with code 547/548/549 and 365<br>BR293 with code 547/548/549 and 365 |

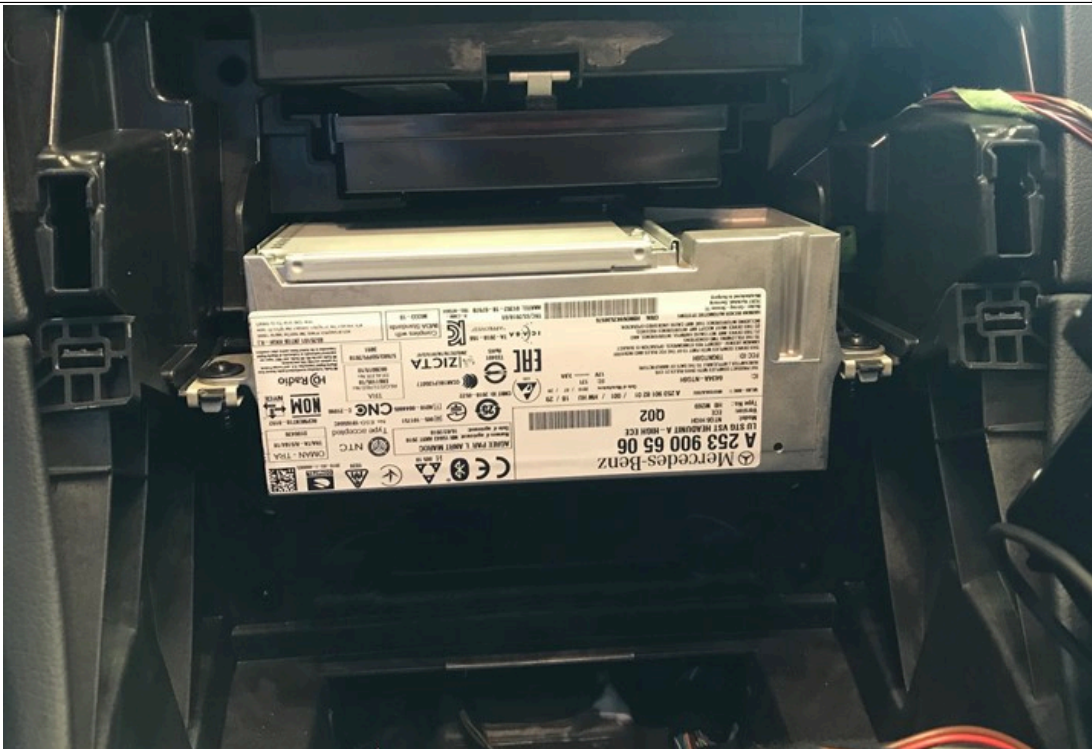
| 253 correct MBUX installation.jpg: |

Incorrect installation of the MBUX multimedia system (A26/17)

| Attachments | |
|---|---|
| 253 correct MBUX installation.jpg | Correct installation position |

Check installation position of the MBUX multimedia system (A26/17) and correct if necessary (see attachment for proper positioning, NOTE: label may be upside down when positioned correctly, do not use the label as a reference).

After correcting the head unit installation position, enter "Dealer Mode" by holding down the "Home" button on the touchpad and the "Radio/Media" button on the upper control panel simultaneously. Select "navigation" -> "Reset Positioning Calibration Data".
