Technical Service Bulletin

60 Panoramic sunroof noises

60 20 40 2054203/4 March 12, 2020. Supersedes Technical Service Bulletin Group 60 number 19-37 dated November 18, 2019 for reasons listed below.

Model(s)	Year	VIN Range	Vehicle-Specific Equipment
Q7	2017	All	Not Applicable
Q7	2018	000001 - 044739	Not Applicable

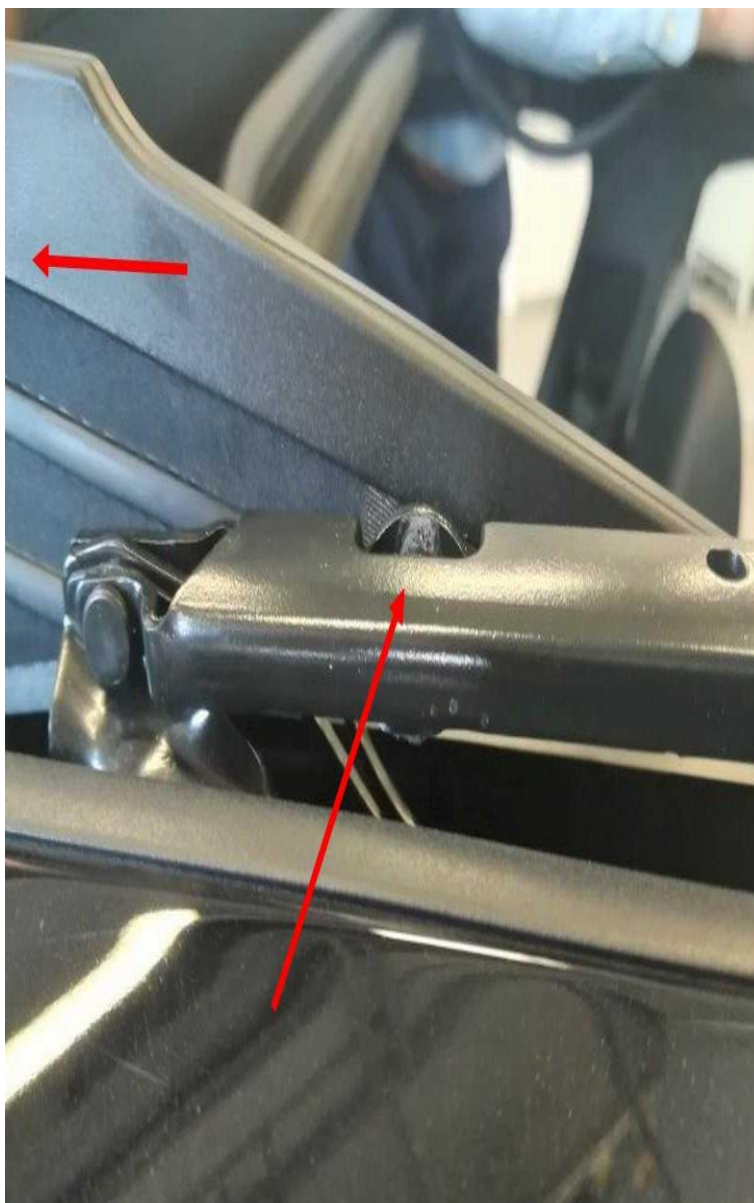
2. Figure 3 shows the left slide and tilt mechanism. The upper left arrow points to the front of the vehicle. The lower arrow points to the first mounting point of the glass panel.

Figure 3. The left side of the slide and tilt mechanism.

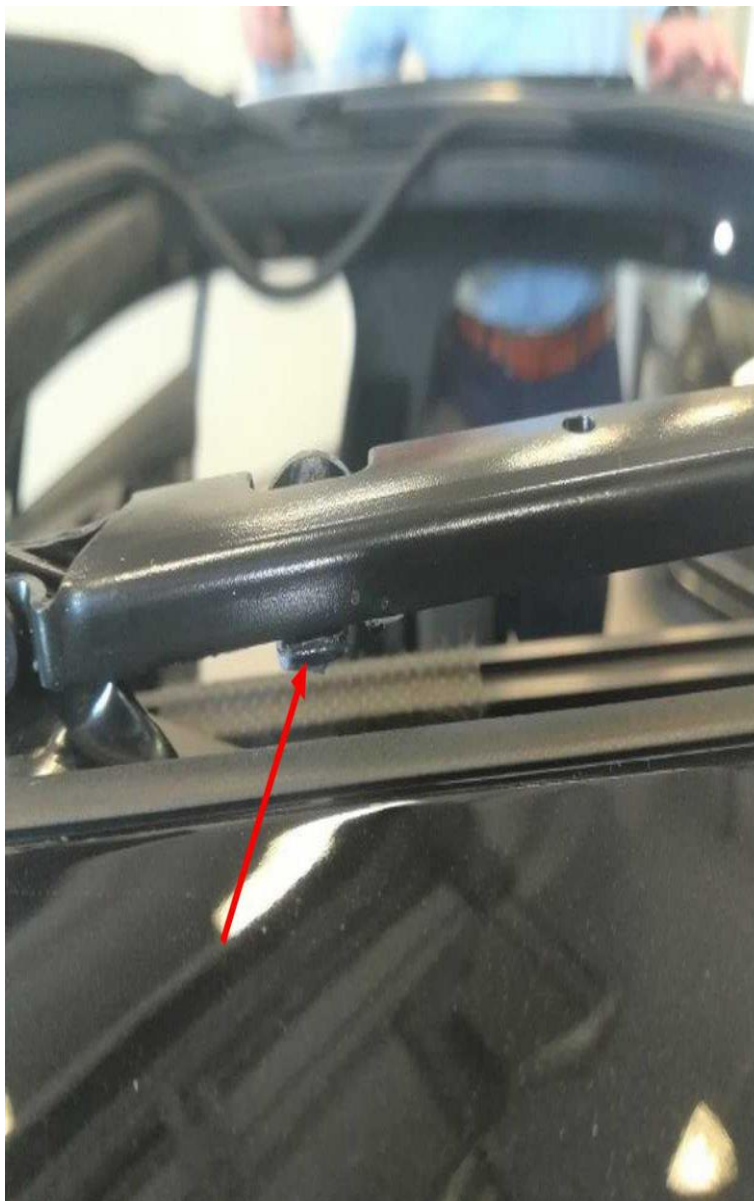
Figure 4. Lug to be lubricated on slide and tilt mechanism.

3. There is a lug under the first mounting point (Figure 4, red arrow). This point has to be lubricated with G 060 567 A2 lubricant.

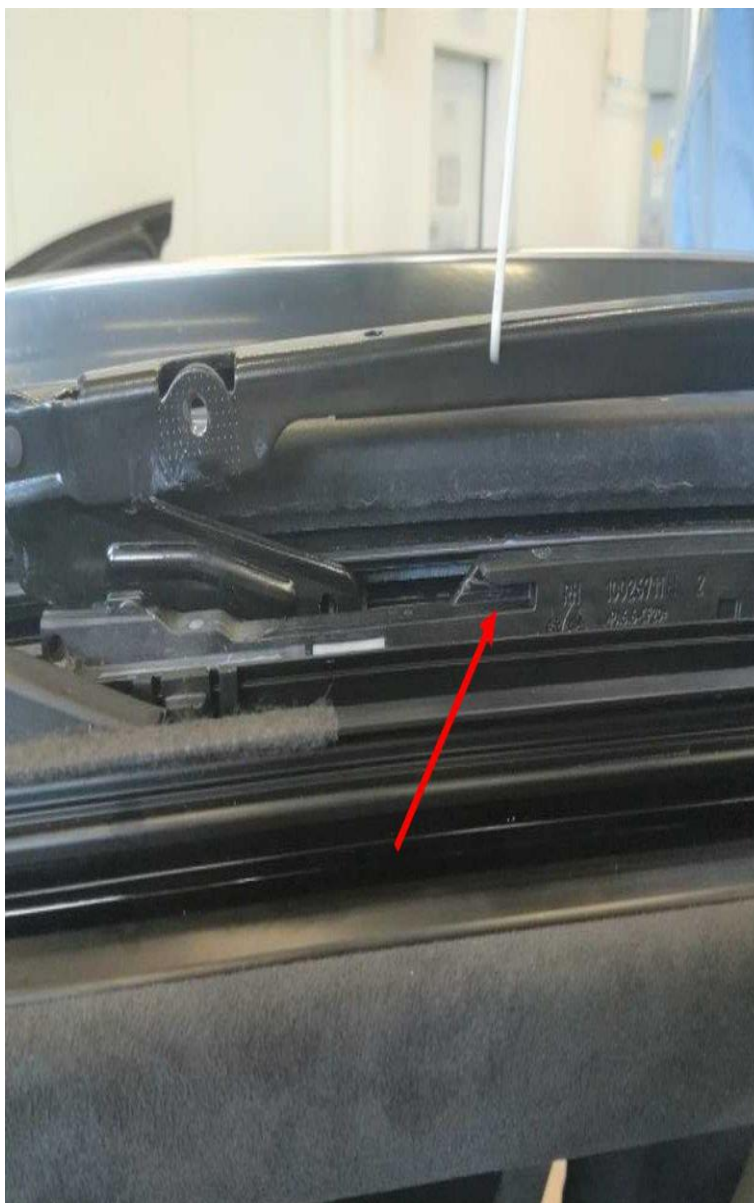
Figure 5. The groove in the slide and tilt mechanism.

4. Figure 5 and 6 shows the right slide and tilt mechanism from the inside. The groove indicated by the red arrow should be lubricated with G 060 567 A2 lubricant.

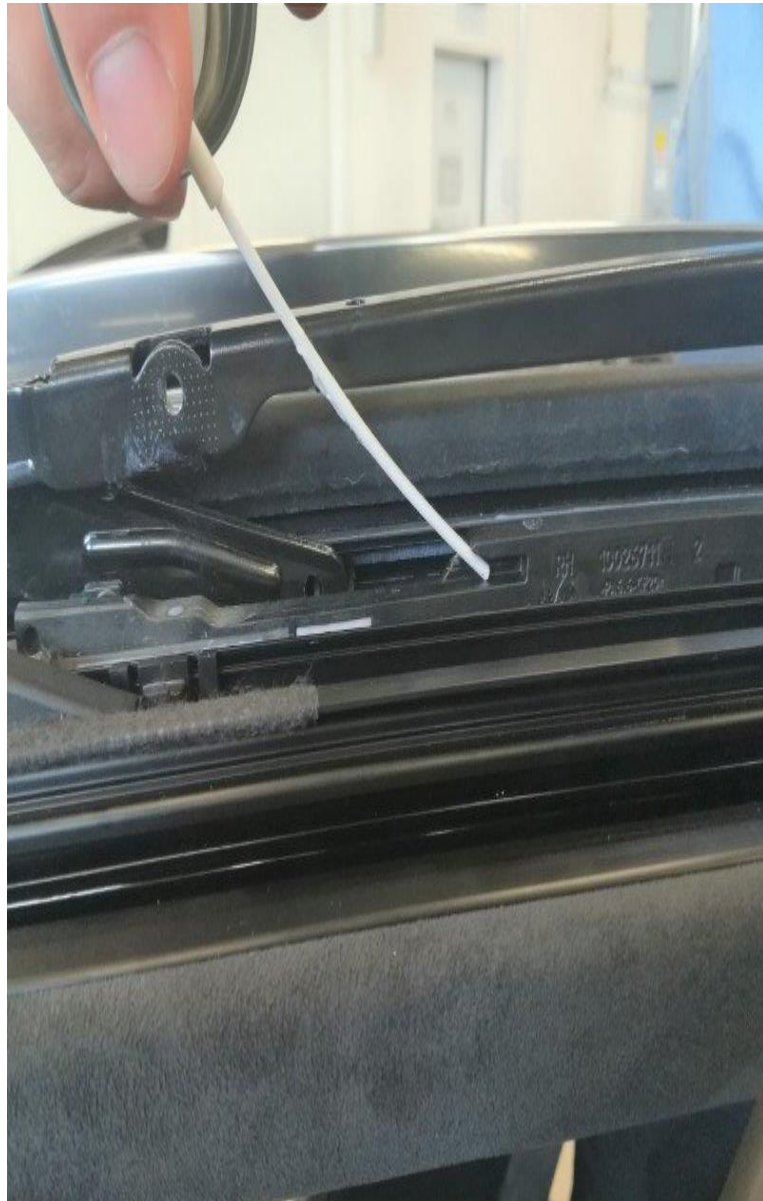
Figure

6. *Lubricating the groove in the slide and tilt mechanism.*

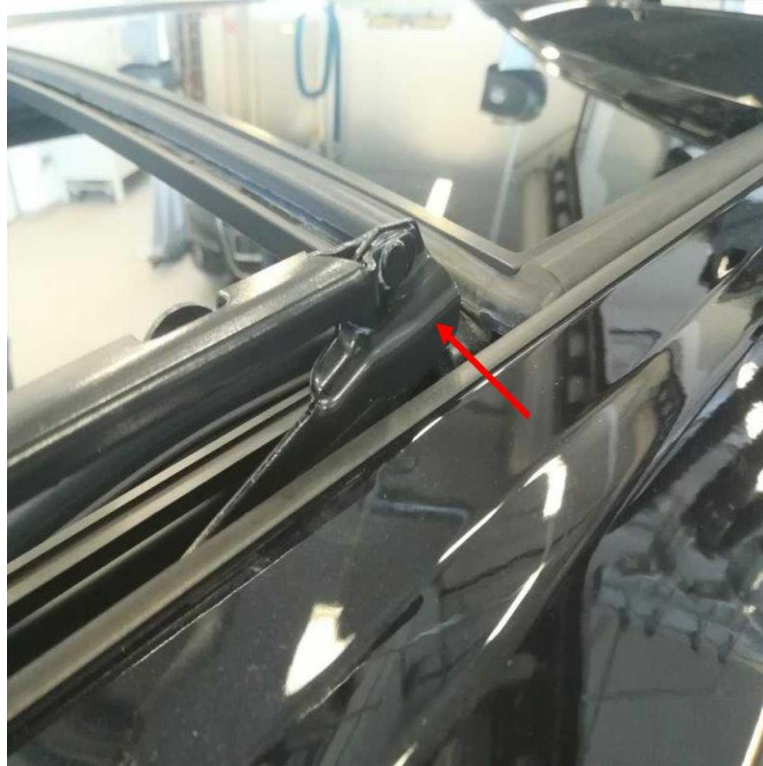
Figure 7. Section of slide and tilt mechanism to be lubricated.

5. Figure 7 and 8 shows the rear section of the left side and tilt mechanism that must be lubricated with G 060 567 A2 lubricant. The outer area of this bracket will be lubricated (see red arrow).

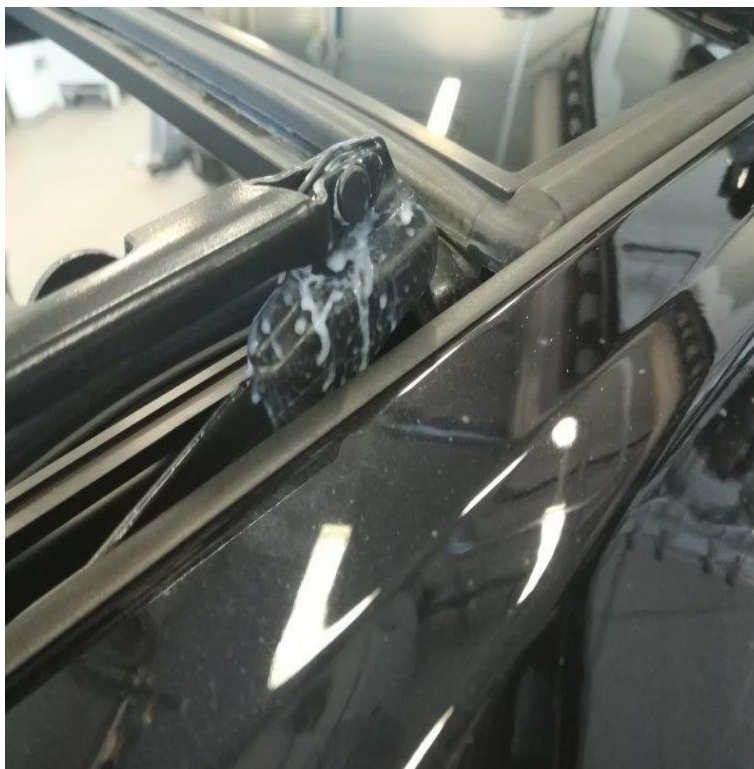
Figure 8. *The bracket after lubrication.*

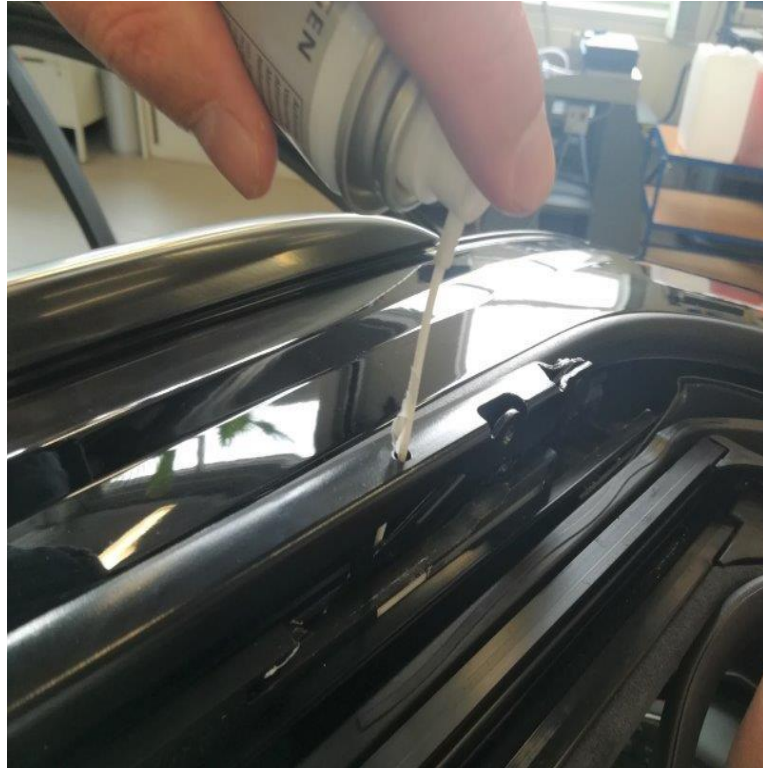
Figure 9. Accessing the channel through the arm of the slide and tilt mechanism.

6. Figure 9 and 10 shows the left front slide and tilt mechanism. The channel that must be lubricated can be accessed with the spray tube through the first hole in the arm as shown.

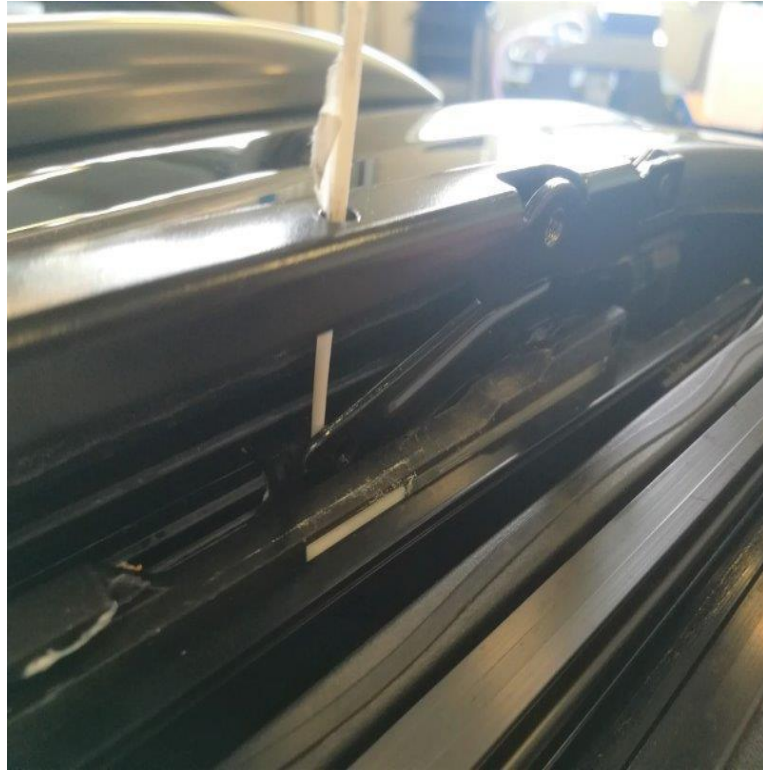
Figure 10. Close up view of the lubrication of the channel under the arm of the slide and tilt mechanism.
