# Technical Service Bulletin

## 90 Instrument cluster: the right databox above the speedometer stays empty

90 20 40 2058749/1 March 3, 2020.

Model(s)	Year	VIN Range	Vehicle-Specific Equipment
A6, A7, A8, Q7, and Q8	2020	All	Audi virtual cockpit (plus)

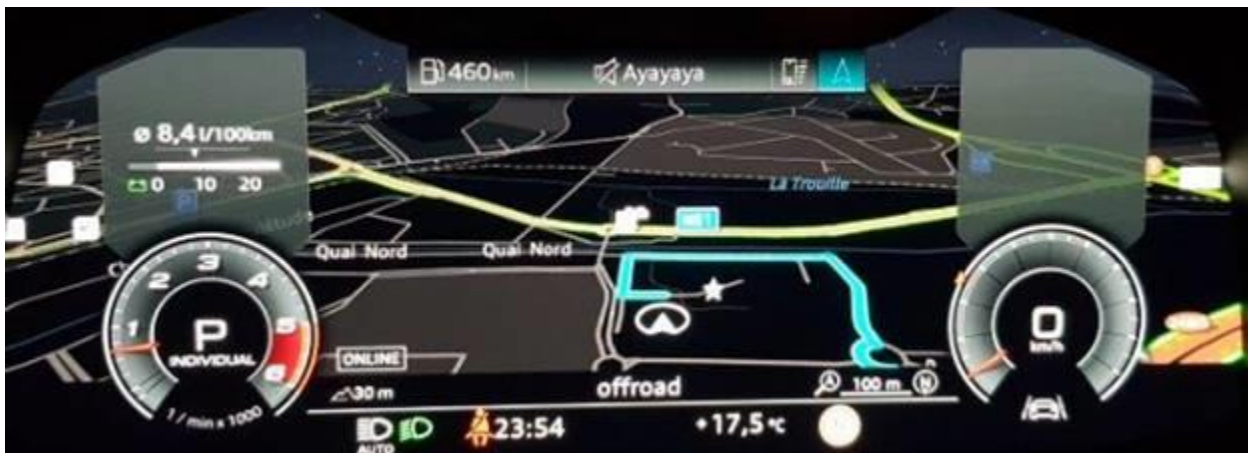
- The small databox on the right side of the Audi virtual cockpit above the speedometer remains empty despite an active route guidance (Figure 1).

Figure 1. Databox is empty during active route guidance.

A software bug in the Audi virtual cockpit can cause the box to remain empty.

1. Follow all instructions in TSB 2056558: *MIB2+: Software Update Instructions*.

2. Update the instrument cluster control module, J285 (address word 0017) using the SVM action code as listed in the table below, if necessary:
