Technical Service Bulletin

91 Trunk lid taillight does not work or flickers, DTC B16D5F1/B16DF52/B16D5F6/B16D7F1/B16D7F6 stored in comfort module

91 20 42 2058647/1 March 2, 2020.

Model(s)	Year	VIN Range	Vehicle-Specific Equipment
Audi e-tron quattro	2019	000001 – 025632	Not Applicable

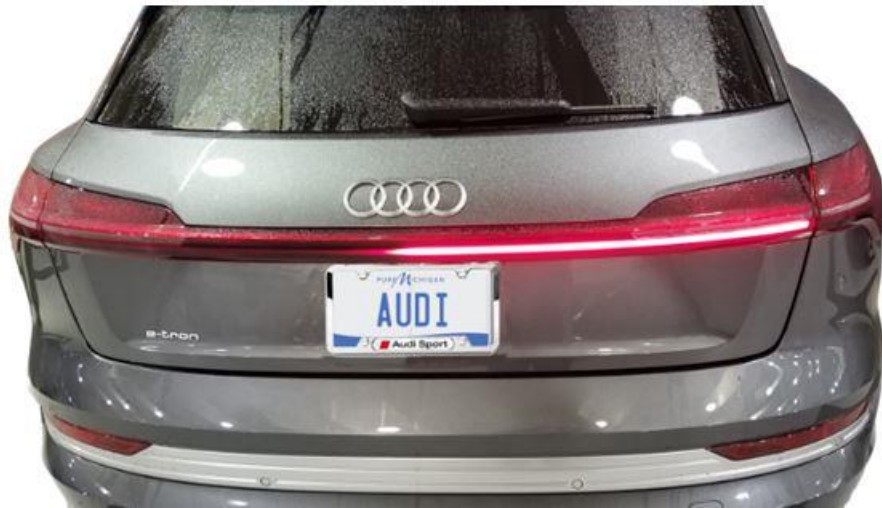
High resistance may form between the printed circuit board and LED contact points within the trunk lid taillight.

This can cause the light to flicker or only be partially lit (Figure 1).

Figure 1. Partially lit trunk lid taillight.

1. Attempt to duplicate the customer concern and compare faults to the workshop findings section of this TSB.
2. If the customer concern and/or the faults match, replace the center taillight. Ensure the GFF log is uploaded to GFF paperless.
