Service Bulletin

Bulletin No.: 17-NA-106

Subject: Interior Cabin Boom, Vibration and/or Rumbling/Droning Noise Heard While Driving Low Speeds in High Gear

Brand:	Model:	Model Year:		VIN:		Engine:	Transmission:
		from	to	from	to		
Chevrolet	Equinox	2018	2020			All	All
GMC	Terrain						
Holden	Equinox

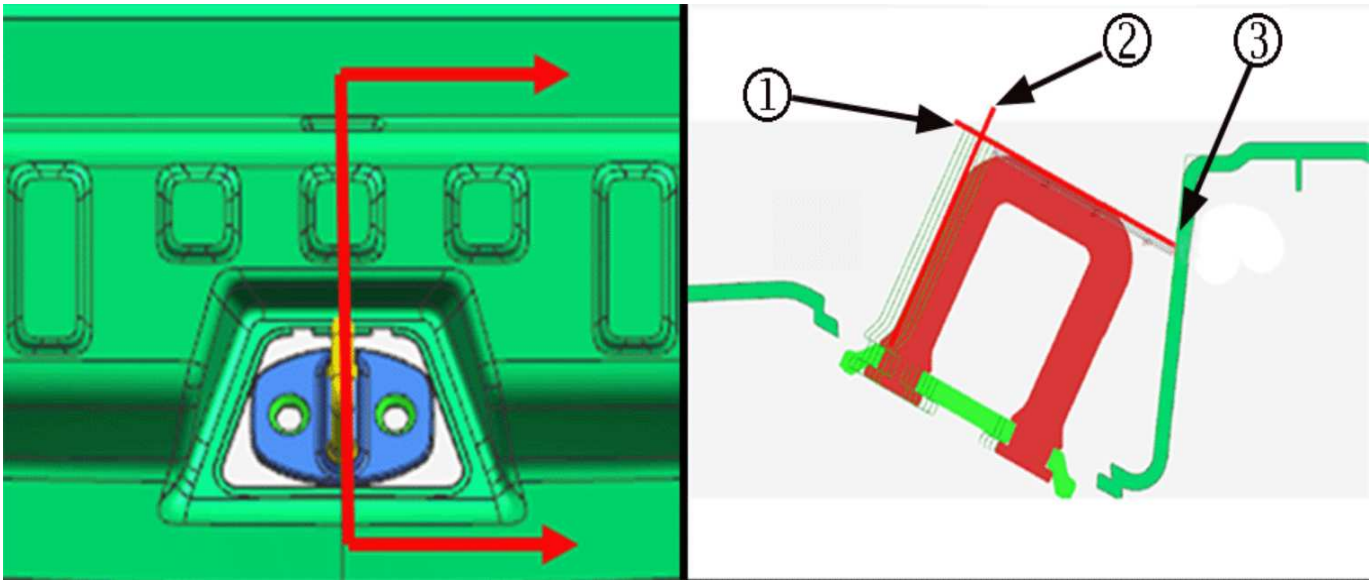
4772397

1. Verify the condition by road testing the vehicle:
 - 1.1. Increase the vehicle speed above 38 mph (61 km/h), then allow the vehicle to shift into a high gear to bring engine speed below 1500 rpm.
 - 1.2. Slow the vehicle down to the minimum speed that holds high gear (typically 35-36 mph (56-57 km/h) for FWD, 32-33 mph (51-53 km/h) for AWD, and evaluate boom noise during steady speed driving.
 - 1.3. Then lightly apply throttle to slowly accelerate and evaluate boom noise under engine load.
2. Once the condition is verified, open the liftgate.

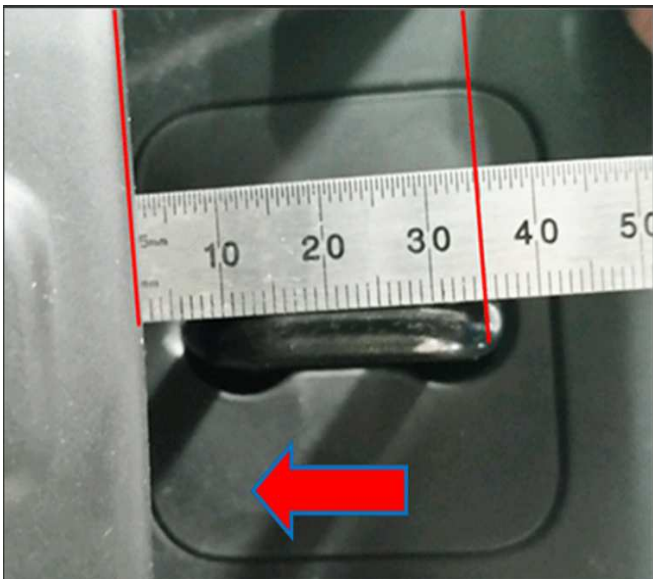
4772398

3. Lay a scale/ruler (1) on top of the liftgate striker and measure the striker position from the rear most edge (2), to the trim panel (3).

- If the striker position measures different than 38 mm (1.50 in), as shown in the graphic example above, continue to the striker adjustment in step # 4.
- If the striker position measurement is 38 mm (1.50 in), the positioning is correct. Jump ahead to the liftgate bumper adjustment in step # 7.

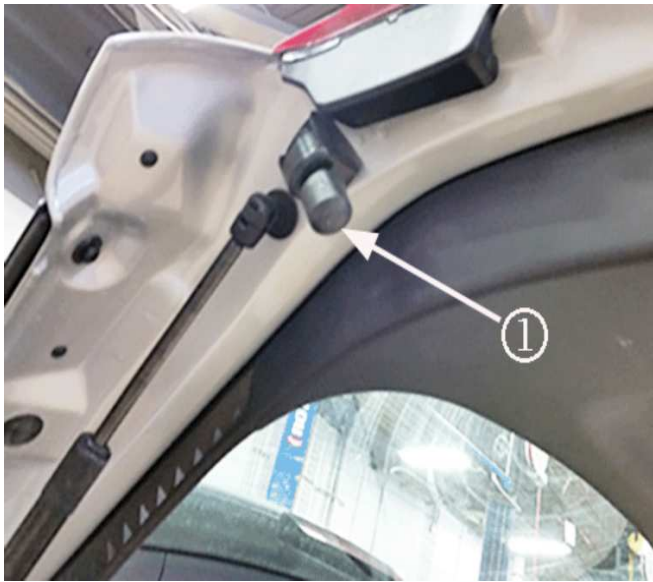
4756821

7. Locate the upper liftgate bumpers (1), one on each side.
