Service Bulletin

Bulletin No.: 17-NA-152

Subject: Front Power Seat Slight Rocking Movement While Shifting Weight from Seat, During Hard Stops, and/or When Driving Over Rough Road Surface

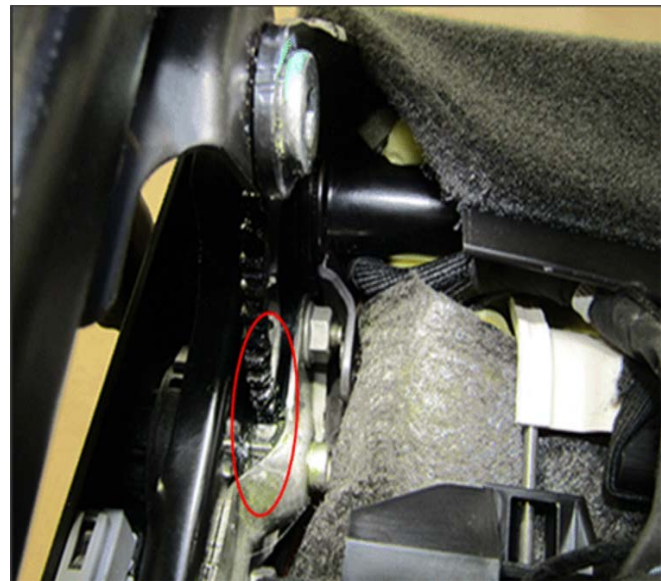
4975757

Note: The intent on applying a load to the height adjuster motor is to force full gear mesh, and lessen any teeth clearance between the gear on the actuator and the sprocket on the seat track, reducing seat movement.
