Service Bulletin

Subject: Ticking, Rattle and/or Buzzing Noise Heard from inside Passenger Compartment, Possible Fuel Leak

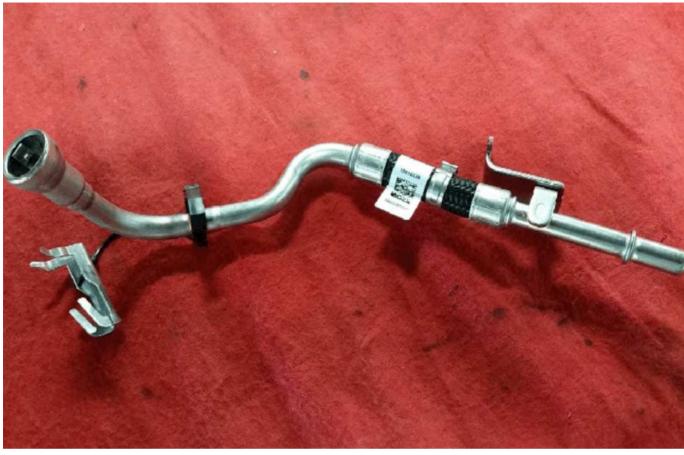
Low pressure fuel feed jumper pipe at engine

Install a new low pressure fuel feed jumper line at the engine, and replace the original design fuel feed line at the tank with the appropriate updated design PN listed in the Parts table, following the procedure below.

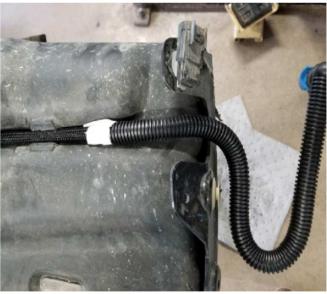
4863840

Updated design fuel feed line at tank
