VEDQuality

Status – Ford

Autonomous Mobility and Safety | Vehicle Dynamics

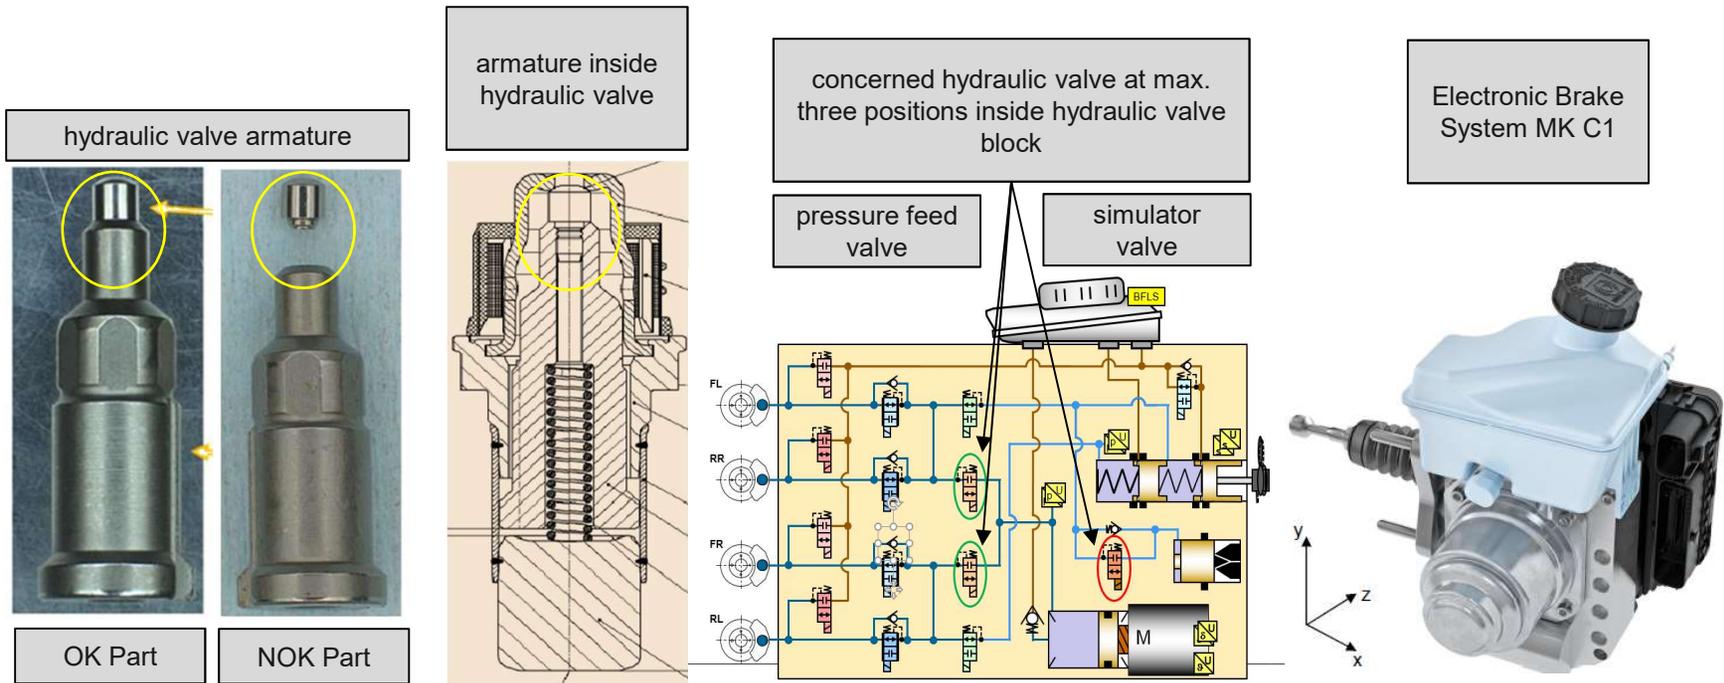
Defect Description

- › 8 x 0-mileage Complaints from Customer
 - › 6 x from BMW
 - › 2 x from Ford
 - › Defect at simulator valve – Customer Complaint = *“hard brake pedal”*
 - › Defect at pressure feed valve – Customer Complaint = *“pressure feed valve unwanted open” – DTC0x4808D1, Red & Yellow warning light ON*
- › Suspected time frame from **7th to 30th of January 2020** based on production dates of valves investigated and found with cracked plunger
- › Tear down and analysis of valves from suspect time frame (Morganton stock)
 - › 6 out of 315 plungers found cracked = 1,93% NOK
(with 90% confidence level NOK rate is within 0,83%-3,72%)
 - › Depending on MK-C1 variant, either 2 or 3 valves are used inside 1 hydraulic valve block
 - › HECU variant with 3 valves, expected NOK rate = 2,47 to 10,8%
 - › HECU variant with 2 valves, expected NOK rate = 1,65 to 7,30%

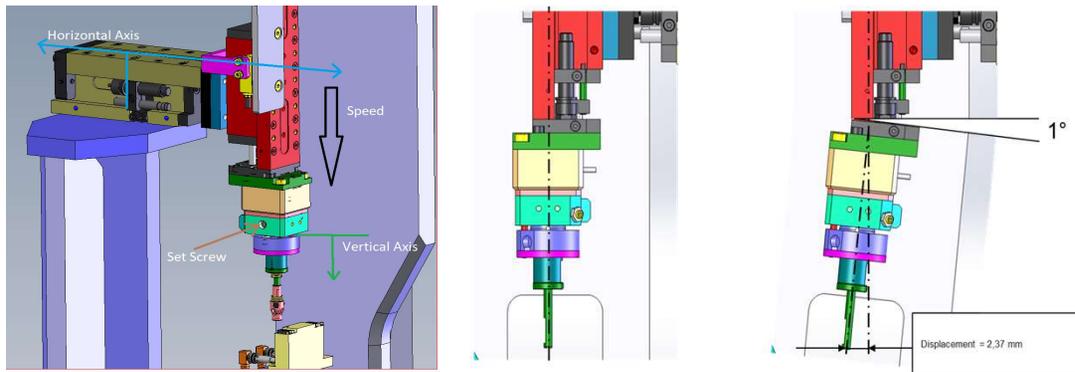
Root Cause at Valve Assembly Continental Plant Morganton

- › Due to crash at the armature assembly station the assembly axis became misaligned
- › Machine stopped and Technician adjusted the alignment w/o recognizing a permanent deformation – after adjustment line was re-started
- › Due to the self centering capability of the assembly head, the machine started to create sporicidal failures – with detection of cracked plunger inside a customer return part, assembly line was stopped at 6th of February
- › Clean date of further completed MK C1 units deliveries with containment valves from sister plant Mechelen in Belgium – 7th of February
