Service Bulletin

Bulletin No.: 20-NA-039

Subject: Malfunction Indicator Light (MIL) Illuminated - DTC P200A, P2384, P111E, P0071, P214E, P2B60, P1010, P226D, P24B0, P2C7A and/or P14D9 Set

Brand:	Model:	Model Year:		VIN:		Engine:	Transmission:
		from	to	from	to		
Chevrolet	Silverado 1500	2020	2020			LM2	
GMC	Sierra 1500

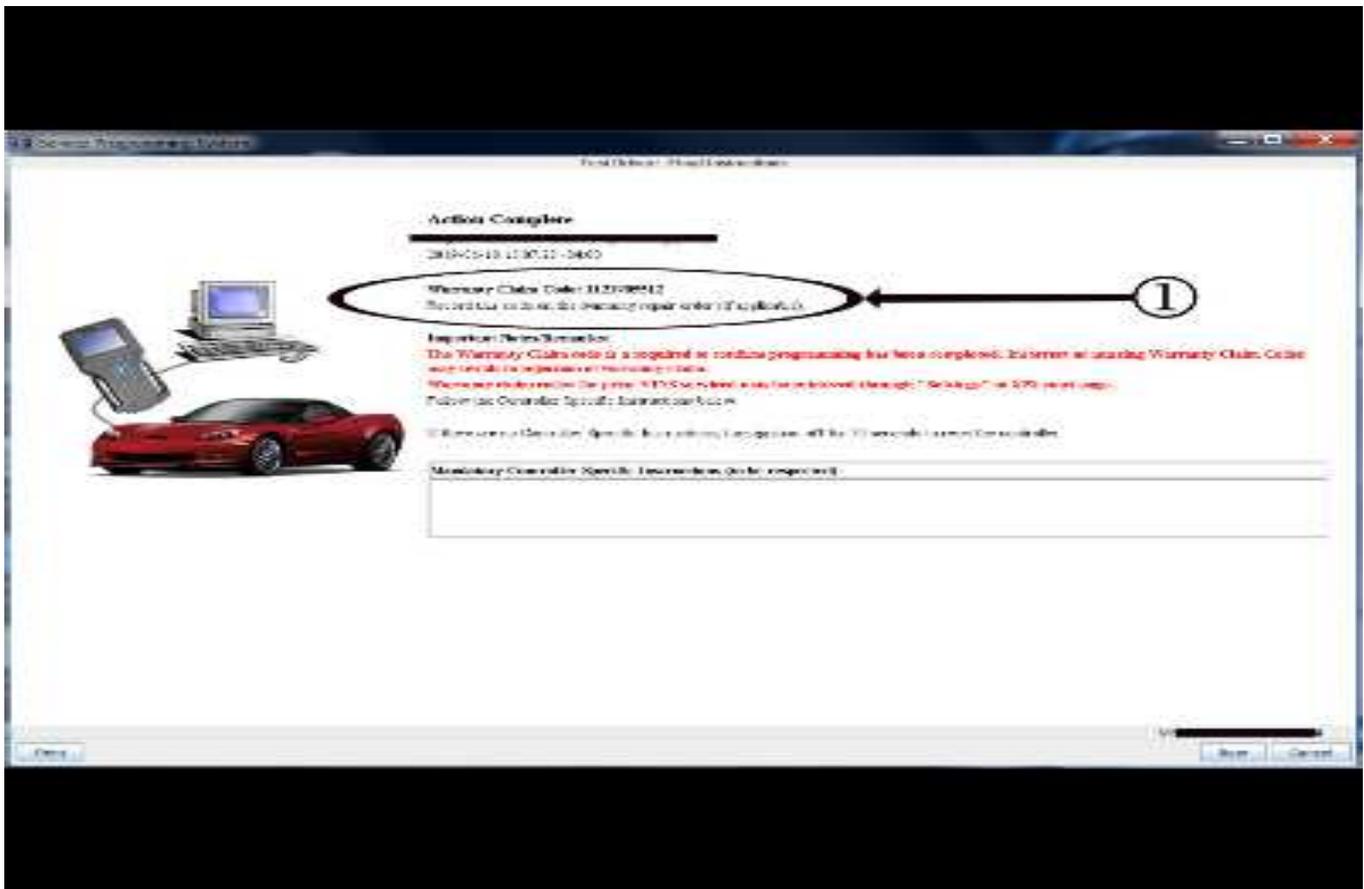
5431209

Important: To avoid warranty transaction rejections, you **MUST** record the warranty claim code provided on the SPS Warranty Claim Code (WCC) screen on the job card. Refer to callout 1 above for the location of the WCC on the SPS screen
