Service Bulletin

Bulletin No.: 20-NA-040

Subject: Pickup Box Power Endgate May Not Open on Initial Press, or May Not Open at All

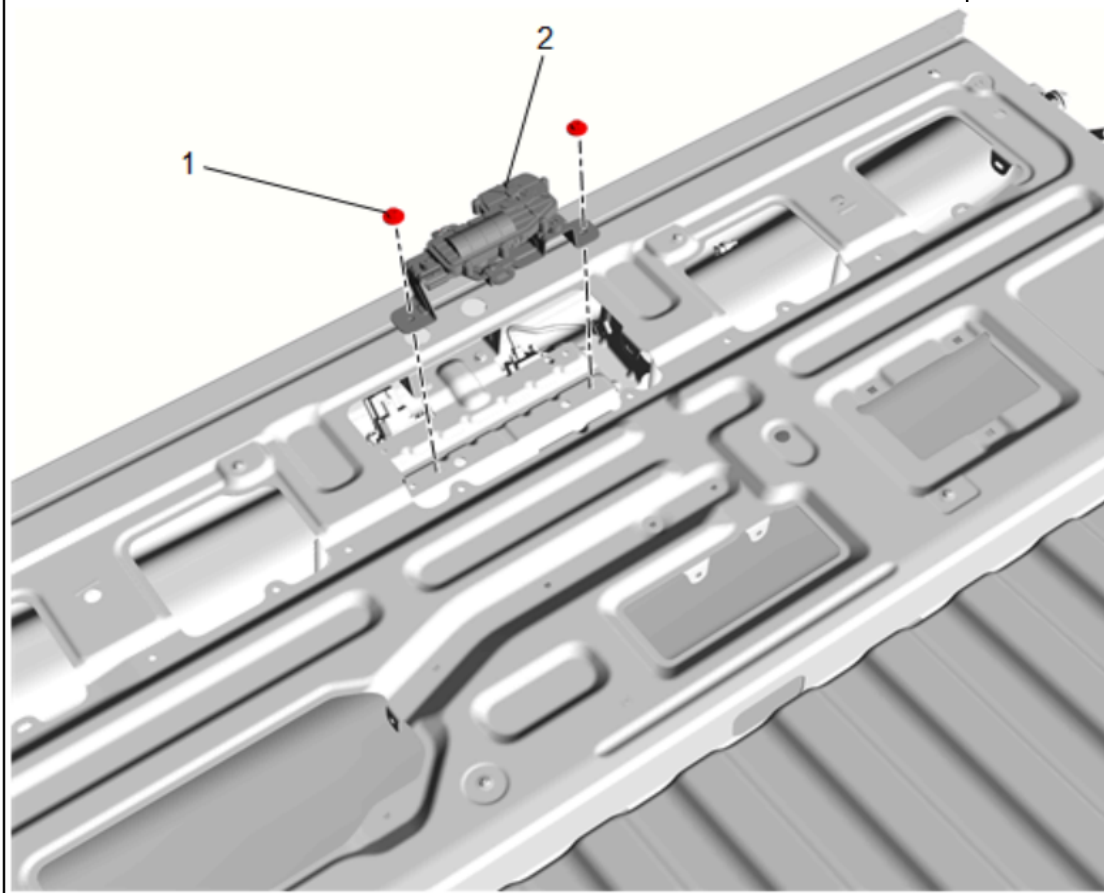
5049815

Involved Region or Country	North America, Europe, Russia, Middle East, Israel, Palestine, South America, Philippines, Australia, New Zealand, Egypt, Africa, South Africa
Additional Options (RPOs)	Equipped with QK1 and QK5
Condition	Some customers may comment on the power endgate may not unlatch or drop on first try, or under some conditions, it may not open at all.
Cause	The cause of the condition may be a combination of excessive spring force and low available voltage, which may cause the latch actuator to fail to function.
Preliminary Procedure	<p>Some vehicles, which have a tonneau cover installed, may be affected by a similar Condition, however the Cause and Correction are completely different from this bulletin. On these vehicles, it will be necessary rule out the tonneau cover as the possible Cause of the condition:</p> <ol style="list-style-type: none"> 1. Open the rear end panel of the tonneau cover. 2. Cycle the power tailgate 5 times using push button activation for auto open and auto close. <ul style="list-style-type: none"> • If the power endgate Does function properly, DO NOT proceed with this bulletin repair, but move on to Bulletin # 20-NA-044 and complete the tonneau adjustment procedure. • If the power endgate still DOES NOT function properly, continue on and complete the Correction outlined in this bulletin.

Upon verifying the condition, replace the pickup box endgate lock actuator (2) with an improved design service part. Refer to *Pickup Box Endgate Lock Actuator Replacement (Power)* in SI.
