Service Bulletin

Bulletin No.: 20-NA-044

Subject: Endgate Will Not Auto Open or Auto Close After Accessory Tonneau Cover Installation, and/or Poor Fit of Tonneau Cover to Endgate

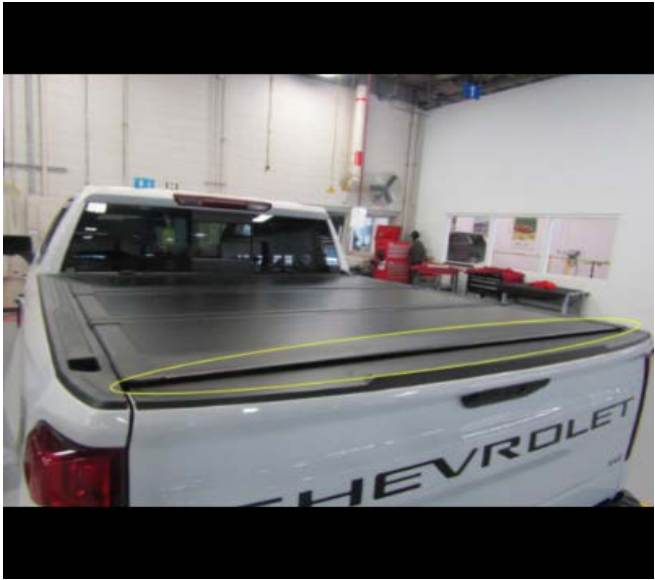
<p style="text-align: right;">5527998</p> <p>The cause of the condition may be by excessive interference between the endgate and the tonneau cover.</p>
<p>Correction</p>	<p>Adjust the tonneau cover can following the steps in the Service Procedure below.</p> <ul style="list-style-type: none"> • If the tonneau cover is a GM accessory, follow the adjustment procedures in the Service Procedure below. GM tonneau covers are only the listed part numbers in the tables below. • If the tonneau cover is non-GM (IBP), contact the manufacturer of cover for specific adjustment instructions. Non-GM tonneau covers can be identified by non-GM branding. Contact information for the manufacture can be found with the installation instructions provided with the kit, or by searching the part number in the Electronic Parts Catalog.

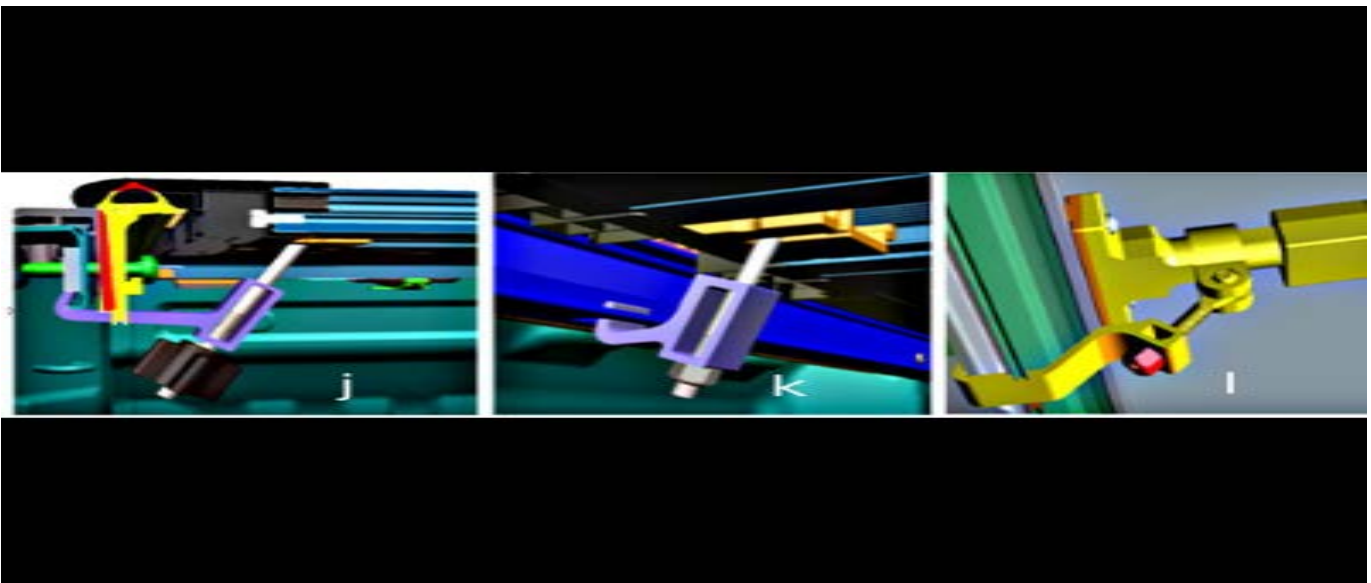
5527999

Note: The clamps noted above are examples of the, Hand Knob Style (1), Newer Version (2) and Soft Tri-fold (3).

1. Open the tonneau cover to the full open position and secure with stowage straps.
2. Locate the forward clamp on the side rails.
3. Using an 11mm wrench, loosen the clamp nut, while holding the hand knob to prevent the clamp bolt from releasing.

4. Loosen hand knob of the clamp. **(Knob is on Hard Tri-fold Only).**
5. Slide the clamp assembly inboard to release the clamp from the pickup box.
6. If installed, disconnect the safety tether.
7. Repeat steps #2 - 6 on the opposite side.
8. Remove the tonneau cover assembly.
